SAMPLE RESERVE STUDY REPORT

St. John's Church and School

REPLACEMENT RESERVE REPORT

ST. JOHN'S CHURCH AND SCHOOL

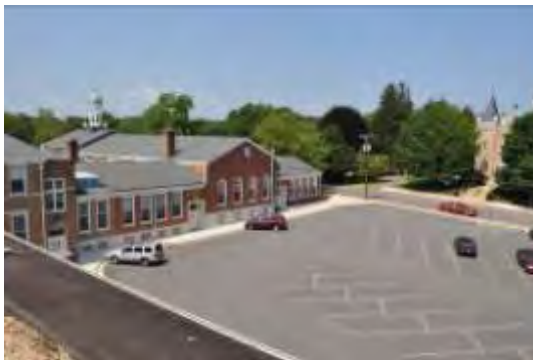
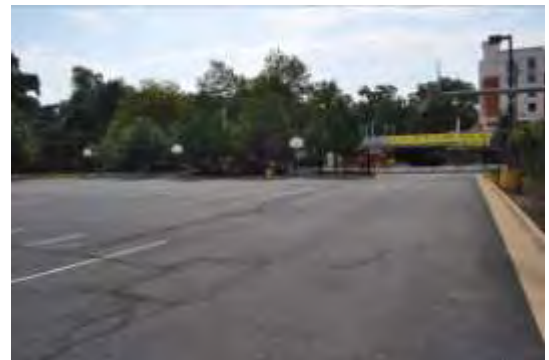
Asphalt Pavement. The Church is responsible for the parking areas, and paths within the facility. In general, the Church's asphalt pavements are in good condition.

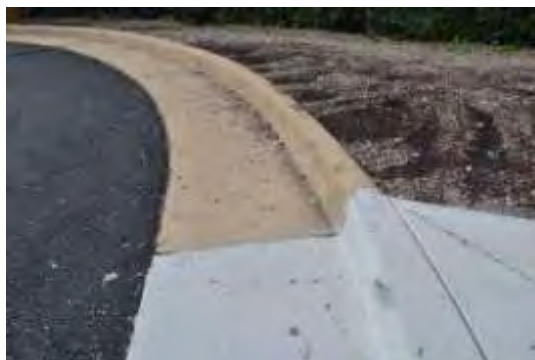
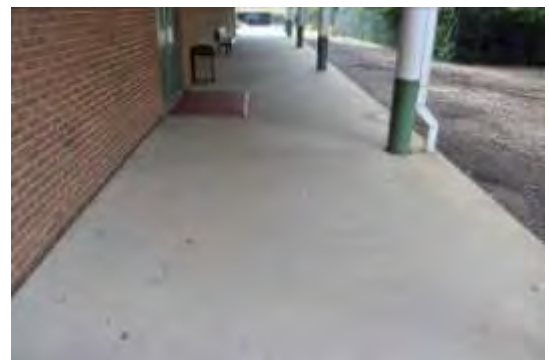
Concrete Work. The concrete work includes the community curbs, sidewalks, leadwalks, stairs, stoops, and other flatwork. We have modeled for curb replacement when the asphalt pavement is overlaid. The overall condition of the concrete work is good.

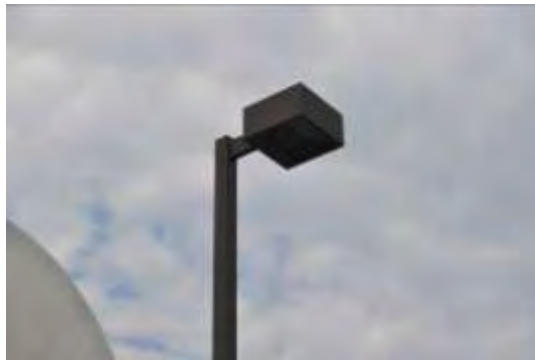
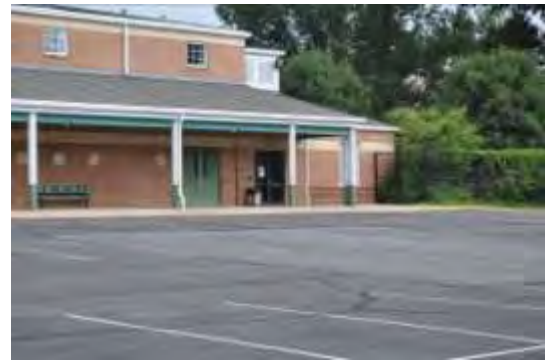
Site Lighting. The Church is responsible for the operation of the facility's site lights, and there are poled streetlights, and building mounted lights. The lighting system was not on at the time of our site visit. We understand that the lighting system is in operating condition.

This study assumes replacement of the light fixtures every 15 to 20 years, and pole replacement every 30 to 40 years. When the light poles are replaced, we assume that the underground wiring will also be replaced.

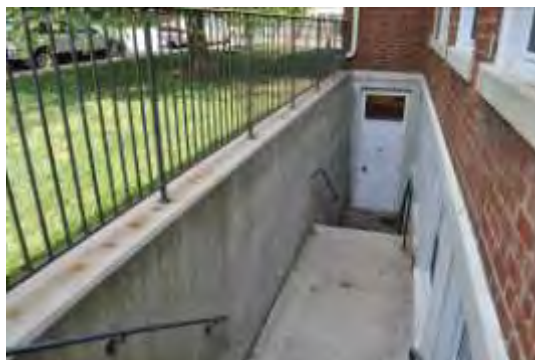
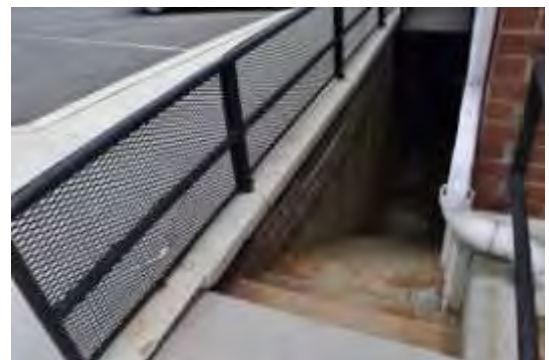
Retaining Walls. The Church maintains masonry, poured concrete and stone retaining walls. The retaining walls are in mixed condition relative to the age of the installation.

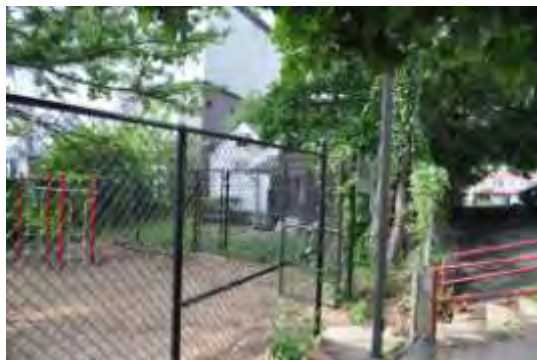
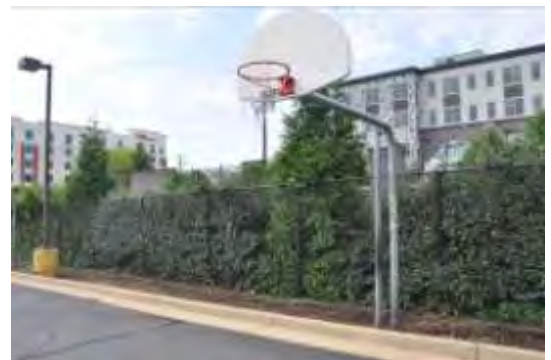
Fencing. The Church maintains metal fencing that is in generally good condition. Fencing systems have a large number of configurations and finishes that can usually be repaired as a maintenance activity by replacing individual components as they become damaged or weathered.

Protection from string machine damage during lawn maintenance can extend the useful life of some fence types. Protection from this type of damage is typically provided by applying herbicides around post bases or installing protective sheathing.

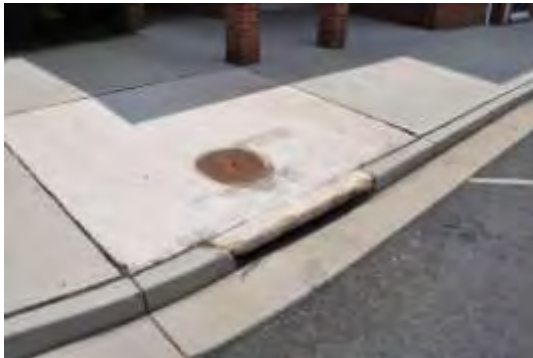
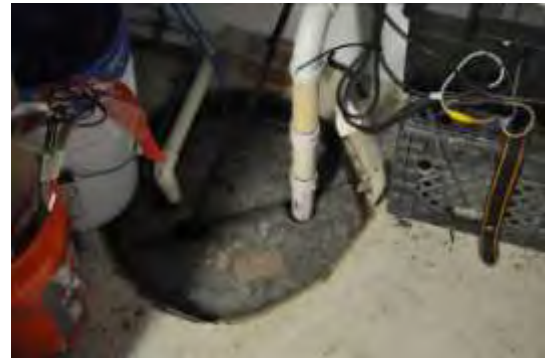
Storm Water Management. Storm water can be problematic in areas with high runoff water or dramatic changes in elevation. Typically, the majority of storm water management systems are maintained by the county or municipality. This study attempts to include the portions of the system are considered common property. The share line between municipality and community responsibility is often obscure and subject to the judgment of the county authority.

Storm water management components include the entire network of underground piping, runoff beds, swales, drains, French drains, curb inlets, drop inlets, and site grading. Many installations have a service life equal to or greater to the life of the life of the community and will not require replacement.

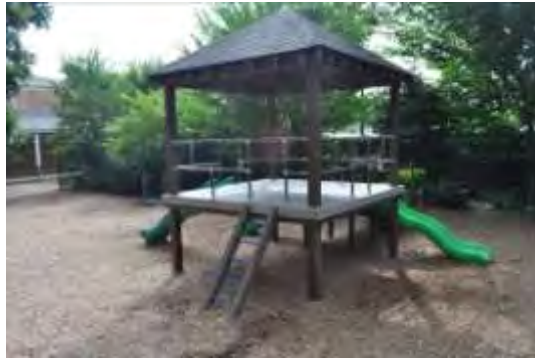
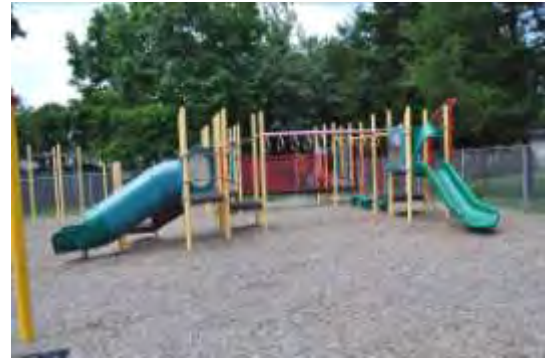
Tot Lots. The facility maintains two tot lots. These tot lots include play structures, miscellaneous play equipment, and a wood chip surface. The facility facilities are in generally good condition.

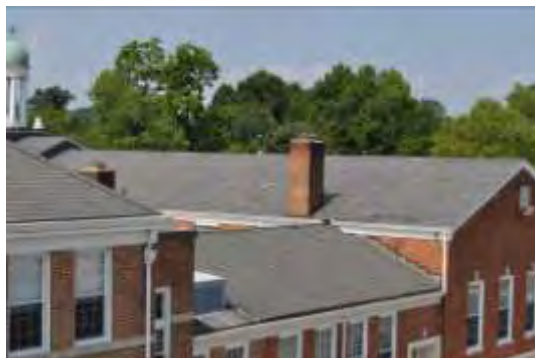
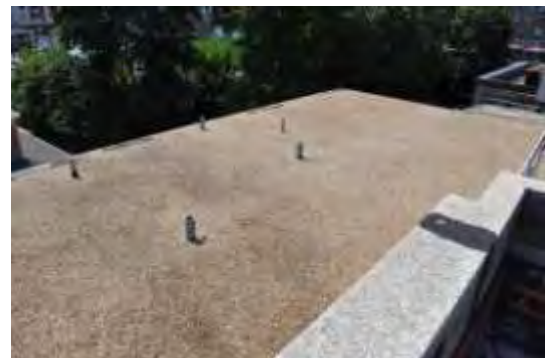
Building Roofing. The buildings are roofed in asphalt, slate, and flat roofing systems that are in generally mixed condition based on the age of the installation.

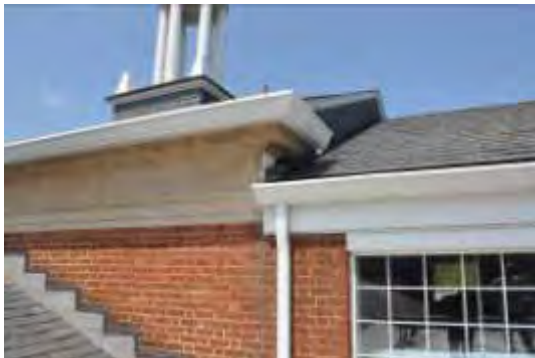
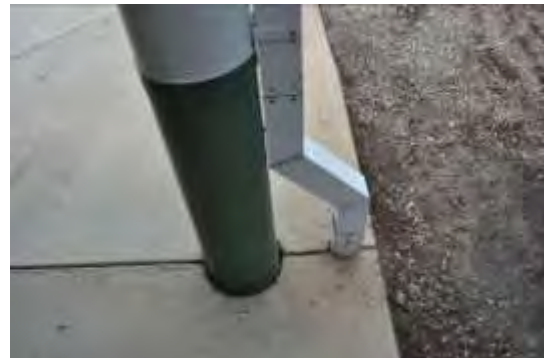
It is recommended that all gutters be cleaned at least twice each year. If there are a large number of trees located close to a building, consider installing a gutter debris shield that will let water into the gutters but will filter out leaves, twigs, and other debris.

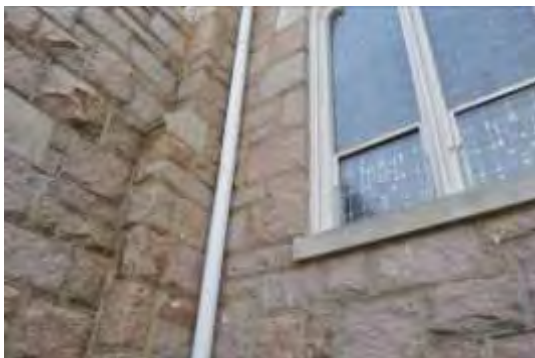
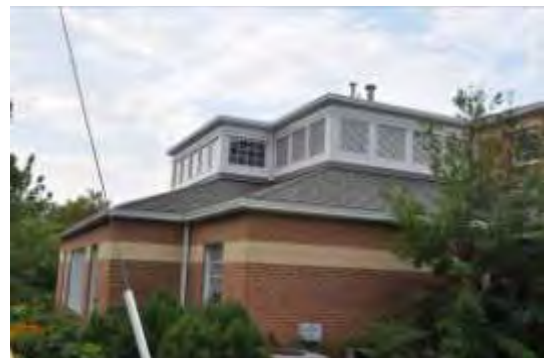
Siding and Trim. The exteriors of the buildings are clad in wood, vinyl, and masonry siding and trim. The siding and trim materials are in generally good condition.

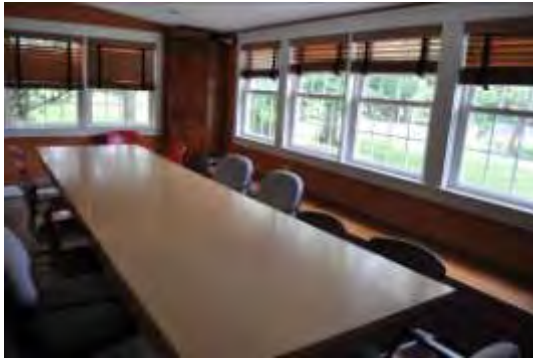
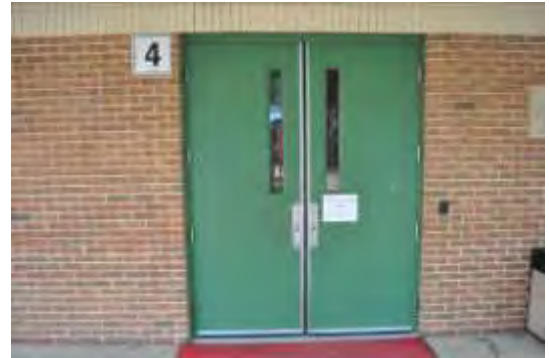
The Church is responsible for all of the windows and exterior doors of the facility. The windows and doors are in generally good condition.

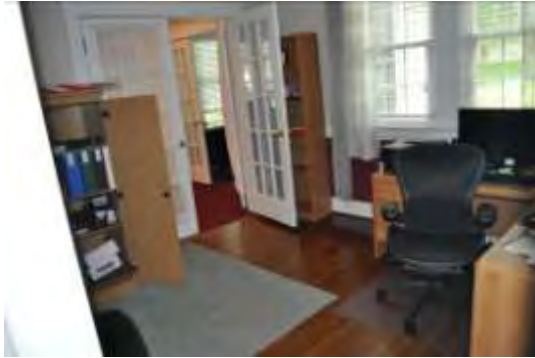
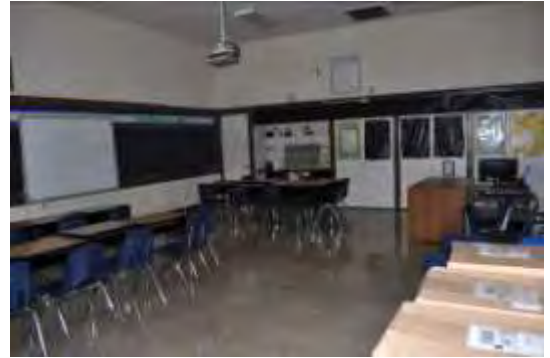
Building Interiors. The Church maintains the lobbies, halls, classrooms, residences, offices, and meeting area that are in generally good condition.

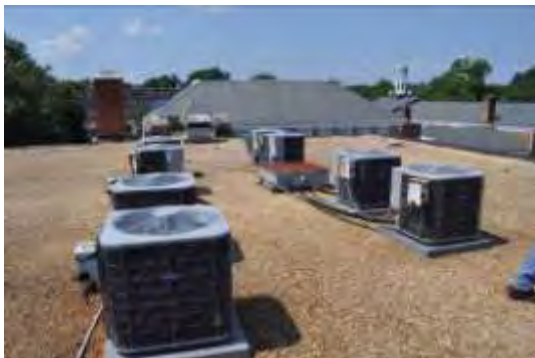
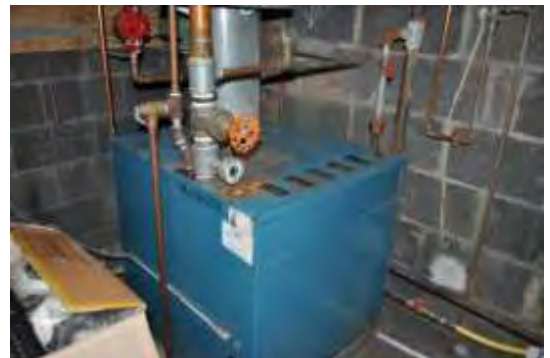
Split and Package HVAC Systems. The heating ventilation and air conditioning (HVAC) of the facility are reported to be in good operating condition. Detailed inspection and testing of these systems is beyond the scope of this study.

The Church maintains a number of HVAC systems that use the refrigerant known as R22. This refrigerant will be phased out of production by the year 2030 and was generally phased out of use in new systems in 2010.

See the EPA, HCFC Phase-out Schedule on our website at <http://mdareserves.com/resources/links/building-system>. Since most of the community's AC systems rely on the old R22 refrigerant, we assume that the HVAC replacement will include upgrading to the new refrigerant, which is likely to require the replacement of the entire system, including the compressor, coil, and line-set.

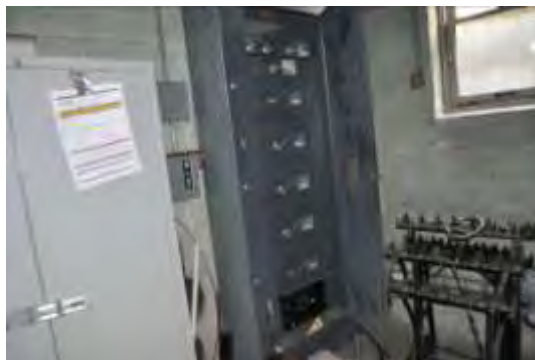
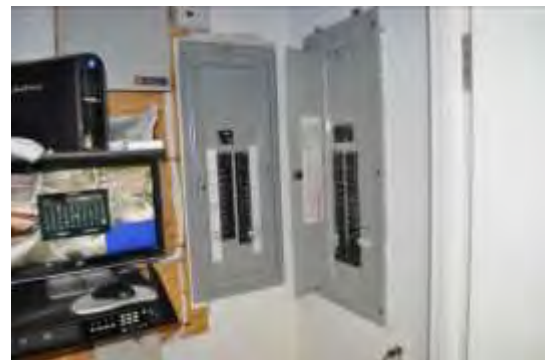
Building Electrical Service. The electrical systems of the buildings are reported to be operating normally.

In order to maintain this equipment properly, periodic tightening of all connections is recommended every three to five years. Insurance policies in some cases may have specific requirements regarding the tightening of electrical connections. It is also recommended that outlets, sockets, switches, and minor fixtures be replaced at a maximum of every 30 years.
