REPLACEMENT RESERVE REPORT FY 2016

YOUR HOA

YOURTOWN, NORTH CAROLINA

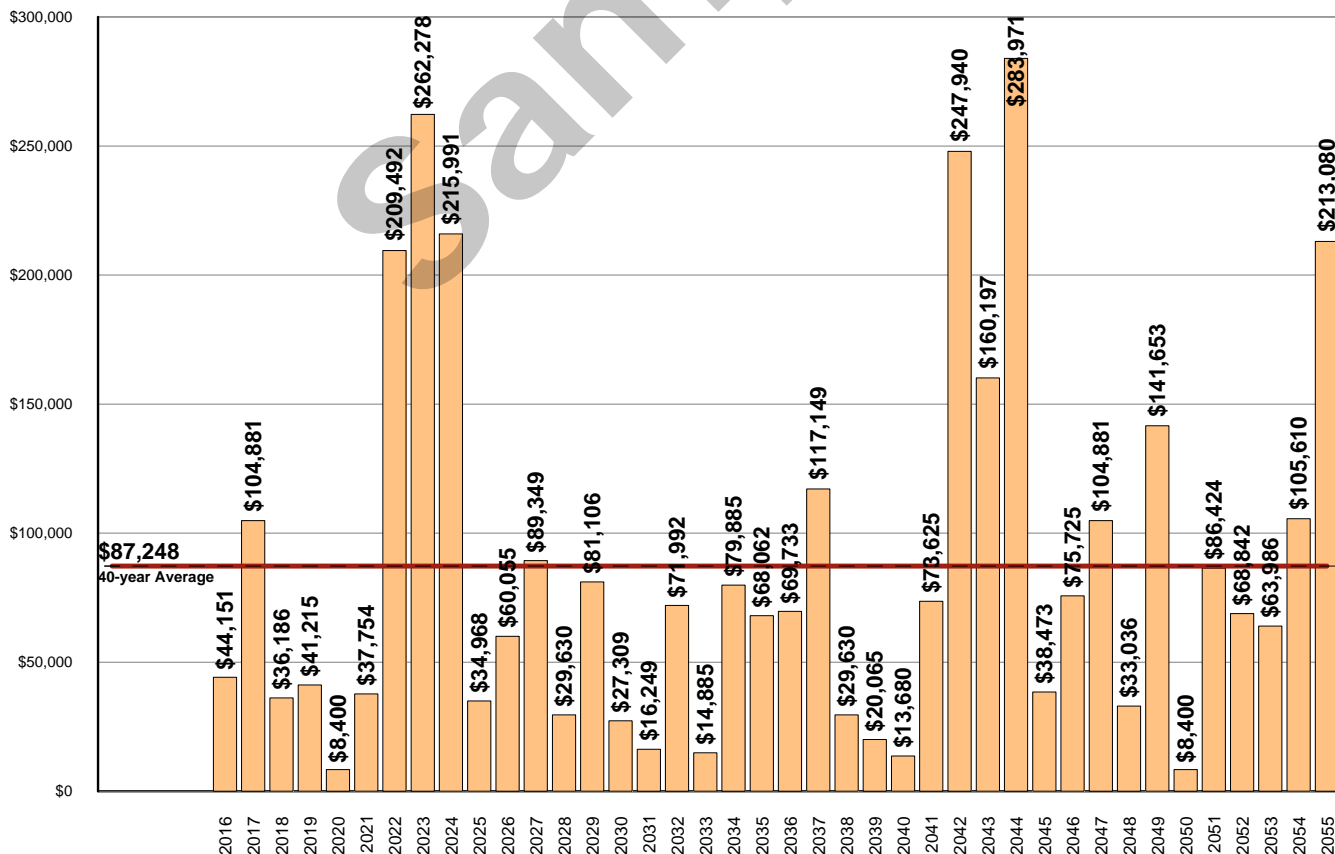
#2 - Annual Expenditures for Projected Replacements Graph

This graph shows annual expenditures for Projected Replacements over the 40-year Study Period. The red line shows the average annual expenditure of \$87,248. Section C provides a year by year Calendar of these expenditures.

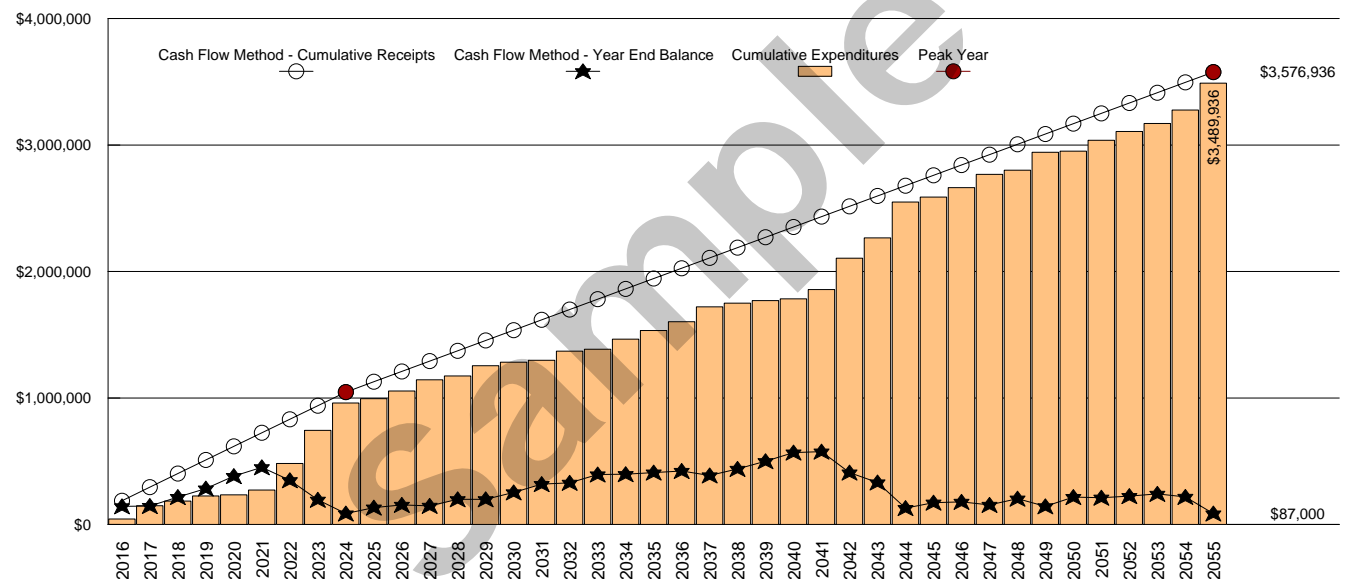
#4 - Cash Flow Method - Graph of Cumulative Receipts and Expenditures - Years 1 through 40

Recommended Replacement Reserve Funding has been calculated using the Cash Flow Method (also called the Straight Line or Threshold Method). This method calculates a constant annual funding between peaks in cumulative expenditures, while maintaining a Minimum Balance (threshold) in the Peak Years.

- **Peak Years.** The First Peak Year occurs in 2024 with Replacement Reserves on Deposit dropping to the Minimum Balance after the completion of \$960,347 of replacements from 2016 to 2024. Recommended funding declines from \$107,483 in 2024 to \$81,594 in 2025. Peak Years are identified in Chart 4 and Table 5.
- **Minimum Balance.** The calculations assume a Minimum Balance of \$87,000 in Replacement Reserves. This is approx. 12 months of average expenditures based on the \$87,248, 40-year average annual expenditure.
- **Cash Flow Method Study Period.** Cash Flow Method calculates funding for \$3,489,936 of expenditures over the 40-year Study Period. It does not include funding for any projects beyond 2055 and in 2055, the end of year balance will always be the Minimum Balance.

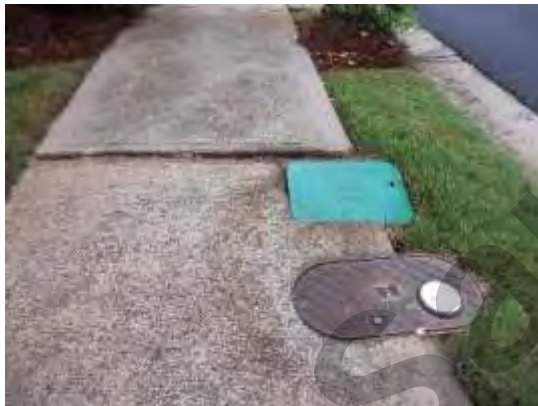
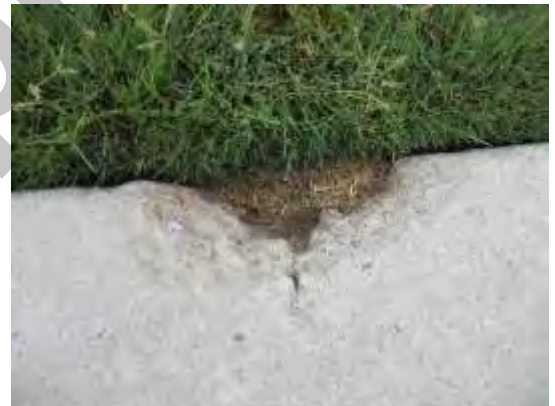
Concrete Work. The concrete work includes the community curbs, sidewalks, concrete pads and other flatwork. We have modeled for curb replacement when the concrete flatwork is replaced. The overall condition of the concrete work is good to poor with a few tripping hazards and poor patching of the curbs.

The standards we use for recommending replacement are as follows:

- Trip hazard, ½ inch height difference.
- Severe cracking.
- Severe spalling and scale.
- Uneven riser heights on steps.
- Steps with risers in excess of 8¼ inches.

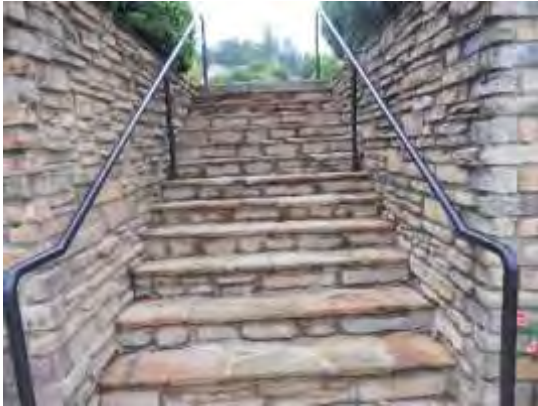
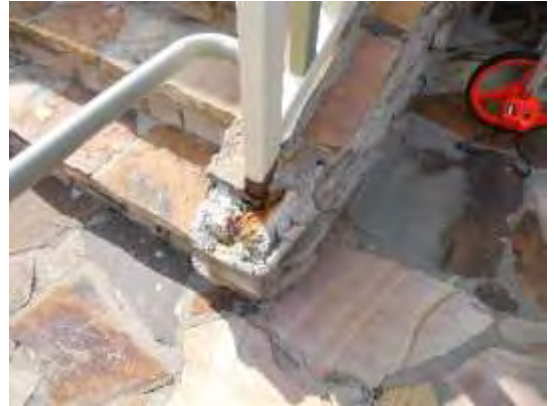
Stone Steps. The community has several sets of exterior steps that are of stone construction. The general condition of the steps is good to fair with a number of defects.

- **Failed Mortar Joints.** A number of the mortar joints between the stones have failed and are in need of repointing.
- **Cracks.** Movement of the base material under the bricks has resulted in the development of cracks in a number of the stone steps.
- **Settlement.** We noted some locations where steps have settled, creating uneven surfaces that pose a trip hazard.

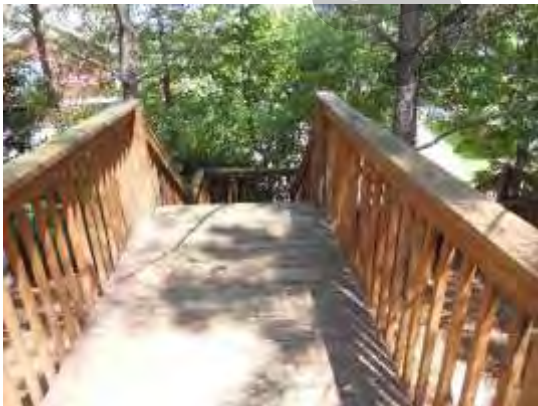
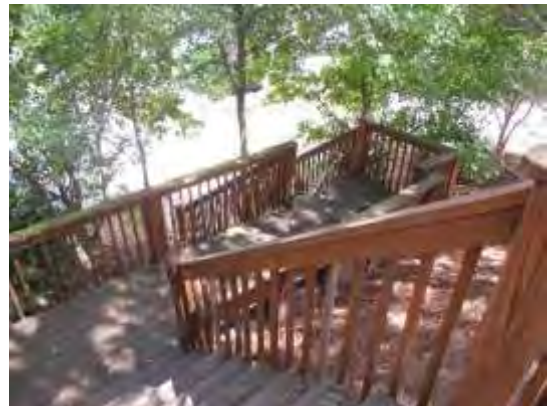
Exterior Wood Stairs. The exterior stairs consist of wood treads and landings with wood stringers. The stairs are in good condition.

The wood in the exterior stairs expands and contracts with changes in temperature and moisture levels within the wood, leading to cracks. Untreated, these cracks will expand and can lead to the development of rot within the wood.

It is recommended that the Association inspect all stairs at least once each year. All areas with moderate cracking or rot should be replaced. Areas covered with mold should be cleaned and treated.

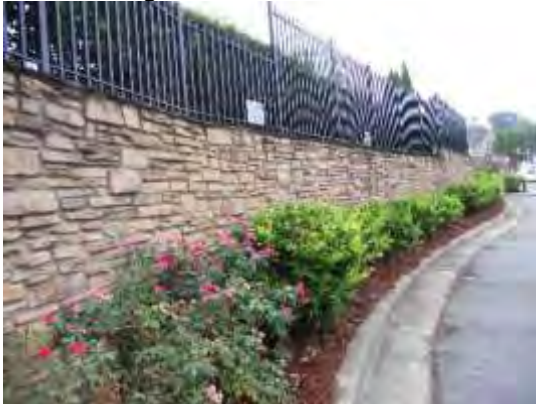
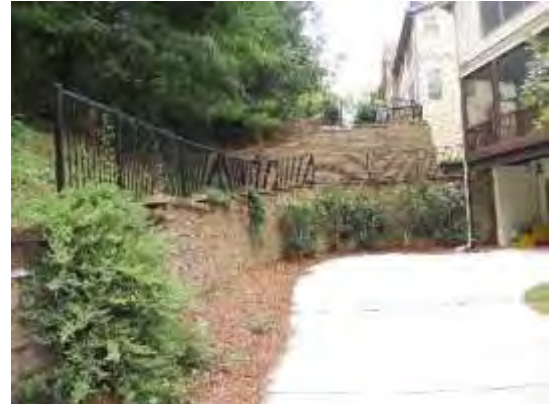
Retaining Walls. The Association maintains several stone and segmental block retaining walls. The retaining walls are in good condition.

Movement and displacement of any retaining wall is a sign of general settlement or failure. This typically is in the form of leaning and bowing, and can involve the entire wall or localized sections of the wall. Typically, these types of movements are gradual and may require the replacement of the wall. Movement of retaining walls located near other buildings or structures may negatively affect the stability of the adjacent structure. These conditions can become extremely costly if not properly identified, monitored, and addressed.

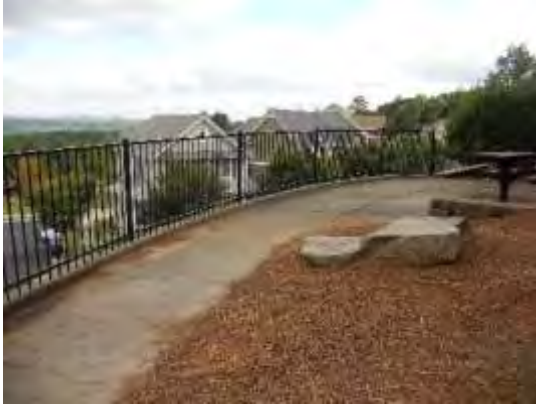
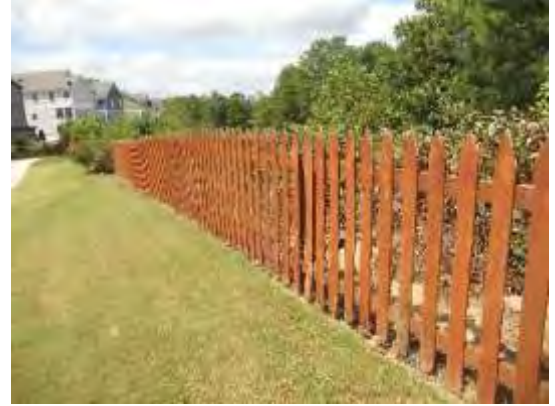
Fencing. The Association maintains wood, aluminum and chain-link fencing that is in generally good condition. Fencing systems have a large number of configurations and finishes that can usually be repaired as a maintenance activity by replacing individual components as they become damaged or weathered.

Protection from string machine damage during lawn maintenance can extend the useful life of some fence types. Protection from this type of damage is typically provided by applying herbicides around post bases or installing protective sheathing.

Pressure treated wood fencing should be cleaned and sealed every year or two. Typically the least cost fencing option, this type of fence can last 15 to 20 years if maintained properly.

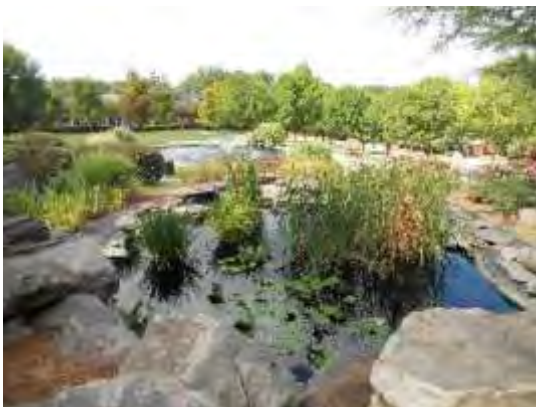
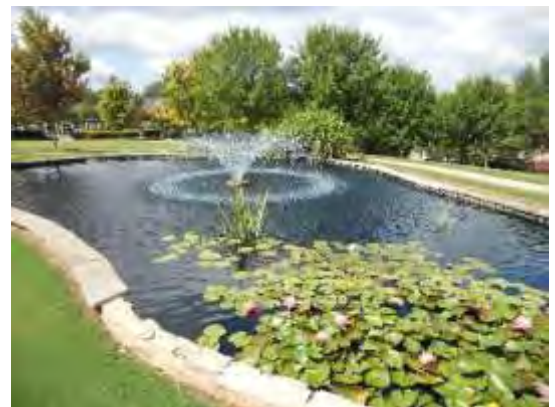
Ponds. The community is served by two feature ponds. The ponds are lined with a membrane that is reported to be leaking. The pond is fed by a well and the water is used for irrigation in the common areas. We have provided for the replacement of the pumps and membrane. Keeping the ponds clean is a maintenance function and not included in the analysis.

Based on our understanding, we recommend the following:

- Periodically remove accumulated debris and vegetation growing in and around the ponds.
- Survey the ponds to establish the current profile of the bottom. After five years of operation, have the pond re-surveyed to establish new depths to determine the local siltation rate. This will establish the frequency required for periodic dredging.
- Periodically sample and test for contaminants.
- Consult with local contractors to determine the cost of removing and disposing of the spoil, once its nature is known.

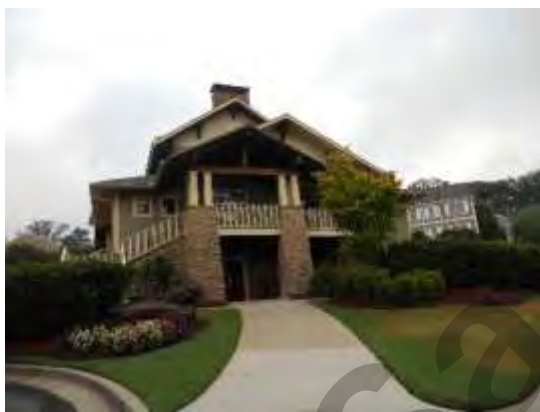
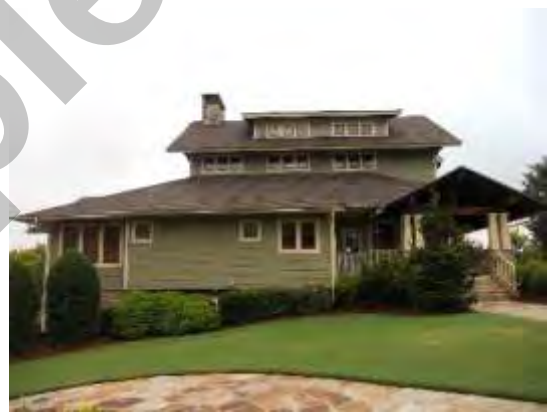
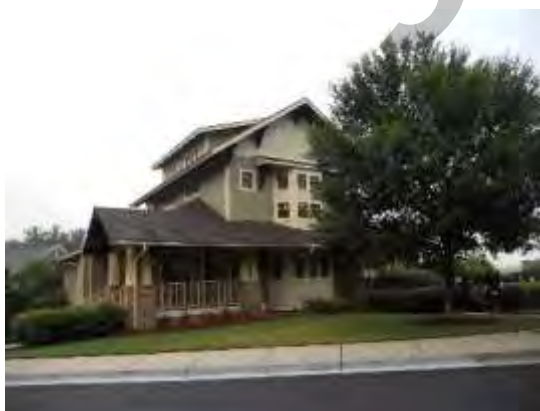
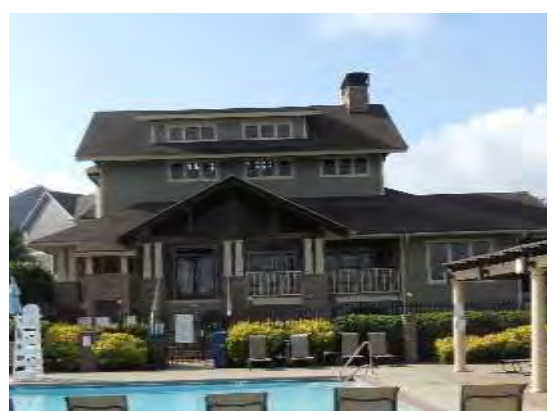
Building Roofing. The clubhouse is roofed in a green roof product that has a recall for product failure. Roof is not expected to last for normal life and we have programmed replacement accordingly with a 25-year asphalt roof product.

Asphalt shingle roofs can have a useful life of 20 to 50 years depending on the weight and quality of the shingle. Weathered, curled, and missing shingles are all indications that the shingles may be nearing the end of their useful life.

Access to the roof was not provided at the time of inspection. Annual inspections are recommended, with cleaning, repair, and mitigation of vegetation performed as needed. Access, inspection, and repair work should be performed by contractors and personnel with the appropriate access equipment who are experienced in the types of roofing used for the facility.

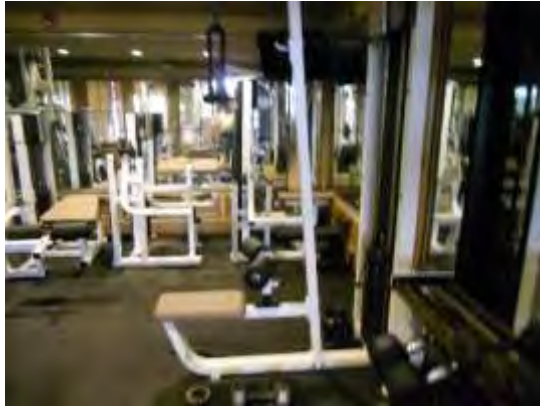
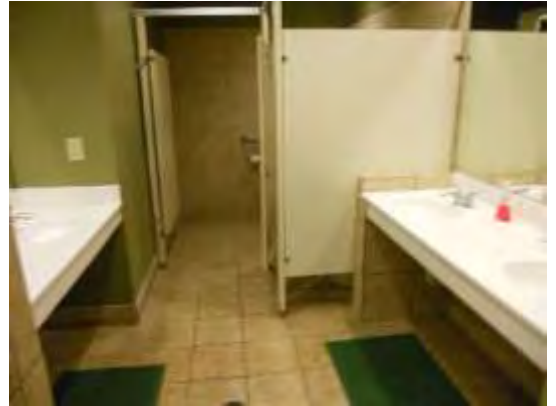
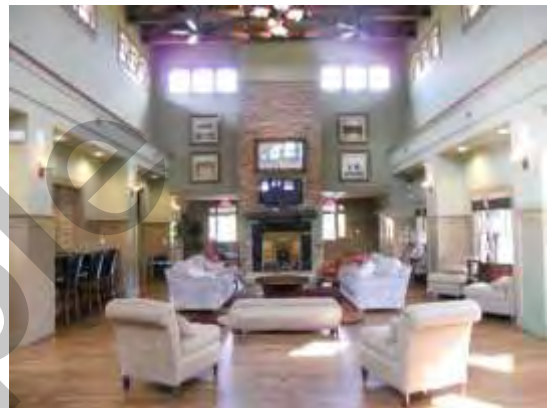
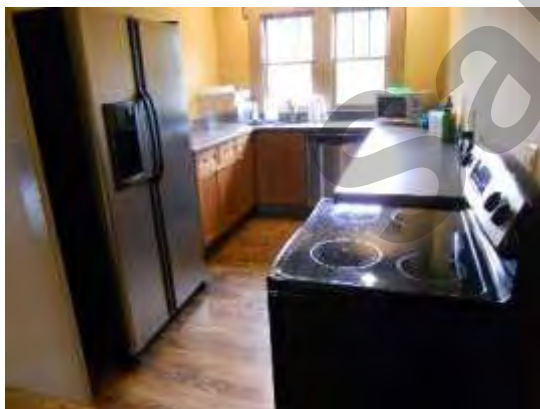
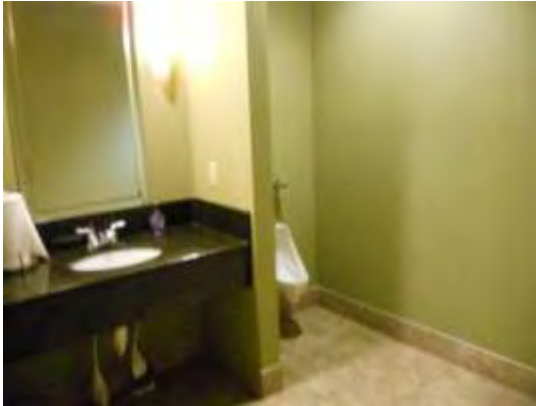
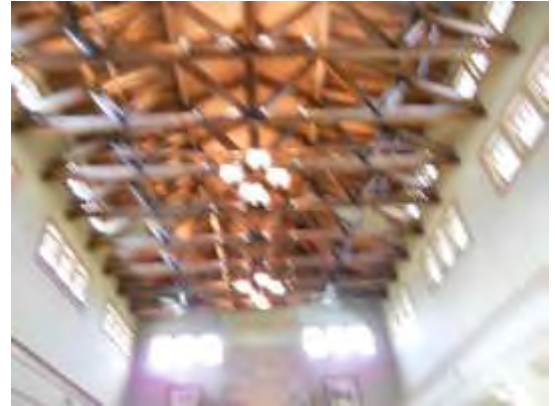
Restrooms. The two restrooms and two locker rooms in the Club House are in good condition. We have provided an allowance for the renovation of all four rooms.

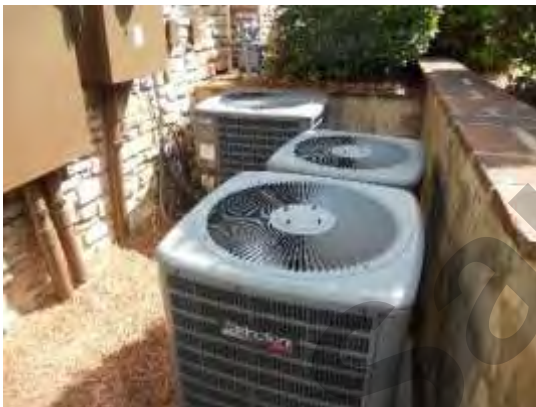
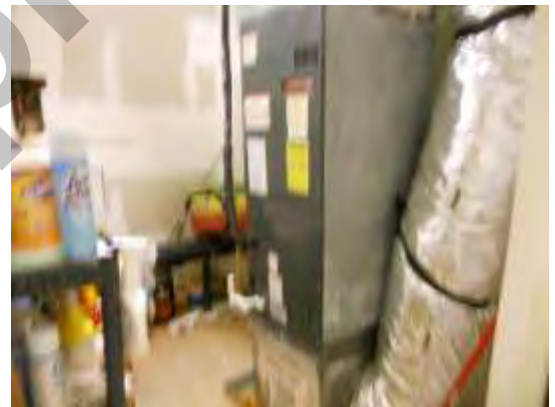
Split and Package HVAC Systems. The heating ventilation and air conditioning (HVAC) of the facility are reported to be in good operating condition. Detailed inspection and testing of these systems is beyond the scope of this study.

The Association maintains a number of HVAC systems that use one of the new generation refrigerants. Unlike the old R22 refrigerant, the new refrigerants are expected to be available throughout the period of this study. However, the operating pressure for new refrigerant systems is approximately twice as high as older systems. Many of the standard components have not been redesigned for these higher pressures, including the coils, which generally fail due to metal fatigue.

Even though manufacturers continue to predict 15 to 20-year life cycles for HVAC equipment that use these new refrigerants, this is not proven by historical data. We therefore recommend anticipating a normal economic life of 15 years for all HVAC equipment that uses pressurized refrigerants of these types.

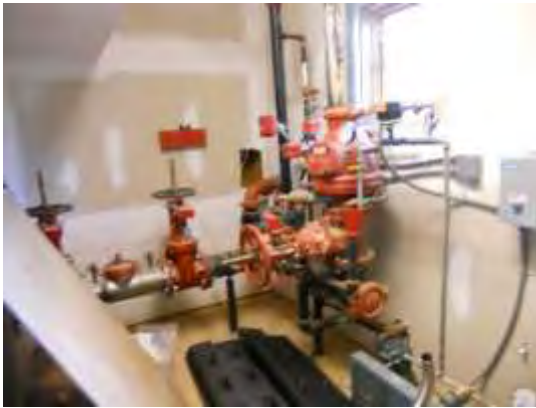
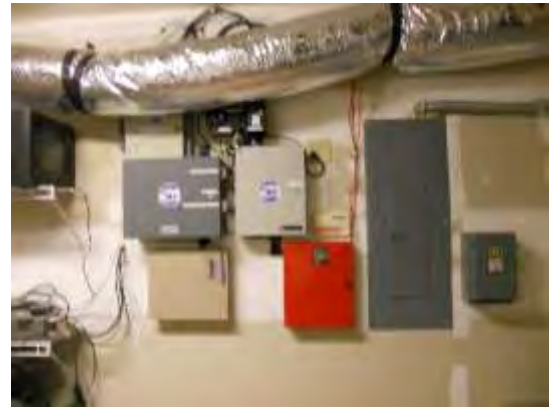
Fire Safety Systems. The building is fitted with a fire safety system that includes sprinklers and alarms, and these are reported to be operating normally. Testing and inspection of fire safety systems are not included in this study.

Sprinkler pipe systems have a wide variety of configurations and requirements depending on their age, condition, and jurisdictional location. Specific county and municipal codes can make a significant difference on what your facility's specific requirements may be.

Building fire alarm systems have a service life of 15 to 25 years. While the panels may continue to operate past this point, changes in fire safety technology and building fire safety codes tend to render them obsolete. In addition, manufacturers only support their systems for a limited period, typically about 15 years. After this time, it may be increasingly difficult to obtain replacement parts and service. When it becomes necessary to upgrade the fire alarm system, differences in the technologies and new code requirements are likely to require upgrades in lighting, sensors, alarms, and other system and sub components.

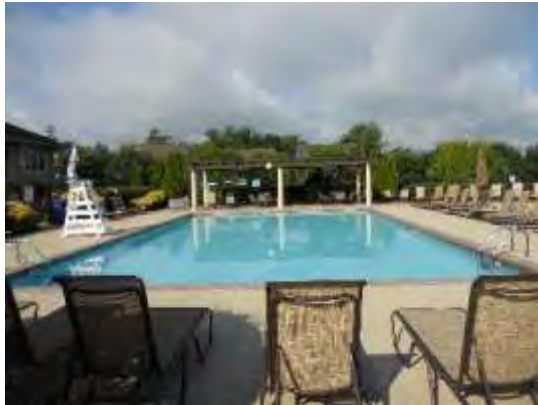
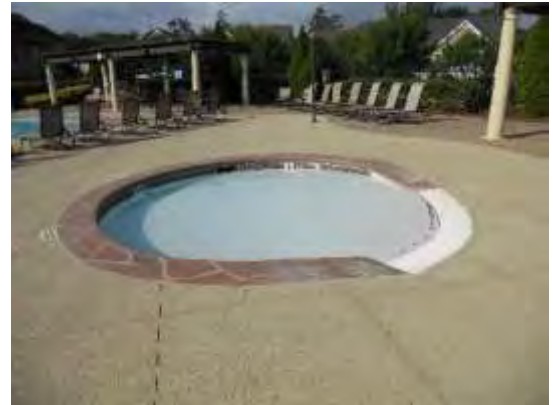
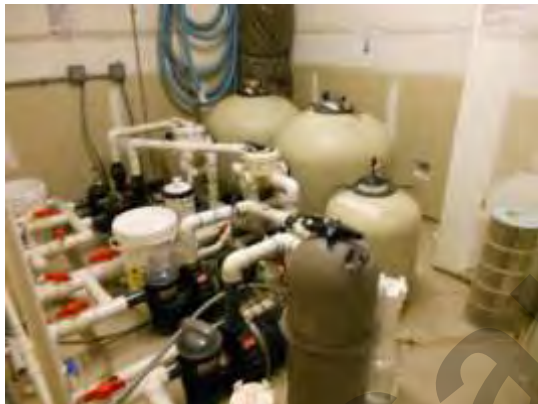
Swimming Pool. The community operates an outdoor pool and wading pool of concrete construction. Listed below are the major components of the pool facilities:

- Pool Shell. The shell for the swimming pool is in good condition.
- Pool Deck. The pool has a concrete and pavers deck. The overall condition of the deck is good.
- Pool Deck Coating. The concrete pool deck is coated. The coating is in fair condition. We have assumed a service life for the coating of ten years.
- Whitecoat. The pool whitecoat is in good condition. We have assumed a service life of eight to ten years for the pool whitecoat.
- Waterline Tile. The waterline tile is in good condition. We have assumed that the waterline tile will be replaced or restored when the pool is whitecoated.
- Coping. The pool is edged with masonry coping. The coping is in good condition.
- Pump and Filter System. The filter system is in fair operating condition.
- Pool Fence. The swimming pool is enclosed by a metal fence that is in good condition.

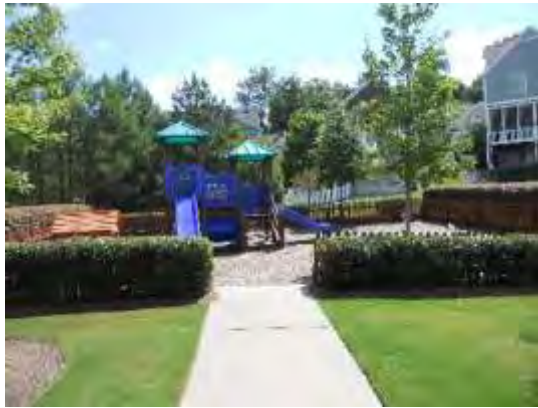
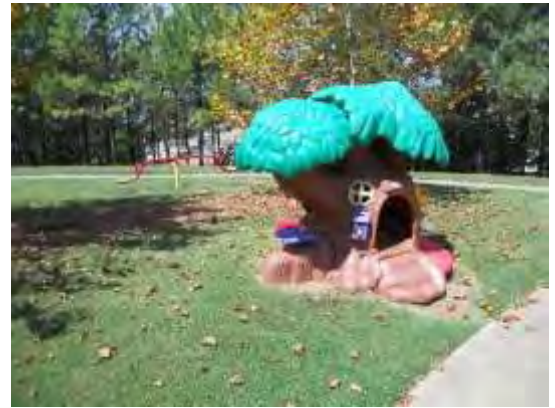
Tot Lots. The community maintains a tot lot. The tot lot includes play structures, miscellaneous play equipment, synthetic borders, and a wood chip surface. The facility is in generally good condition. The wood chip surface is displaced or missing or does not appear to be adequate.

The safety of each individual piece of playground equipment as well as the layout of the entire play area should be considered when evaluating a playground for safety. The installation and maintenance of the protective surfacing under and around all equipment is crucial. Please note that the evaluation of the equipment and these facilities for safety is beyond the scope of this work.

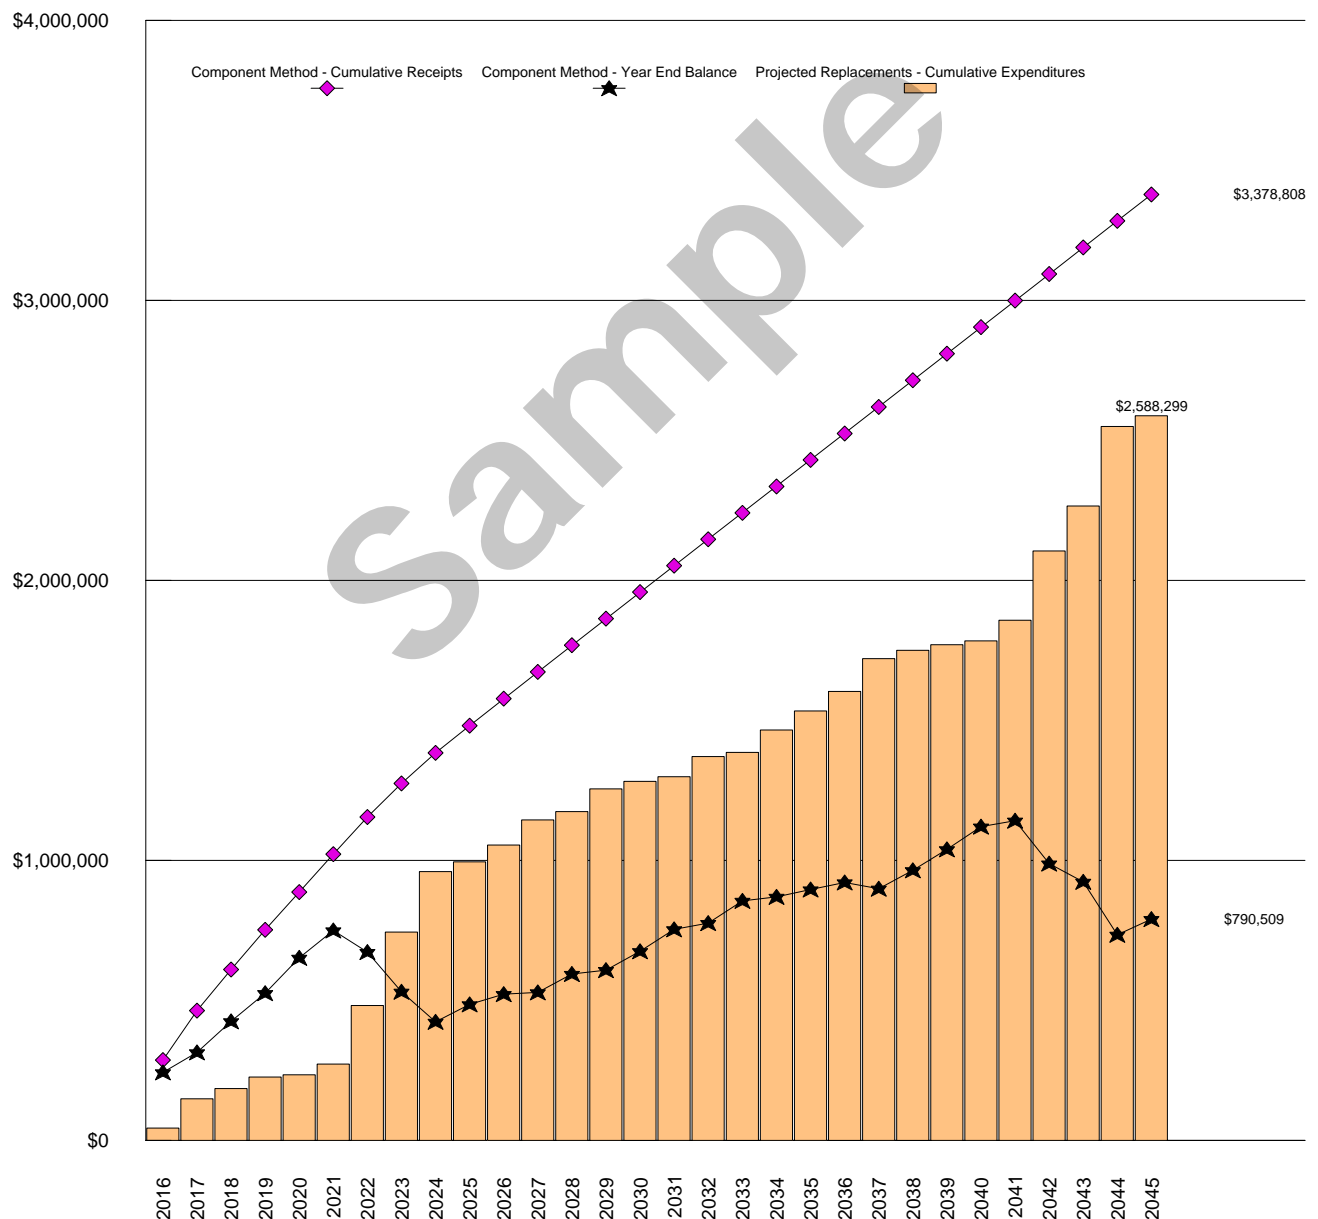
Component Method - Cumulative Receipts and Expenditures Graph

- **Current Funding Objective.** A Current Funding Objective is calculated for each of the Projected Replacements listed in the Replacement Reserve Inventory. Replacement Cost is divided by the Normal Economic Life to determine the nominal annual contribution. The Remaining Economic Life is then subtracted from the Normal Economic Life to calculate the number of years that the nominal annual contribution should have been made. The two values are then multiplied to determine the Current Funding Objective. This is repeated for each of the 96 Projected Replacements. The total, \$720,722, is the Current Funding Objective.
