# LEVEL 1 REPLACEMENT RESERVE REPORT FY 2022 A SAMPLE HOMEOWNER'S ASSOCIATION

# REPLACEMENT RESERVE REPORT

## A SAMPLE HOMEOWNER'S ASSOCIATION

ANNAPOLIS, MARYLAND  
January 18, 2022

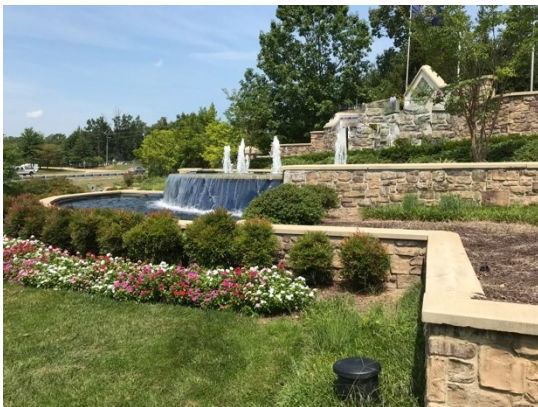
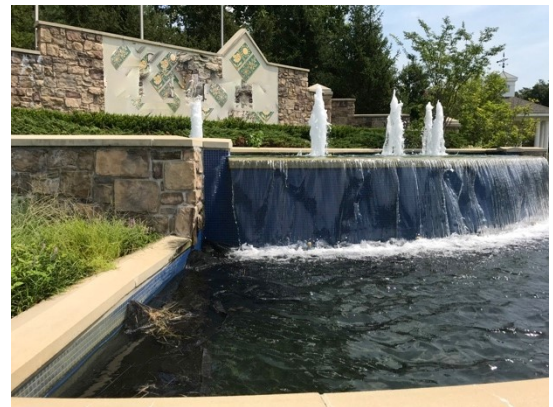
**Entry Monument and Signage.** The Association maintains two entry monuments with fountains. The monuments are made of stone masonry and are in good condition. The Association has plans to change the text and logo.

We recommend repointing and replacement of defective areas of the masonry as needed. The Association may want to consider applying a coat of Siloxane or other appropriate breathable sealant to mitigate water penetration and further degradation of the masonry work. For additional information, please see the appropriate links on our web site at <http://mdareserves.com/resources/links/building-exterior>.

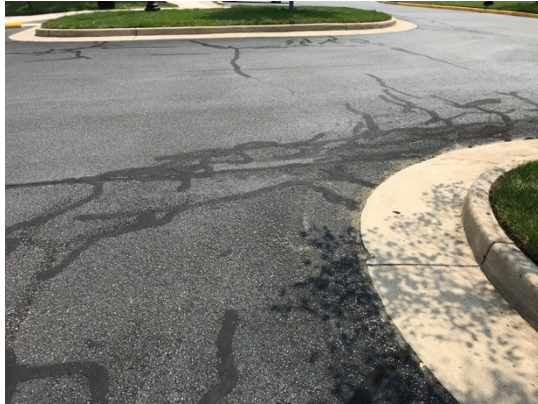
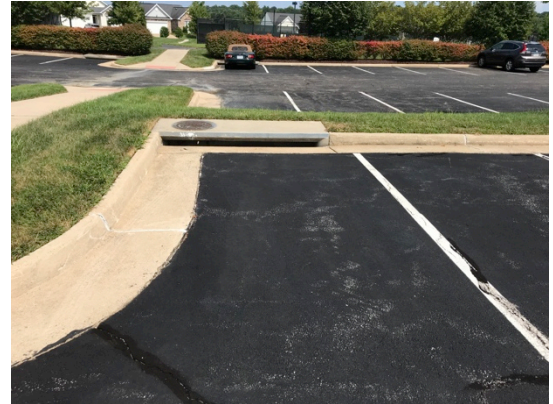
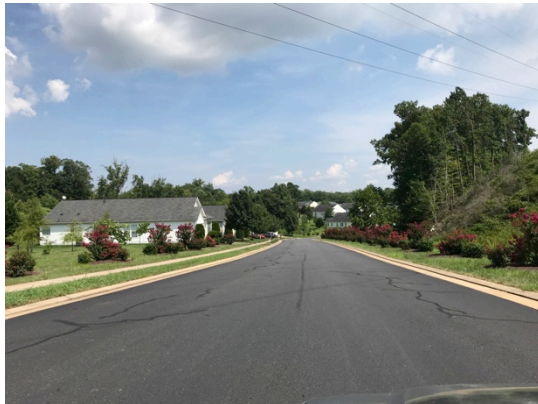
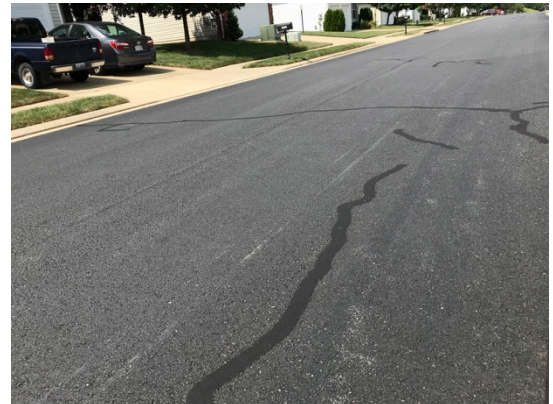
**Asphalt Pavement.** The Association is responsible for the roadways, parking areas, and paths within the community. In general, the Association's asphalt pavements are in good condition, with minor cracking. Most cracks have been repaired.

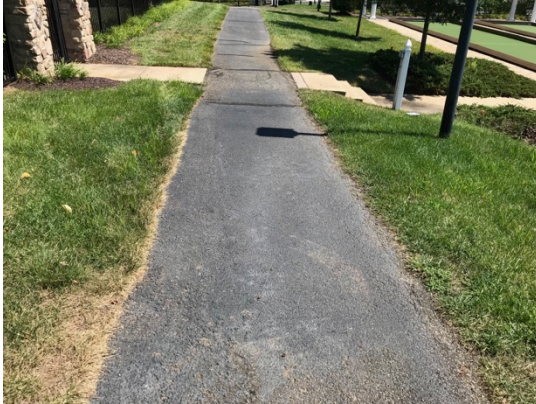
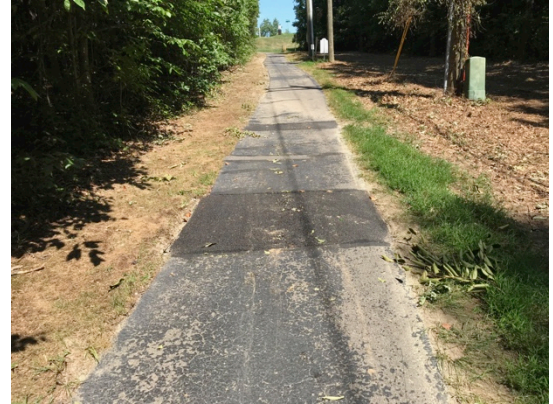
The paths are in fair condition, with minor cracking, trip hazards, and failed sections.

Asphalt paths are typically constructed on native soil. As a result, defects can begin to develop in a few years, leading to costly repairs or early replacement. Additionally, paths typically do not have proper edge confinement and support resulting in longitudinal cracking along the edges of the path. Compacted soil or gravel can mitigate this problem. Lastly, tree root damage is a common issue with asphalt paths, and some communities have had success with a process called root trimming.

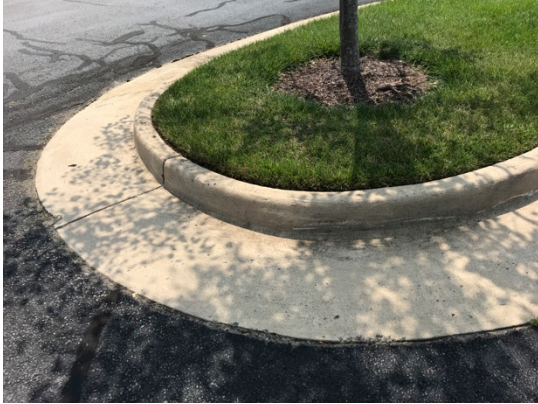
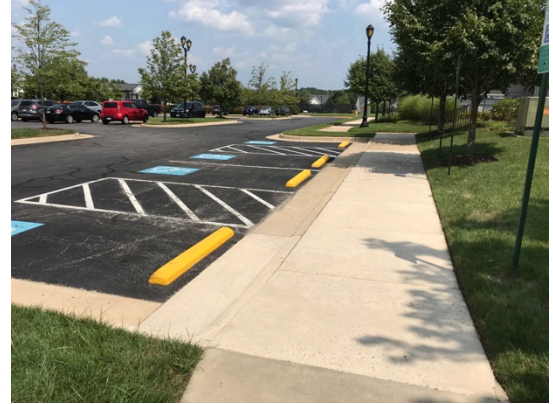
**Concrete Work.** The concrete work includes the community curbs, sidewalks, leadwalks, stairs, and other flatwork. We have modeled for curb replacement when the asphalt pavement is overlaid. The overall condition of the concrete work is good.

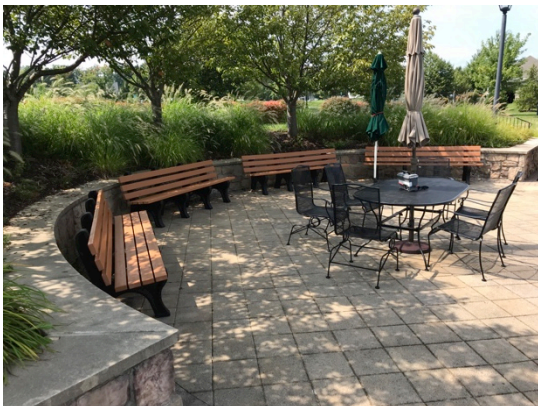
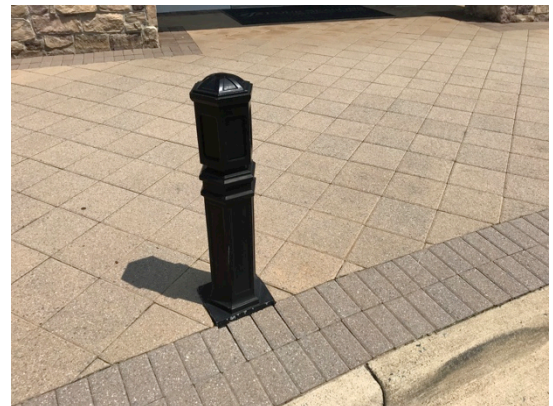
**Unit Pavers.** Unit pavers provide provides a solid, decorative, and renewable surface surfaces that are part of the community's sidewalks, borders, and paths. The overall condition of the unit pavers is good with areas of defects consistent with the age of the installation.

To correct defects and provide the longest service life of the unit paver system, periodic re-setting is required. Re-setting provides an opportunity to replace broken unit pavers, fill in voids in the foundation material, and level the surface. We have included an allowance for periodic re-set of portions of the system.

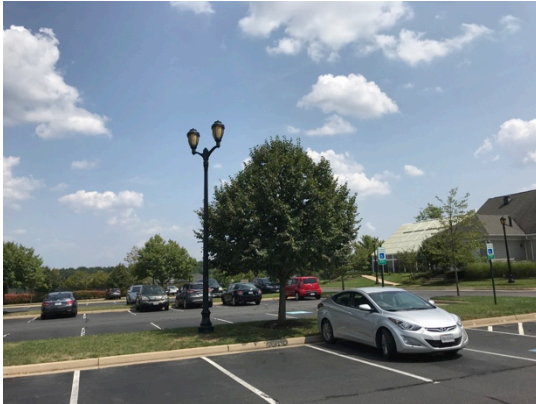
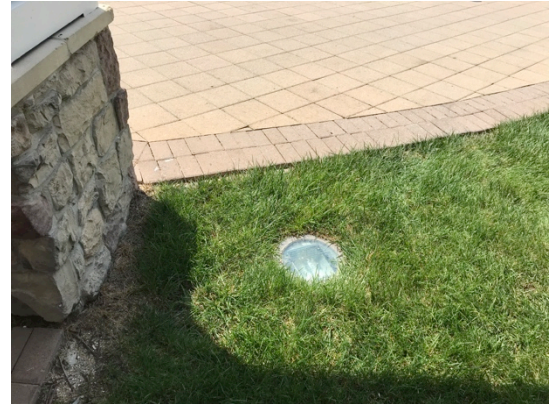
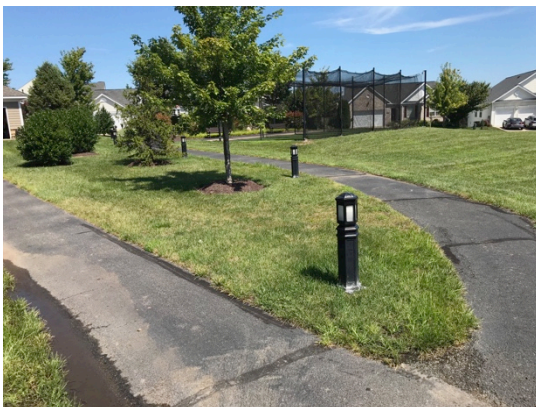
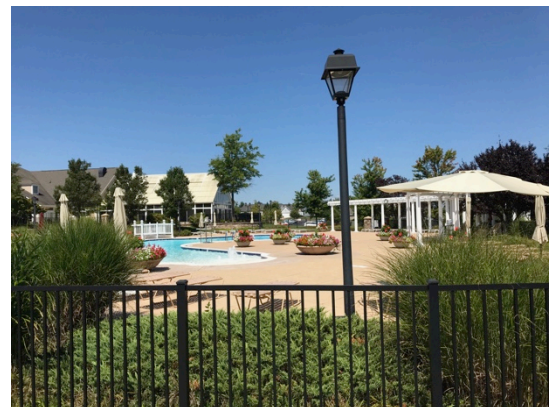
**Site Lighting.** The Association is responsible for the operation of the facility's street and walkway lights near the Community Center. Other lighting is maintained by the utility. The lighting system was not on at the time of our site visit. We understand that the lighting system is in operating condition.

This study assumes replacement of the light fixtures every 15 to 20 years, and pole replacement every 30 to 40 years. When the light poles are replaced, we assume that the underground wiring will also be replaced.

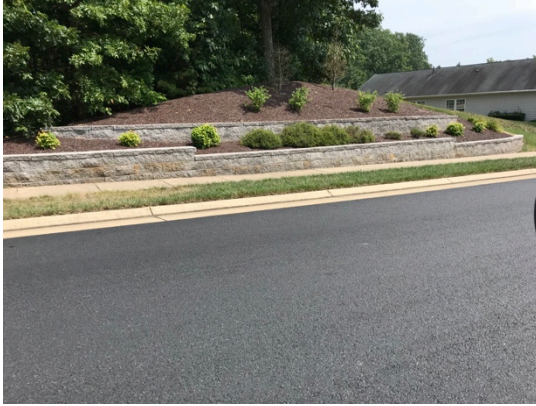
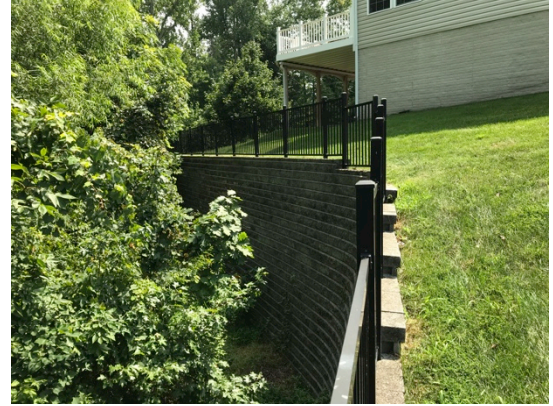
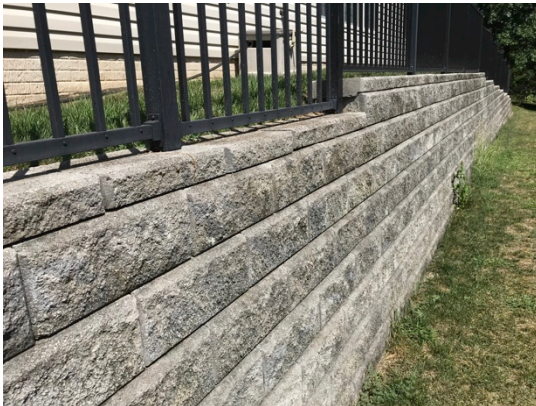
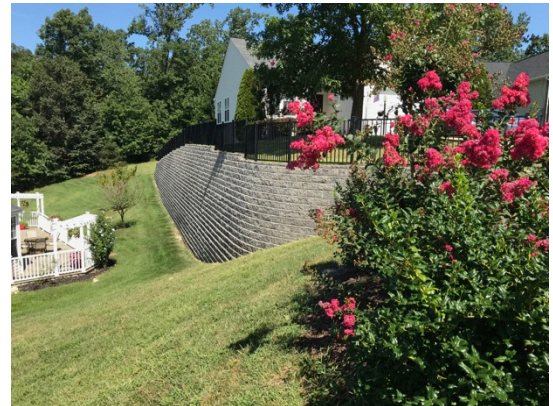
Retaining walls in general are designed to provide slope stabilization and soil retention by means of a structural system. Typically, walls that are three feet high or more require some level of design.

Movement and displacement of any retaining wall is a sign of general settlement or failure. This typically is in the form of leaning and bowing, and can involve the entire wall or localized sections of the wall. Typically, these types of movements are gradual and may require the replacement of the wall. Movement of retaining walls located near other buildings or structures may negatively affect the stability of the adjacent structure. These conditions can become extremely costly if not properly identified, monitored, and addressed.

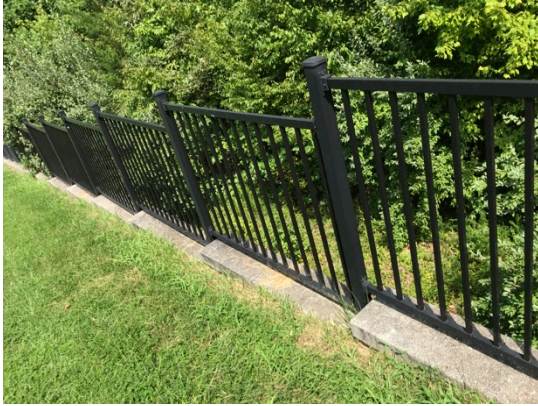
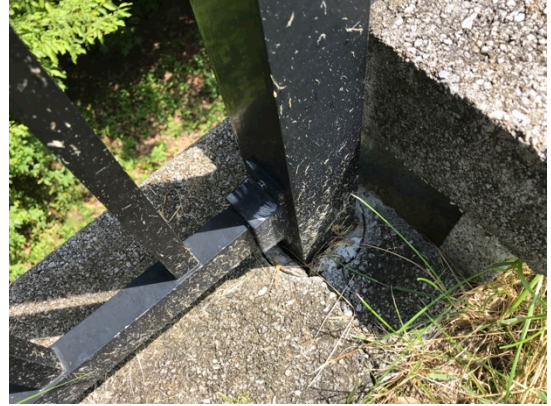
**Fencing.** The Association maintains metal fencing at the retaining walls that is in generally good condition. Fencing systems have a large number of configurations and finishes that can usually be repaired as a maintenance activity by replacing individual components as they become damaged or weathered.

Protection from string machine damage during lawn maintenance can extend the useful life of some fence types. Protection from this type of damage is typically provided by applying herbicides around post bases or installing protective sheathing.

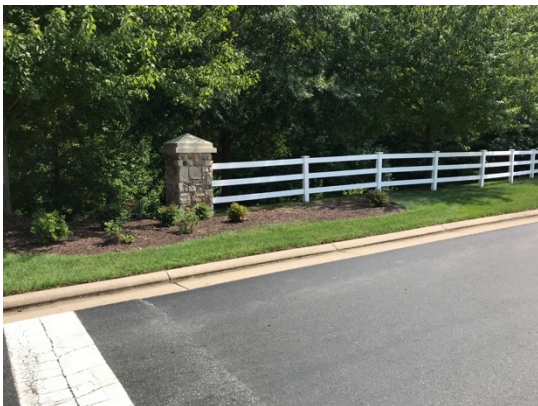
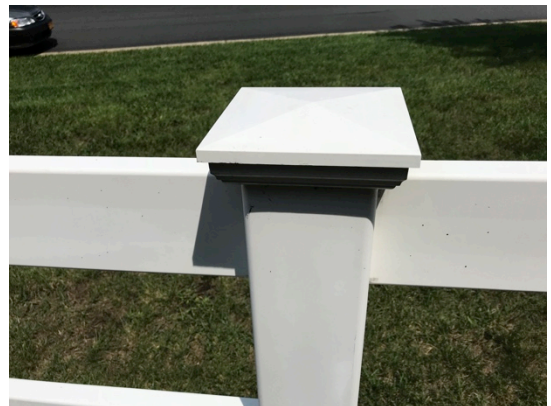
**Fencing, Vinyl Split Rail.** The Association maintains vinyl split rail fencing that is in generally good condition. This type of fencing is typically replaced on an as needed basis when railings and posts deteriorate or become unsightly.

Protection from string machine damage during lawn maintenance can extend the useful life of the railing posts. Applying herbicides around post bases or installing protective sheathing are the typical ways of protecting from string machine damage.

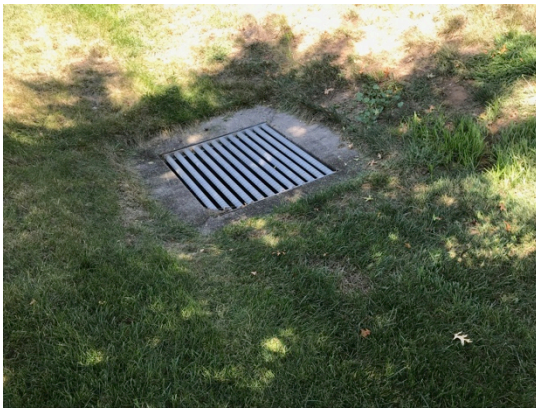
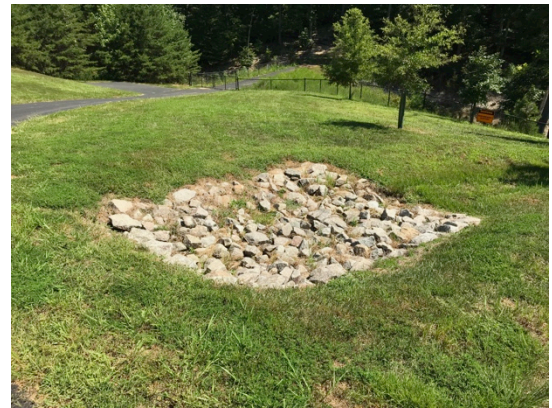
**Stormwater Management.** Storm water can be problematic in areas with high runoff water or dramatic changes in elevation. Typically, the majority of stormwater management systems are maintained by the county or municipality. This study attempts to include the portions of the system are considered common property. The share line between municipality and community responsibility is often obscure and subject to the judgment of the county authority.

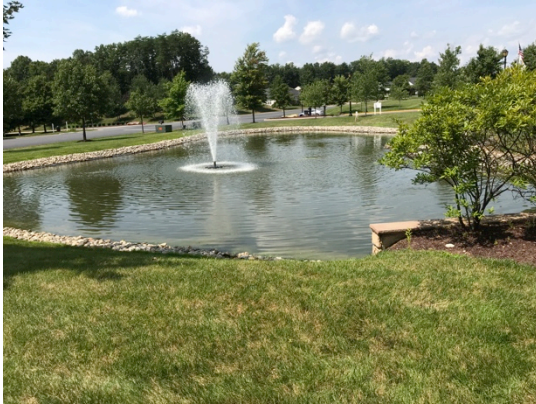
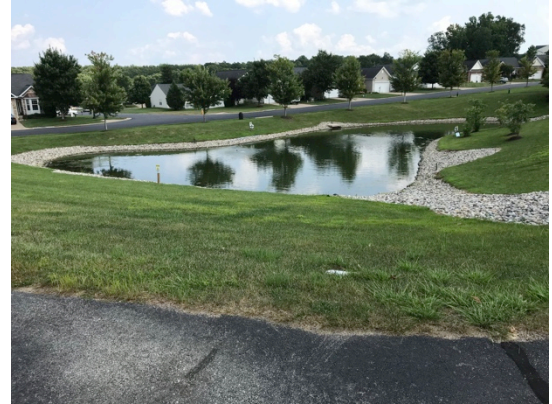
**Storm Water Ponds.** The community is served by a several storm water ponds.

Ponds will accumulate silt and over time and lose the ability to store storm water at design levels, which could result in overflows and minor local flooding. In addition, water quality can be negatively affected by increased siltation and debris accumulation. Accordingly, ponds require periodic dredging.

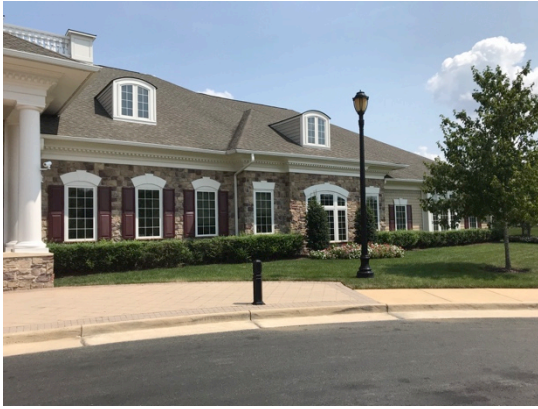
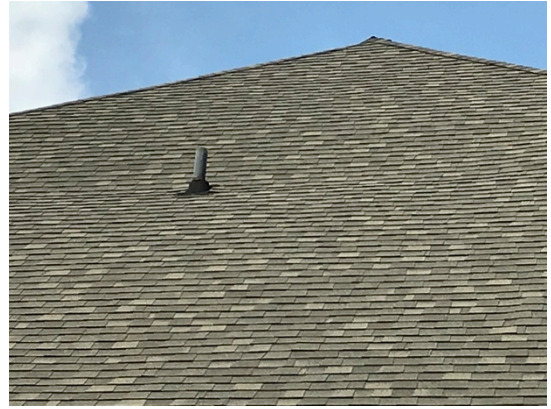
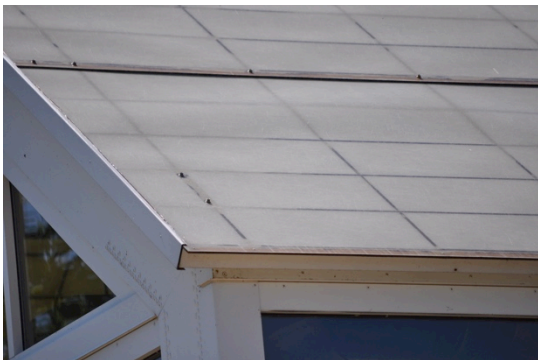
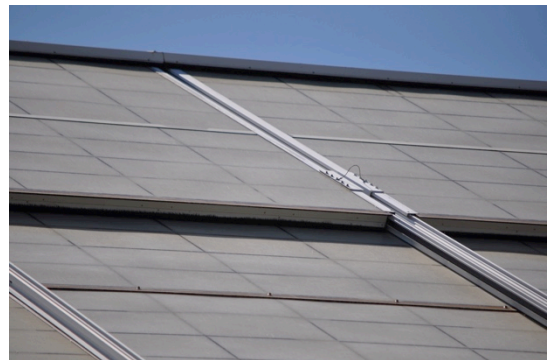
**Building Roofing.** The Community Building is roofed in asphalt shingles that are in generally good condition.

Asphalt shingle roofs can have a useful life of 20 to 50 years depending on the weight and quality of the shingle. Weathered, curled, and missing shingles are all indications that the shingles may be nearing the end of their useful life.

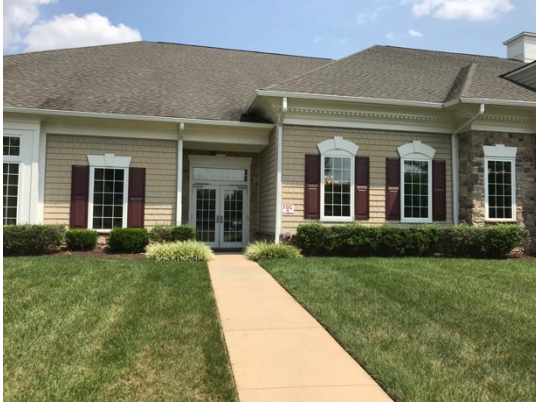
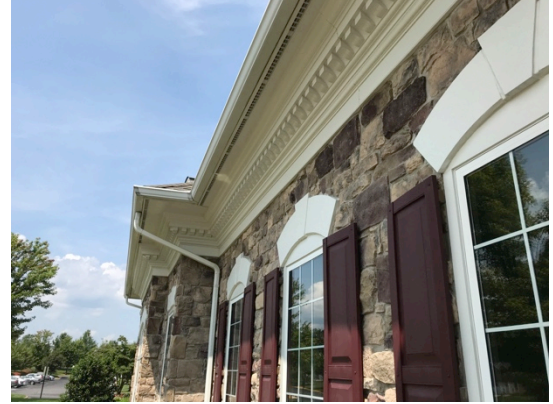
Vinyl siding and trim can have an extended useful life if not damaged by impact, heat, or other physical reasons. However, the coatings and finishes typically have a useful life and over time begin to weather, chalk, and show their age. For these reasons, we have modeled for the replacement of the siding and trim every 25 years.

Stone masonry is used as the main exterior cladding of the building. As masonry weathers, the mortar joints will become damaged by water penetration. As additional water gains access to the joints, repeated freeze-thaw cycles gradually increase the damage to the mortar joints. If allowed to progress, even the masonry units such as brick, block, and stone can have their surfaces affected and masonry units can become loose.

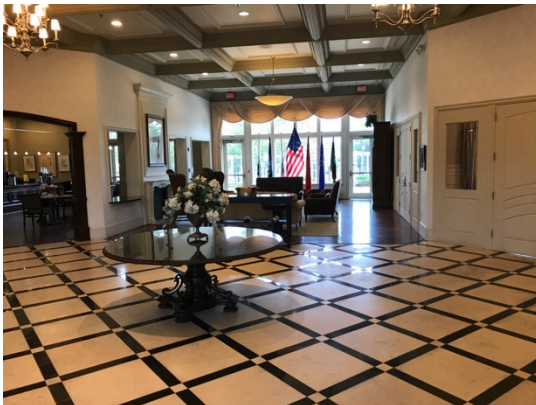
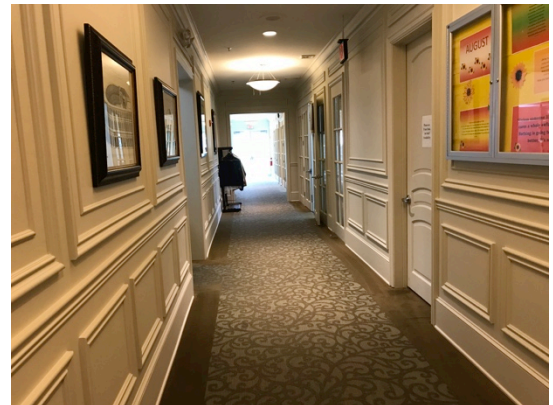
**Common Interiors.** The Association maintains the lobbies, halls, meeting room, café, ballroom, billiard room, fitness center, locker rooms, and other common interior spaces that are in generally good condition.

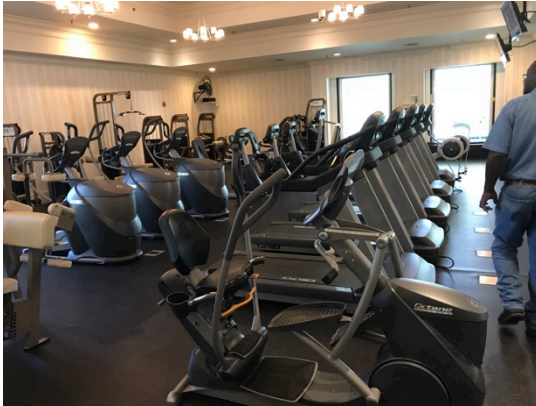
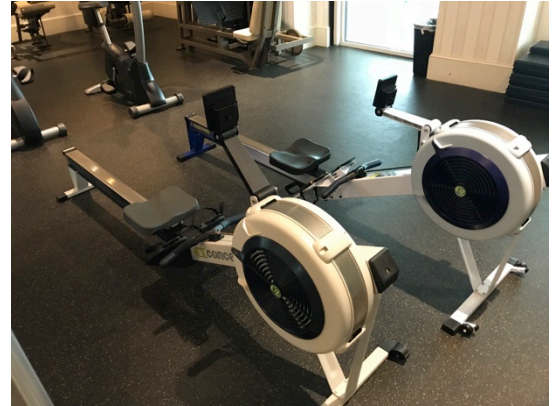
**Health and Fitness Center.** The Health and Fitness Center includes exercise equipment, associated restrooms/ showers. Listed below are the major components:

- Flooring. The rubber gym floor is in good condition with only one area where the seam is failing. We have assumed a service life of 10 years.
- Exercise Equipment. The equipment is in generally good condition.

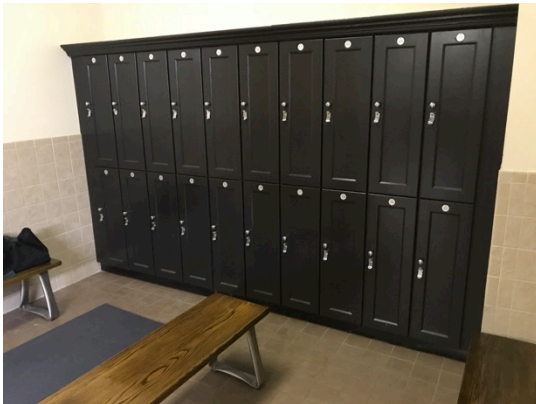
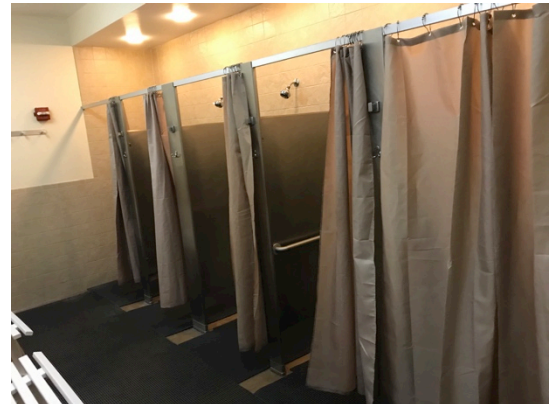
**Locker Rooms.** The locker rooms for the swimming pool and exercise facility are located adjacent to the fitness center and pool. The overall condition of the locker rooms is good. Listed below are the major components of the locker rooms:

- Ceramic Floor Tile. The ceramic tile in the locker rooms is in good condition.
- Lockers. The locker rooms have half full height, lockers. All are in good condition. We have assumed a 30-year service life for these lockers.
- Light Fixtures. Illumination is provided by ceiling-mounted light fixtures. The fixtures are in Good working condition and do not provide adequate lighting. Fixtures of this type have a typical service life of 25 years.
- Shower and Restroom Fixtures. All shower and restroom fixtures are in good condition. We have assumed a service life of 20 years for the fixtures and that all fixtures will be replaced at the same time as part of a general renovation of the restroom.

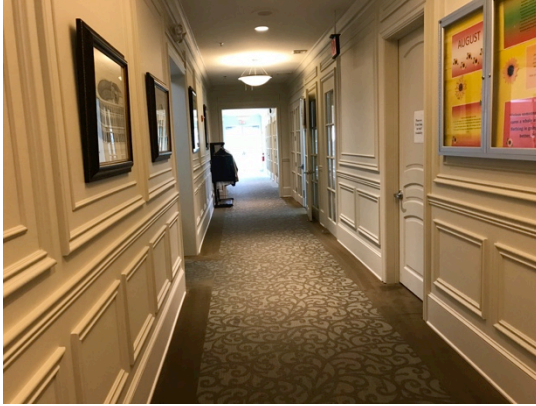
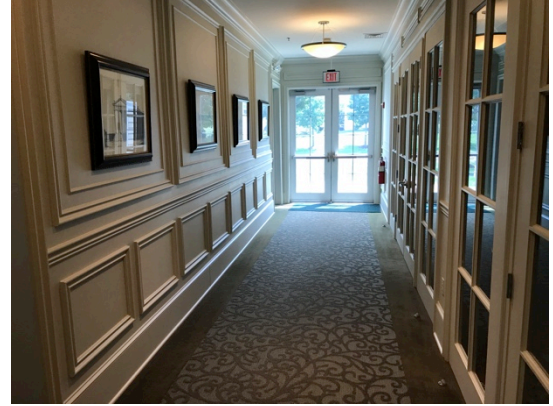
**Corridors.** The Association maintains full-length corridors on each floor of the building. Listed below are the major corridor components that we have included in the Reserve Analysis:

- **Carpet.** The carpet in the building's corridors is in good condition. Commercial carpet of this construction in this type of application has a typical service life of 7 to 10 years.
- **Light Fixtures.** Corridor illumination is provided by wall mounted and ceiling mounted light fixtures. The fixtures are in good working condition and provide adequate lighting. Fixtures of this type have a typical service life of 25 years but may be replaced during normal renovation projects.
- **Exit Lights.** The building uses illuminated exit lights at each of the exits. The general condition of the building's exit lights is good.
- **Emergency Light Fixtures.** The building uses battery powered light fixtures for emergency lighting in the event of a power outage. The fixtures are in good condition. Fixtures of this type have a typical service life of 20 years.

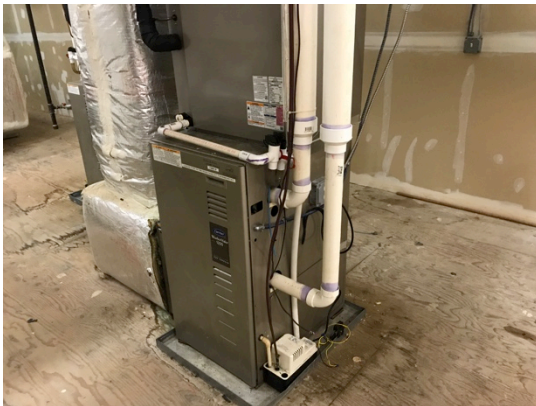
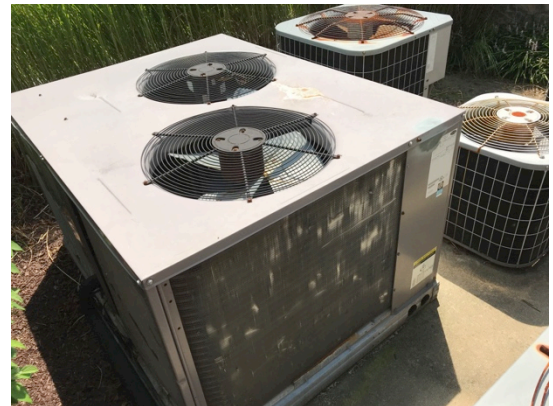
**Split and Package HVAC Systems.** The heating ventilation and air conditioning (HVAC) of the facility are reported to be in good operating condition. Detailed inspection and testing of these systems is beyond the scope of this study.

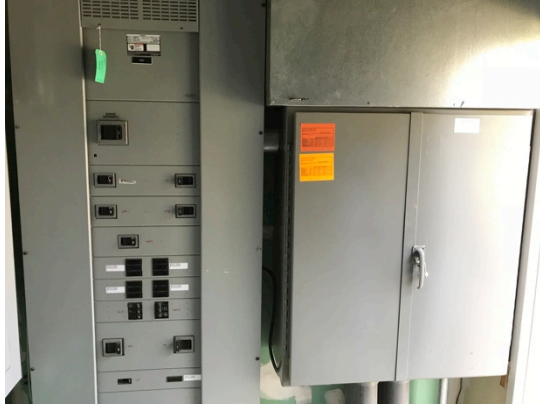
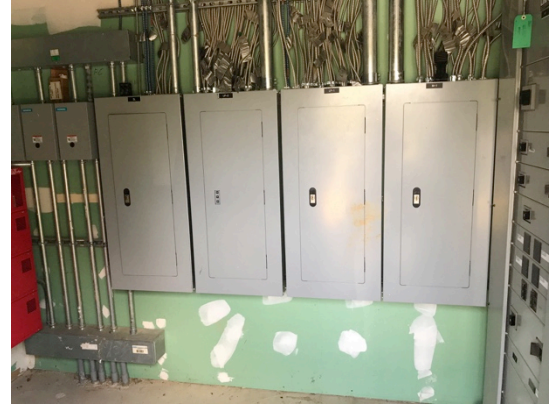
**Building Electrical Service.** The electrical systems of the building(s) are reported to be operating normally.

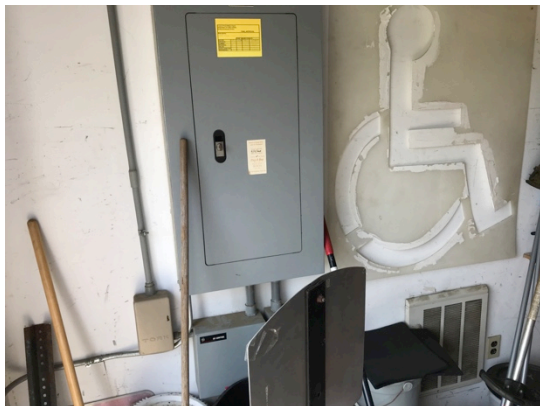
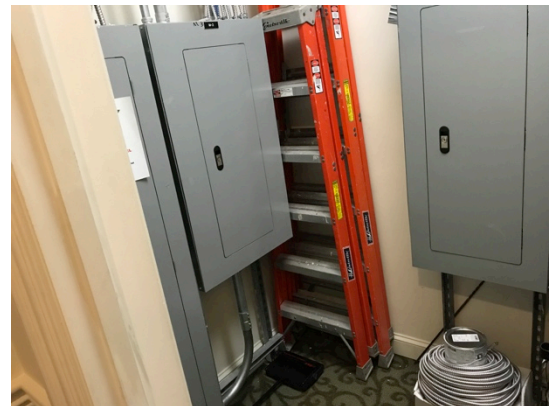
**Electrical Distribution Panels.** The building has a number of electrical distribution panels located throughout the facility. These panels separate the building's electrical power feed into separate circuits while providing protective circuit breakers for each circuit. These panels date to the original construction of the building and have a rated service life of 50 years or more.

The overall condition of the distribution panels is good. As the distribution panel's age, obtaining replacement parts can be expected to become more difficult. When parts no longer are available, the Association will have to replace some of the existing panels. Replacement will have to be performed on an incremental basis, panel by panel. Therefore, we have included funding in the Reserve Analysis for distribution panel replacement on an incremental basis.

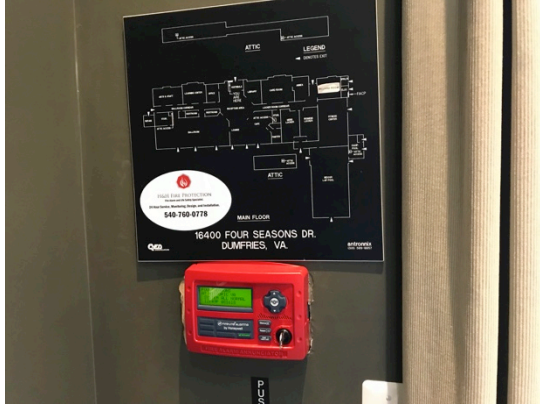
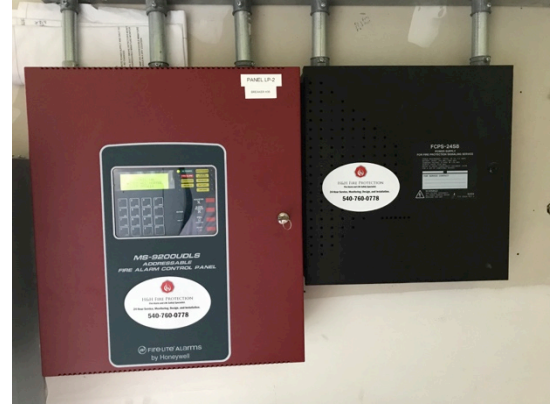
**Fire Safety Systems.** The building is fitted with a fire safety system that includes sprinklers and alarms, and these are reported to be operating normally. Testing and inspection of fire safety systems are not included in this study.

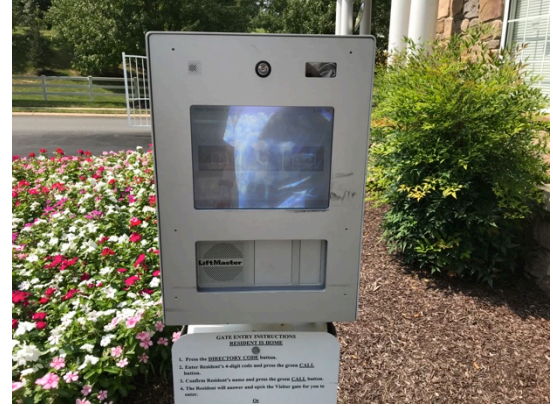
**Security.** The facility is secured by intrusion detection, access control, CCTV and recording (DVR). Security is an important factor in facility management. Electronic security represents a proactive approach to safeguarding the occupants and property.

The current system is very modern. The circuitry and technology are part of a hi-tech industry that will improve over time and make these systems obsolete. Even if the system still functions adequately, replacement is inevitable. At the time of replacement, a 360-degree assessment of vulnerabilities, threats, and needs should be performed to design a new system that matches operating needs of the facility.

For the system to function as designed the following should be practiced:

- Manage inventory and issuance of access cards.
- Maintain electronically actuated door hardware and associated door hardware so that all doors release when activated and fully close thereafter.
- Regularly service drive-gates and garage doors.
- Perform operational testing of cameras and recorders.
- Establish and maintain a relationship with 24-hour monitoring service.
- Establish a call list for security emergencies and test it periodically.

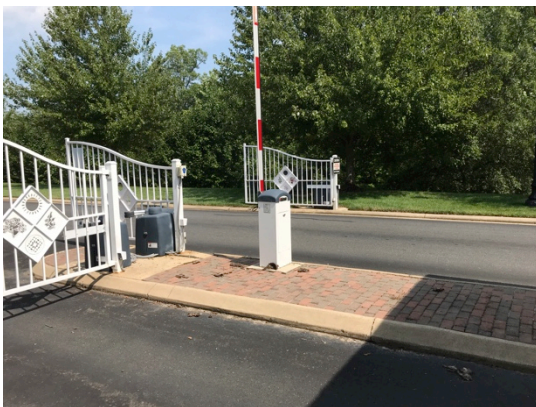
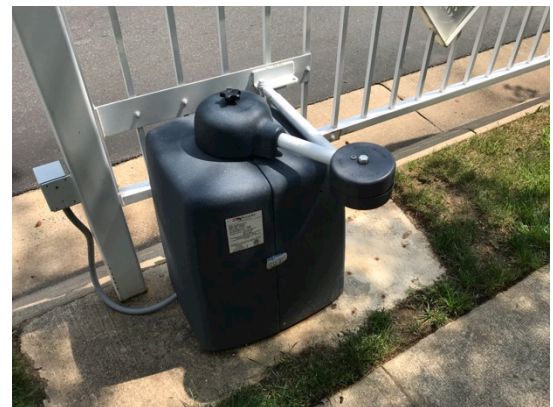
**Vehicle Access System.** Perimeter access control is established via electronic access control and vehicle access gates. The systems are in good condition and operating normally.

- Readers. Maintain all connections and security interfaces.
- Gates. Maintain hinges and fence sections. Keep swing or slide area clear of debris and obstructions.
- Actuators. Inspect actuators periodically to ensure proper function.
- Electrical. Maintain boxes, connections, and conduits to keep out water and moisture.

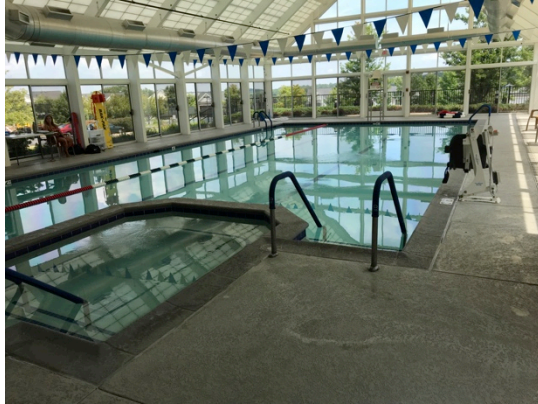
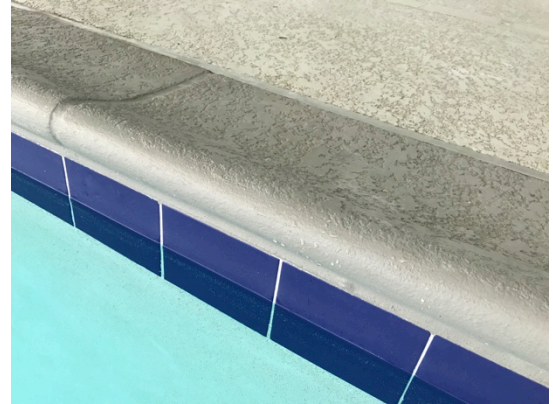
- Pool Shell. The shell for the swimming pool is in good condition.
- Pool Deck. The pool has a concrete deck. The overall condition of the deck is in good condition with no tripping hazards.

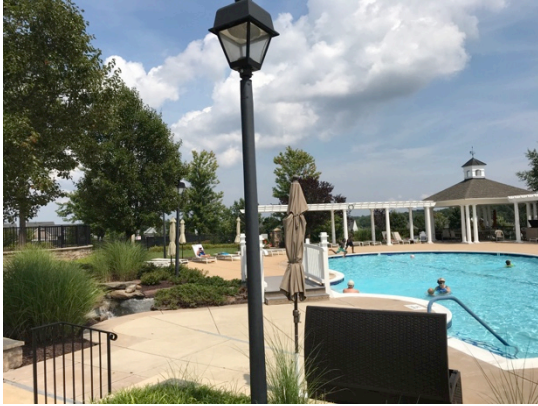
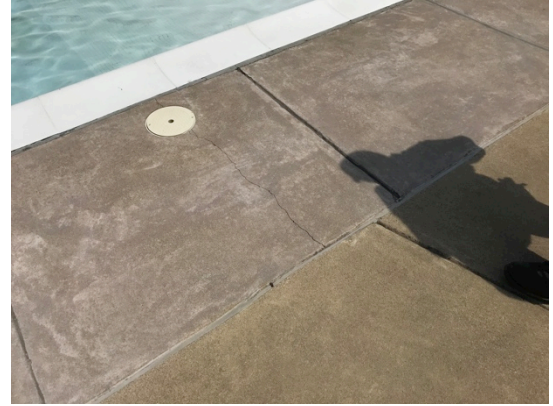
- Pool Shell. The shell for the swimming pool is in good condition.
- Pool Deck. The pool has a concrete deck. The overall condition of the deck is in good condition with a few areas of settlement and tripping hazards.
- Whitecoat. The pool whitecoat is in good condition. We have assumed a service life of eight to ten years for the pool whitecoat.
- Waterline Tile. The waterline tile is in good condition. We have assumed that the waterline tile will be replaced or restored when the pool is whitecoated.
- Coping. The pool is edged with masonry coping. The coping is in good condition.
- Pump and Filter System. The filter system is in good operating condition.
- Pool Fence. The swimming pool is enclosed by a metal fence that is in good condition.

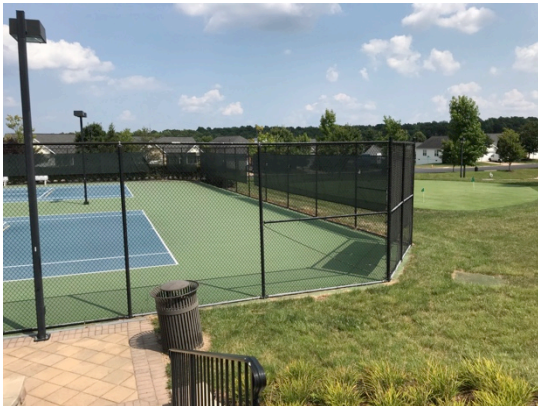
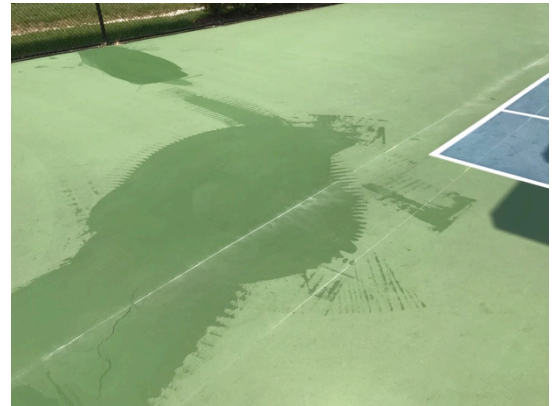
**Courts.** The community maintains multiple tennis courts, bocce courts, a putting green, and a driving pad. The overall condition of these facilities is good.

Listed below are the major components of the tennis court facilities:

- Asphalt Pavement (base layer). We have assumed a service life of 20 to 30 years for the asphalt base layer.
- Color Coat (surface layer). Annual cleaning is recommended to maintain the surface of the court. The base of a tennis court is subject to cracking and low spots known as “birdbaths” that can occur from
