# LEVEL 1 REPLACEMENT RESERVE REPORT FY 2021 SAMPLE PREPARATORY SCHOOL

# REPLACEMENT RESERVE REPORT

## SAMPLE PREPARATORY SCHOOL

SAMPLE, COLORADO  
March 30, 2021

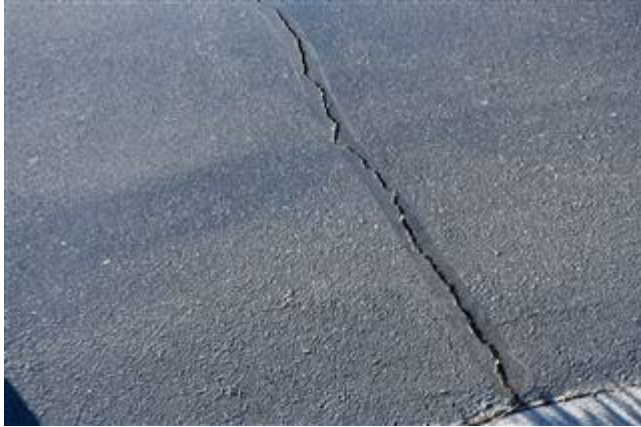
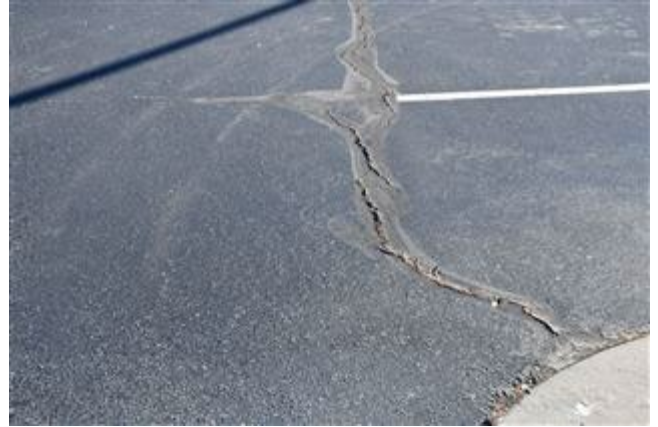
As a rule of thumb, asphalt should be overlaid when approximately 5% of the surface area is cracked or otherwise deteriorated. The normal service life of asphalt pavement is typically 20 to 25 years. The study assumes a cycle of crack sealing every 3 years, with seal coating every 6 years, and after three cycles of seal coat the asphalt would be milled and overlaid at the end of the next cycle.

In order to maintain the condition of the pavement throughout the community and to ensure the longest life of the asphalt, we recommend a systematic and comprehensive maintenance program that includes:

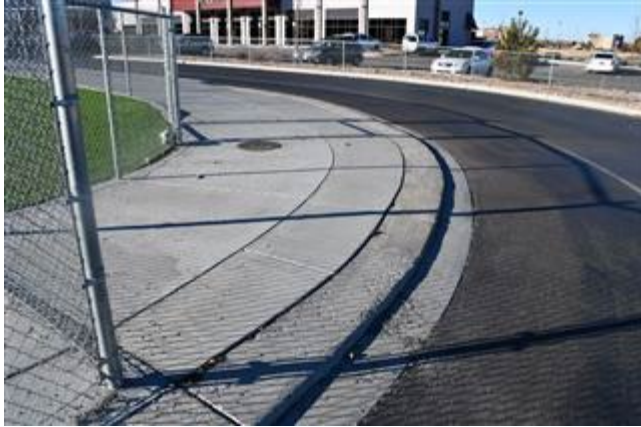
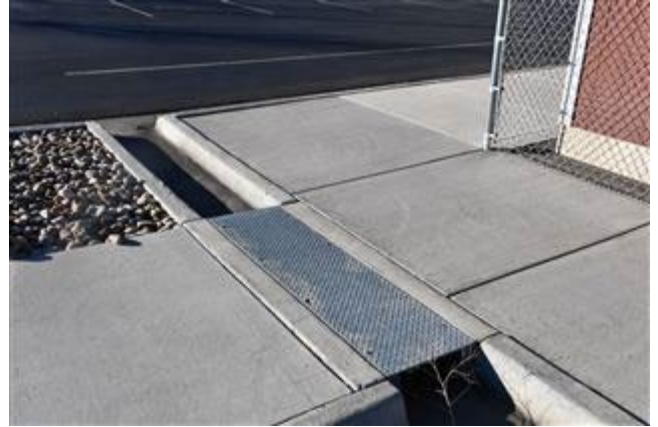
**Concrete Work.** The concrete work includes the school's curbs, sidewalks, and other parking lot drain pans. We have modeled for curb replacement when the asphalt pavement is overlaid. The overall condition of the concrete work is good.

The standards we use for recommending replacement are as follows:

- Trip hazard, ½ inch height difference.
- Severe cracking.
- Severe spalling and scale.
- Uneven riser heights on steps.
- Steps with risers in excess of 8¼ inches.

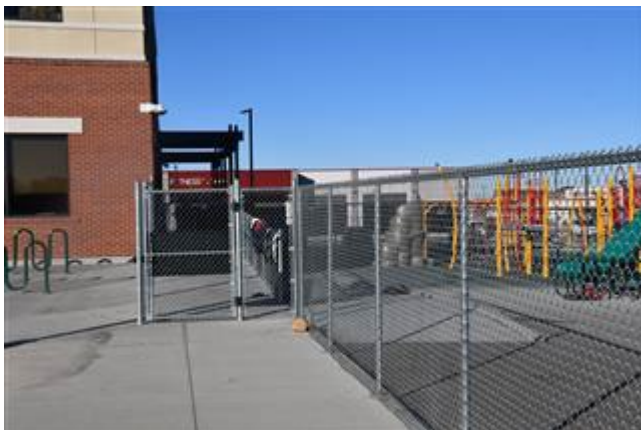
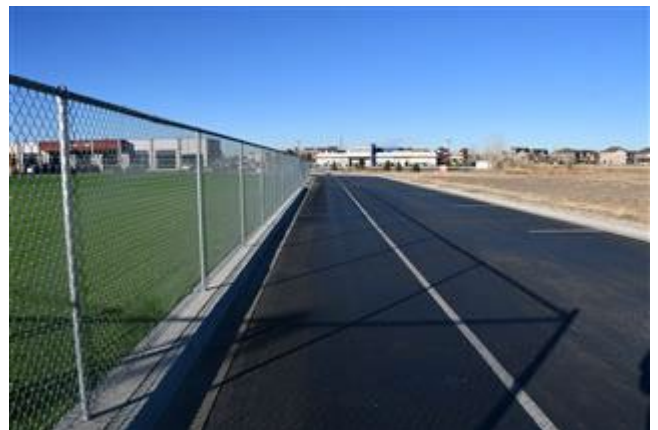
**Fencing.** The Association maintains chain line fencing in good condition.

Chain link fencing can have a useful life of 40 years or more. The Prep School maintains steel fence posts and fasteners that are embedded in concrete.

As part of normal maintenance, we recommend the following:

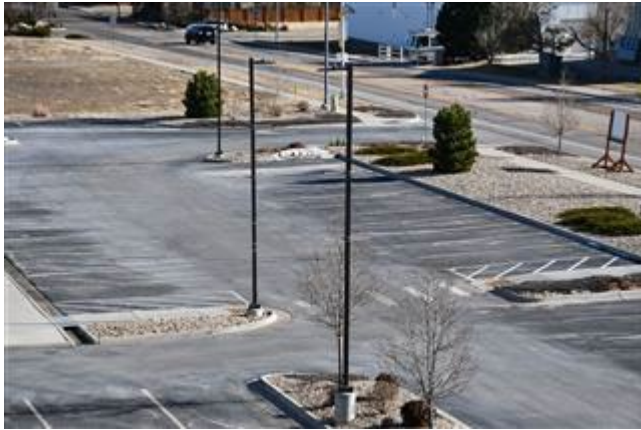
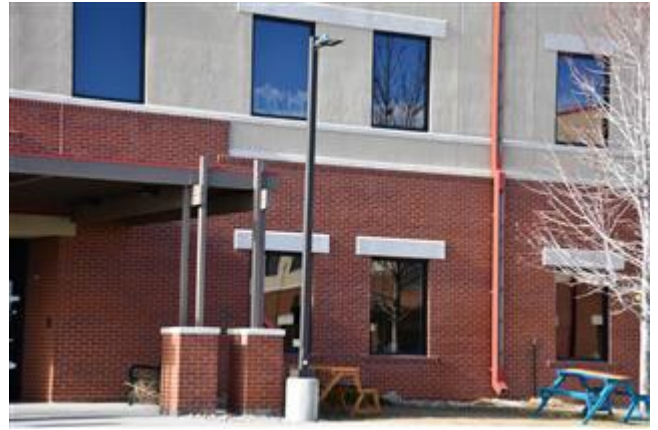
**Site Lighting.** The Prep School is responsible for the operation of the school's walkway and parking lot poled streetlights, and building mounted lights. The lighting system was not on at the time of our site visit. We understand that the lighting system is in operating condition.

For the pole lights the study assumes replacement of the light fixtures every 15 to 20 years, and pole replacement every 30 to 40 years. When the light poles are replaced, we assume that the underground wiring will also be replaced.

When a whole-scale lighting replacement project is called for, we recommend consulting with a lighting design expert. Many municipalities have design codes, guidelines, and restrictions when it comes to exterior illumination.

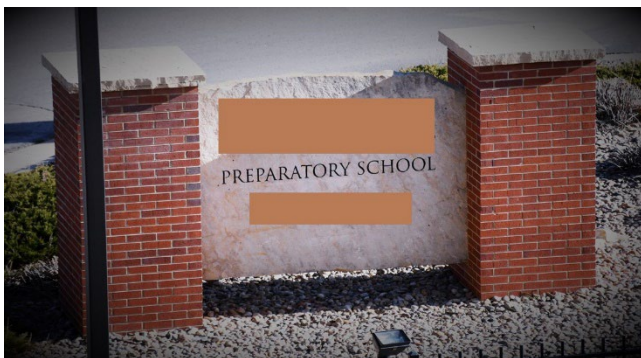
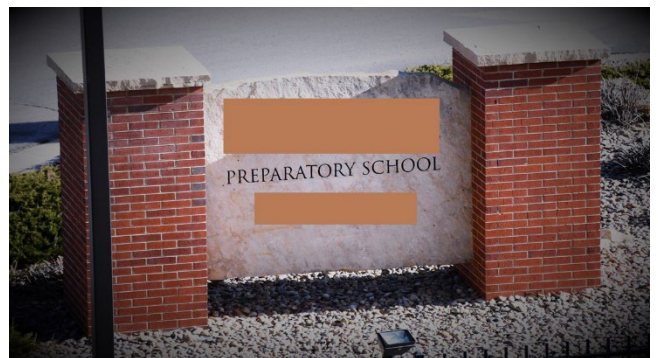
The monument lettering is engrave/carved stone with painted accent. The stone monument should have a useful life of 20 to 30 years with some interim painting.

We recommend repointing and replacement of defective areas of the masonry as needed. The School may want to consider applying a coating of Siloxane or other appropriate breathable sealants to mitigate water penetration and further degradation of the masonry work.

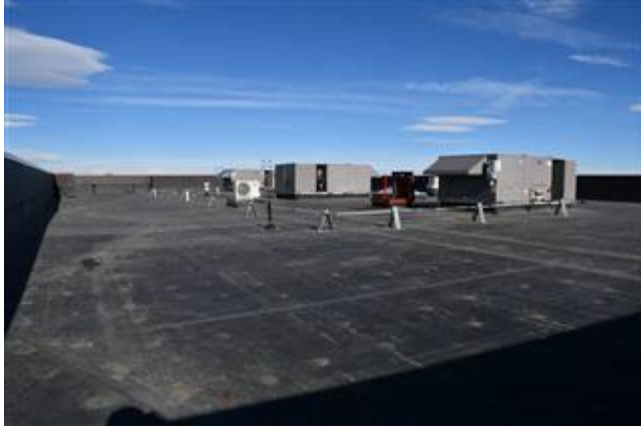
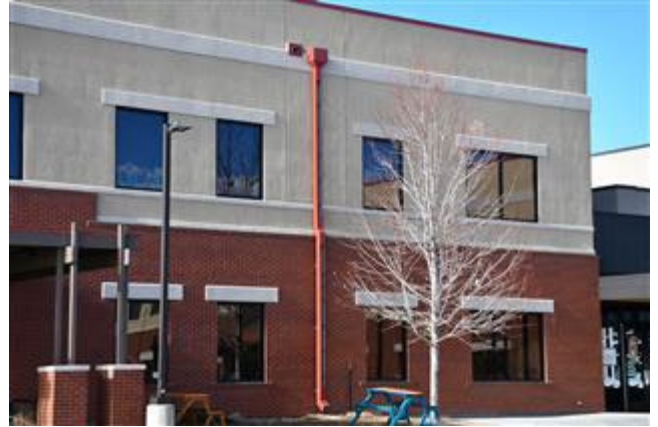
**Building Roofing.** The school building(s) are roofed in flat roofing systems. The EDPM flat roofs are in excellent to good condition.

Flat roofing systems can have a variety of configurations that will greatly affect the cost of replacement including insulation, ballast, the height of the building, and the density of installed mechanical equipment. Flat roofing systems typically have a useful life of 15 to 25 years.

Annual inspections are recommended, with cleaning, repair, and mitigation of vegetation performed as needed. Access, inspection, and repair work should be performed by contractors and personnel with the appropriate access equipment who are expanded in the types of roofing used for the facility.

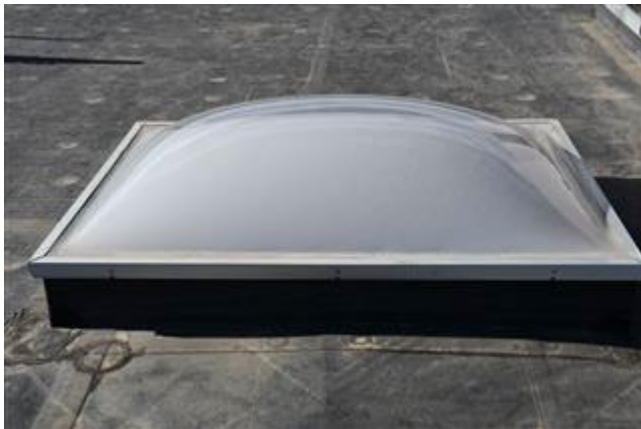
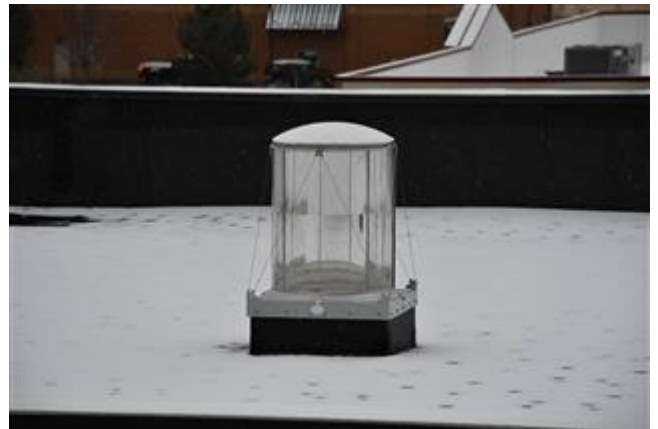
**Skylights/Light Tubes.** The school maintains one skylight over the staircase in the original building and six light tubes over the gym in the new building. The skylight and light tubes are in good condition. The normal life expectancy of these items are 20 to 30 years.

It is recommended that the skylight and light tubes be inspected once each year for structural integrity and weather tightness. If the wall and ceiling area beneath them shows signs of moisture damage, it is important to identify and correct the source of water penetration in order to prevent damage to the building's roof. Closely examine the flashing and roof area immediately surrounding the skylight and light tubes, as these often are the source of leaks attributed to skylights and light tubes.

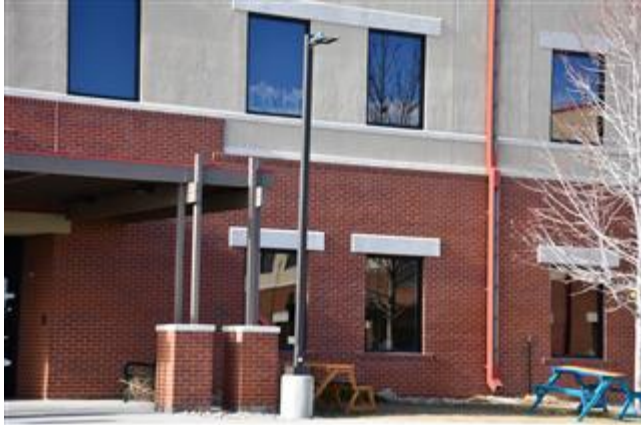
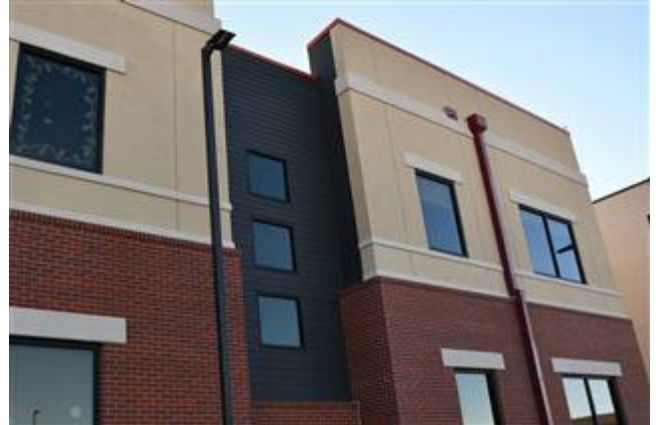
Brick is used as a main exterior cladding of the building. As the brick mortar joints weather, the joints will become damaged by water penetration. As additional water gains access to the joints, repeated freeze-thaw cycles gradually increase the damage to the mortar joints. If allowed to progress, even the masonry units such as brick, block, and stone can have their surfaces affected and masonry units can become loose.

In general, masonry is considered a long-life item and is therefore excluded from reserve funding. However, because weather and other conditions result in the slow deterioration of the mortar in masonry joints, we have included funding in this study for repointing. Repointing is the process of raking and cutting out damaged sections of mortar and replacing them with new mortar.

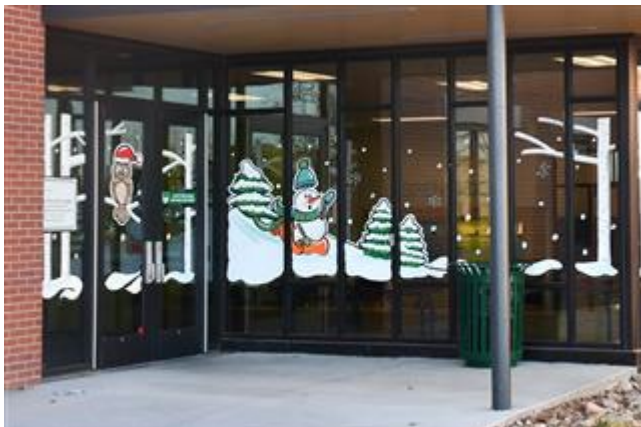
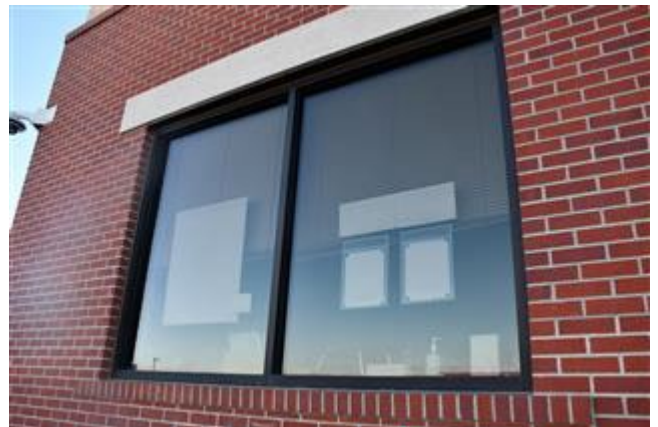
**Windows and Doors.** The Prep School is responsible for the windows and exterior doors of the school. The windows and doors are in generally good condition.

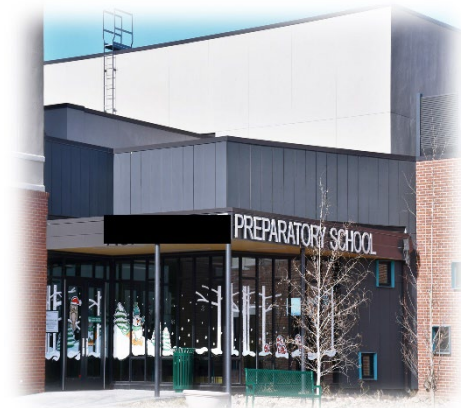
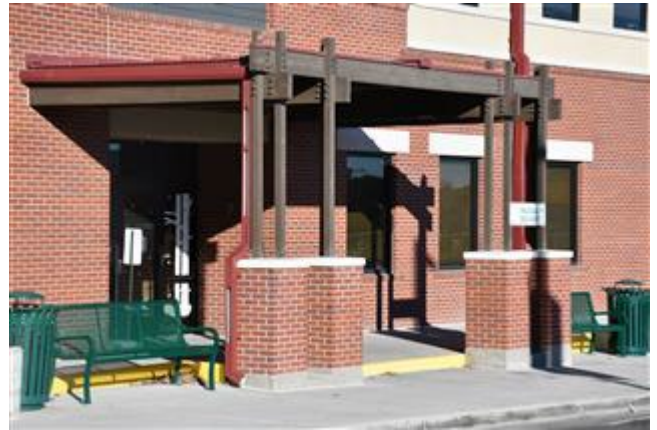
**Entry Canopies.** There are a number of entry canopies over the doorways of each building. They are made of a combination of wood and metal and are in generally good condition.

The study assumes a refurbishment midway through the life expectancy with a full replacement after approximately 40 years.

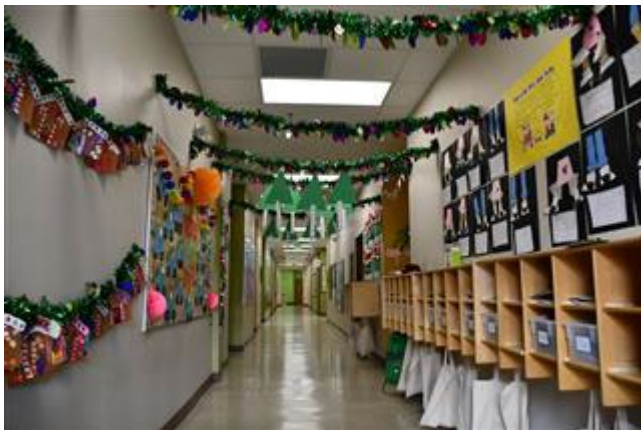
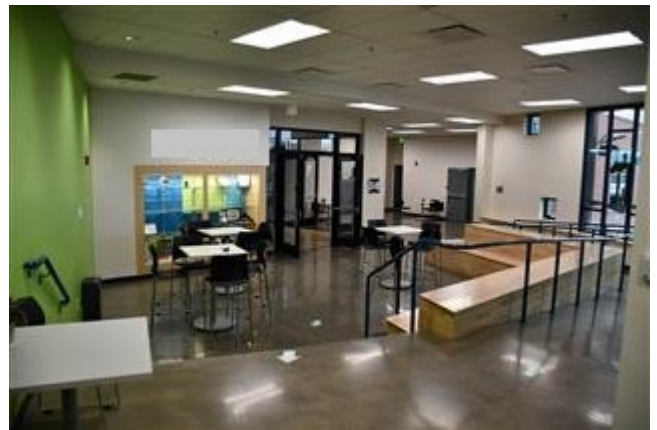
**Common Interiors.** The Prep School maintains the lobby, halls, classrooms, offices, auditorium, gymnasiums, cafeteria, restrooms, and other interior spaces that are in generally good condition.

We have assumed that the school will want to maintain these areas in a commercially acceptable condition. Typically, replacement cycles for common interior spaces vary between 10 to 20 years depending on the aesthetic tastes of the school, usage, and construction. Material selection and the school's preferences are the major factors in selecting the reserve cycles for items such as refurbishing and interior refurbishment. The school will need to establish these cycles as these components age. Maintaining historical records and incorporating these trends and preferences into a future Reserve Study update is the best way to adjust for these cycles.

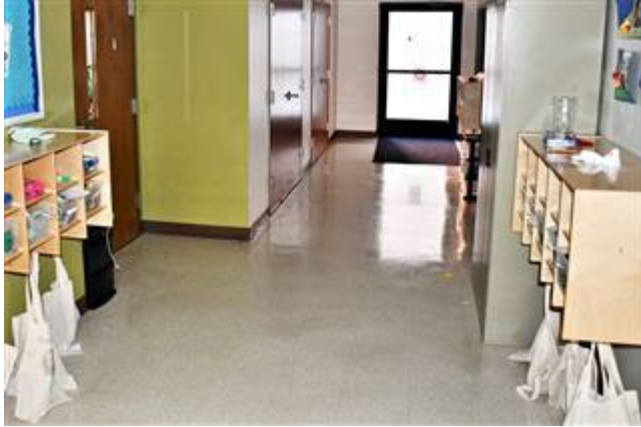
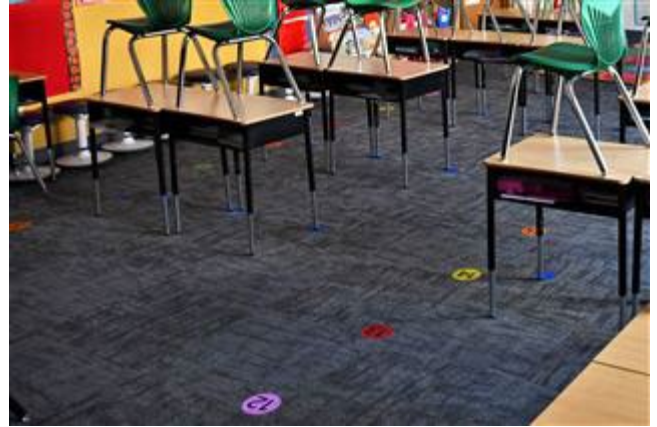
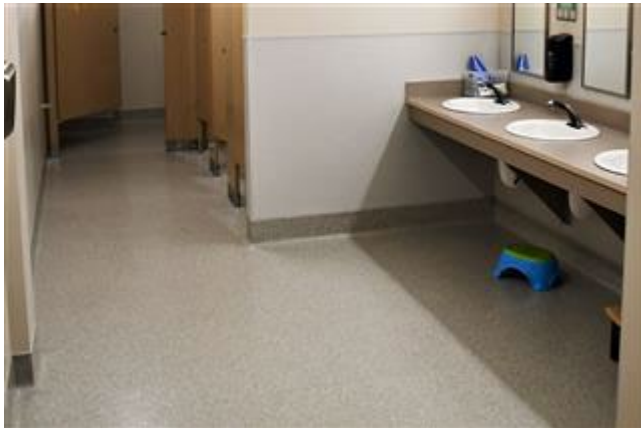
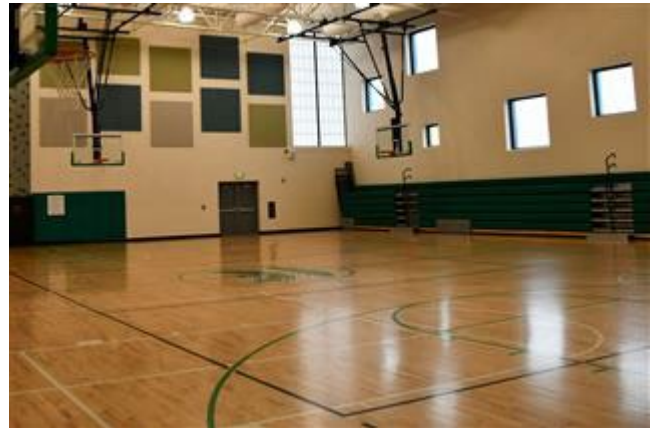
**Flooring.** The school has carpet, vinyl tile, ceramic tile, wood, and rubberized flooring.

- **Carpet.** The carpet in the school's classrooms and offices is in good condition. The school is utilizing carpet tiles which are easier to maintain and can be spot repaired. Commercial carpet of this construction in this type of application has a typical service life of 10 to 15 years.

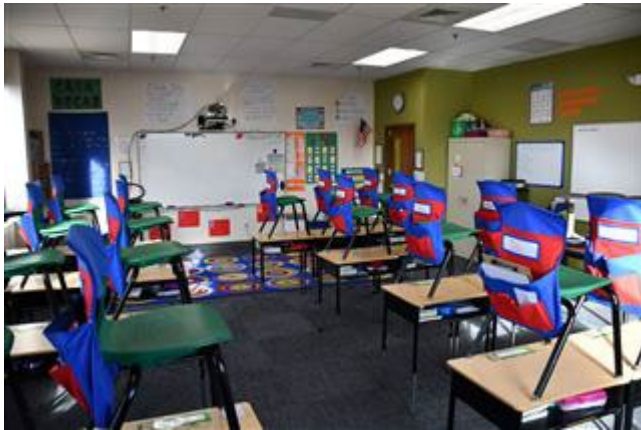
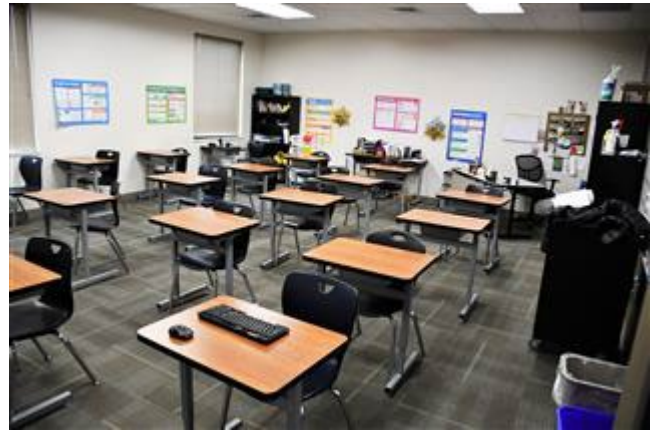
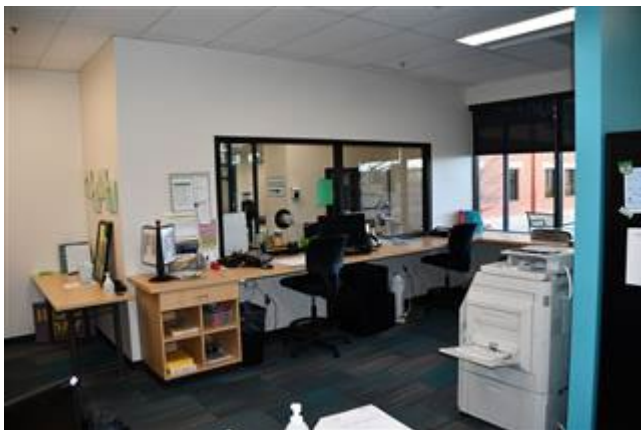
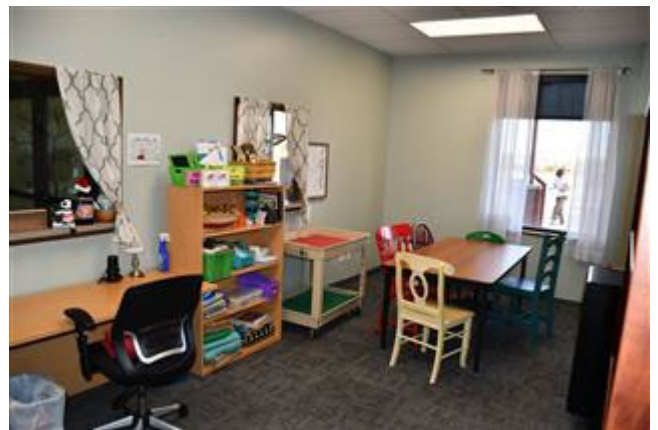
**Furnishings.** The study includes an extensive amount of tables, desks, and chairs for the classrooms and offices. Also included are the large rolling tables for the cafeteria. These items are in good condition and have an expected useful life of 20 to 25 years.

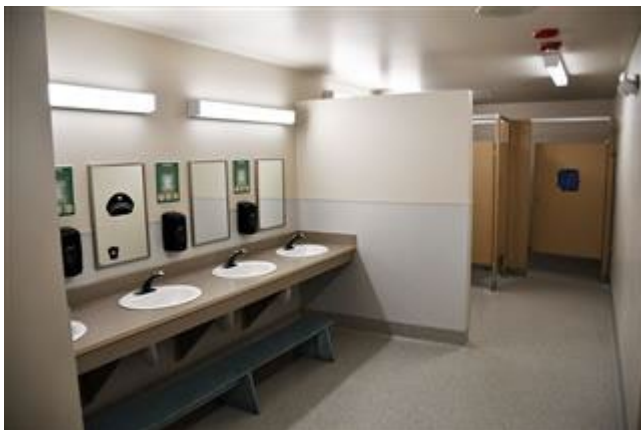
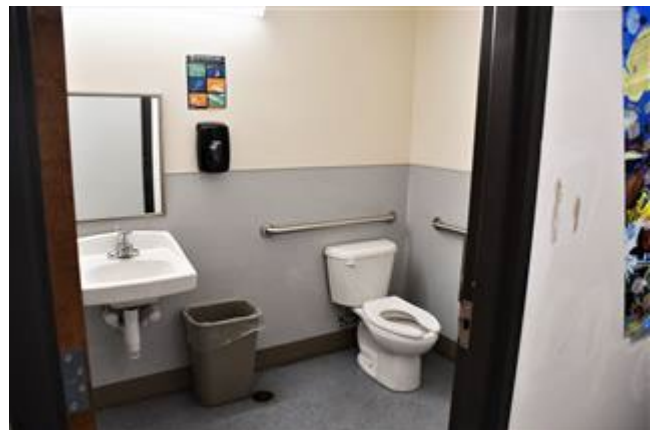
**Restrooms.** The school restrooms consist of toilets, urinals, partitions, and sinks. We have assumed a service life of 30 years for the fixtures and that all fixtures will be replaced at the same time as part of a major renovation of the restroom. A mid-term renovation is planned for the partitions mirrors, dispensers, and other miscellaneous fixtures.

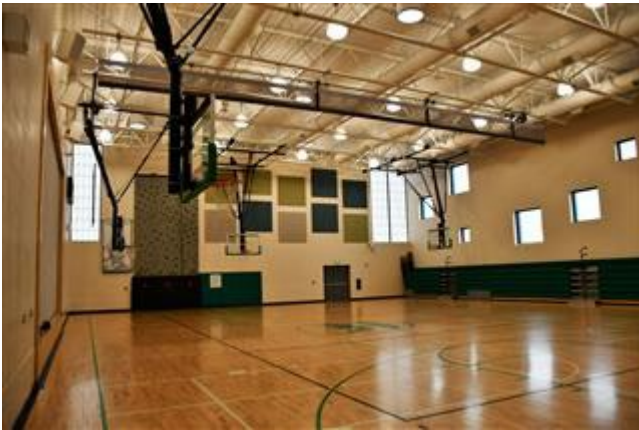
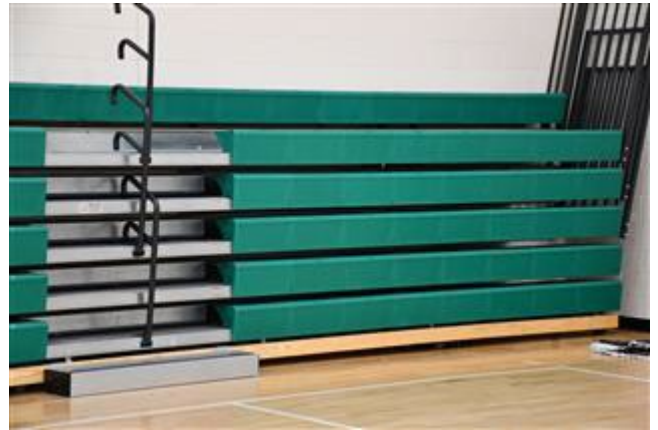
**Gym/Auditorium.** The school gymnasium/auditorium has retractable seating, along with stage lighting and sound system. There are basketball backboards, tennis nets, and a climbing structure. These items were recently constructed and in like new condition.

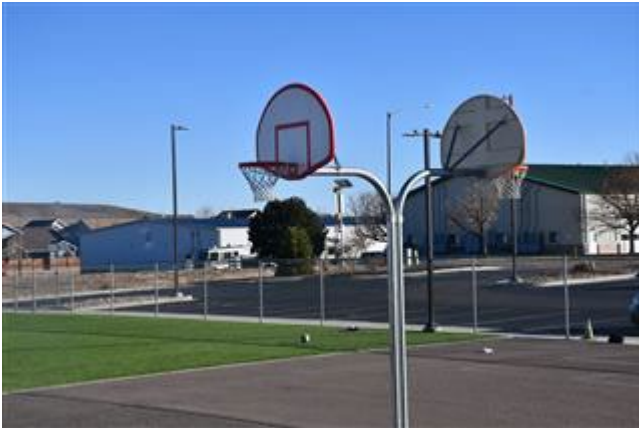
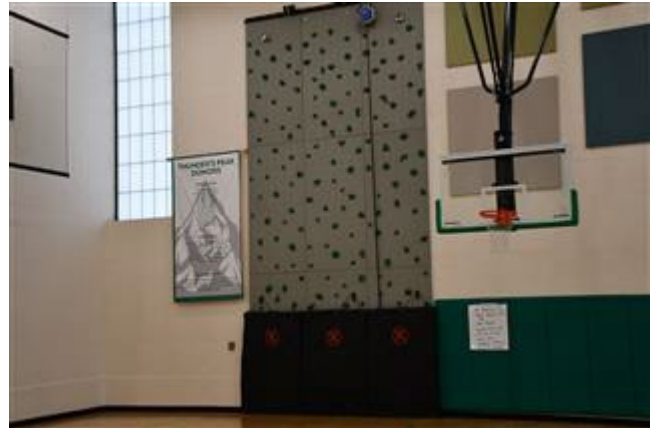
**Basketball Court.** The School maintains a three half basketball courts outside and a number of backstops inside the gymnasium. The overall condition of the components is good.

Replacement of the nets, hoops, and backstops is part of this study and these items are expected to have a 20 year useful life. The nets may require interim replacement under the operating budget.

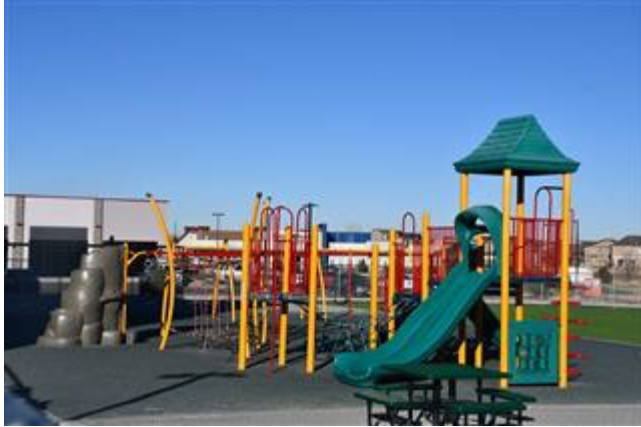
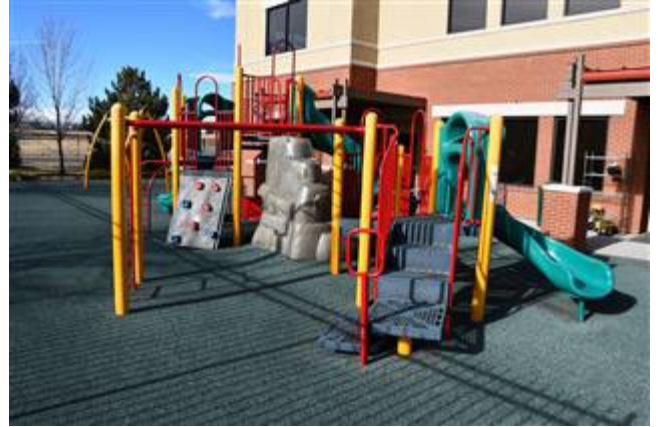
**Tot Lots.** The School maintains two large playground areas and each have tot lots. These tot lots include play structures, miscellaneous play equipment, concrete borders, and a poured rubberized safety surface. The equipment is in generally good condition with minor wear. It is assumed the safety surface will have the same life expectancy as the play structures and be replaced at the same time.

The safety of each individual piece of playground equipment as well as the layout of the entire play area should be considered when evaluating a playground for safety. The installation and maintenance of the protective surfacing under and around all equipment is crucial. Please note that the evaluation of the equipment and these facilities for safety is beyond the scope of this work. Information for playground design and safety can be found in the "Public Playground Safety Handbook", U.S. Consumer Product Safety Commission (Pub Number 325). For a link to this handbook, please see our web site at [www.mdareserves.com/resources/links/recreation](http://www.mdareserves.com/resources/links/recreation).

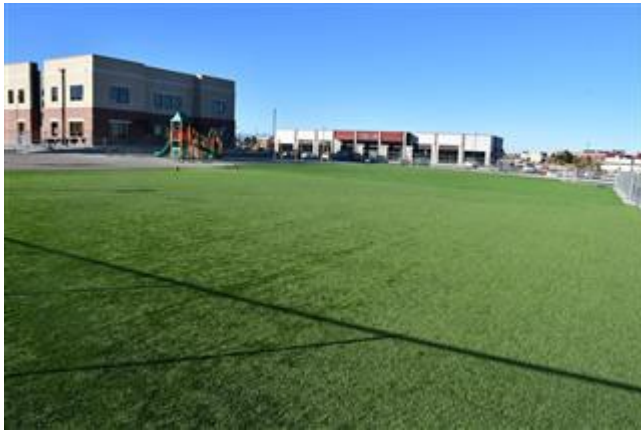
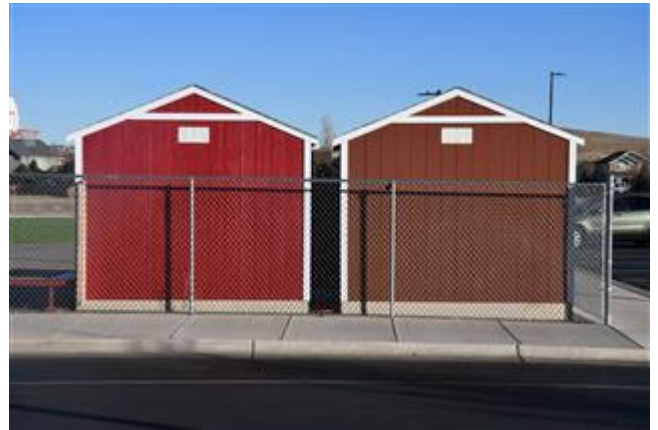
**Artificial Turf.** There is an artificial turf surface for fitness and playground games. The turf is in good condition. Next to the artificial turf field and the basketball courts are two wooden storage sheds used to store the sporting equipment for activities in these areas.
