LEVEL 1 REPLACEMENT RESERVE REPORT FY 2023 SAMPLE CHURCH & SAMPLE MISSION

REPLACEMENT RESERVE REPORT

SAMPLE CHURCH & SAMPLE MISSION

SAMPLE, STATE
November 30, 2021

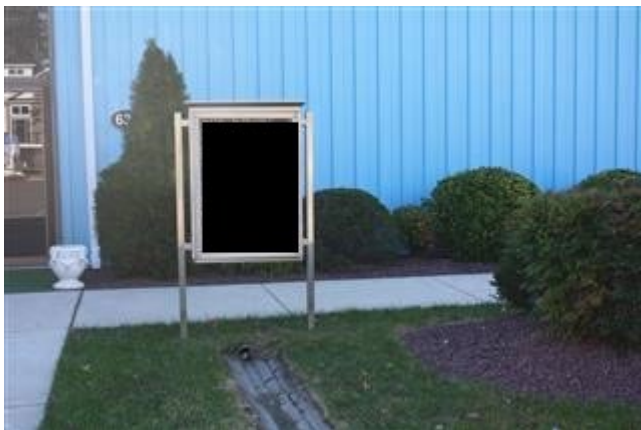
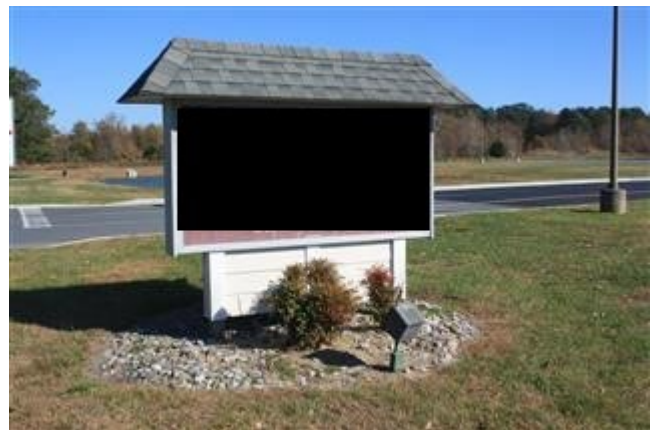
Entry Monument and Signage. The Association maintains informational signs at Sample and an **entry monument at the Mission**. The informational signs are made of metal and are in good condition. The monument is made of wood is in poor condition, with damaged areas and weathering. To keep the monument fresh and appealing, we recommend replacement every 10 to 15 years.

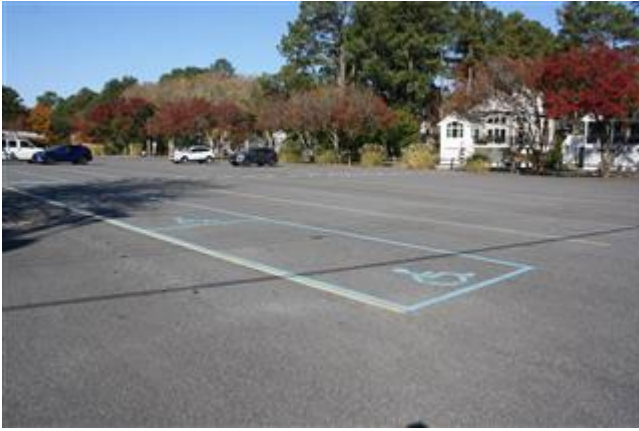
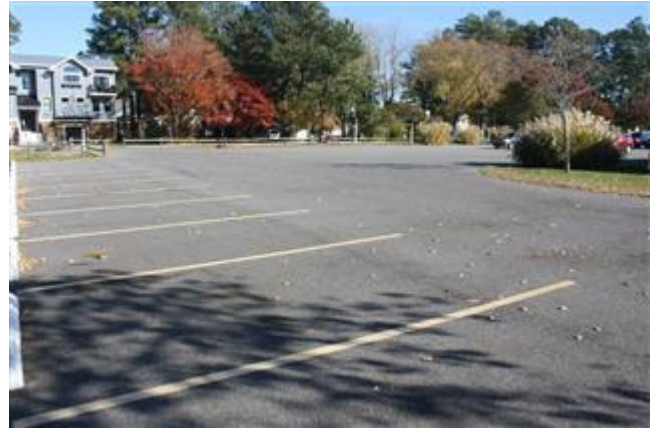
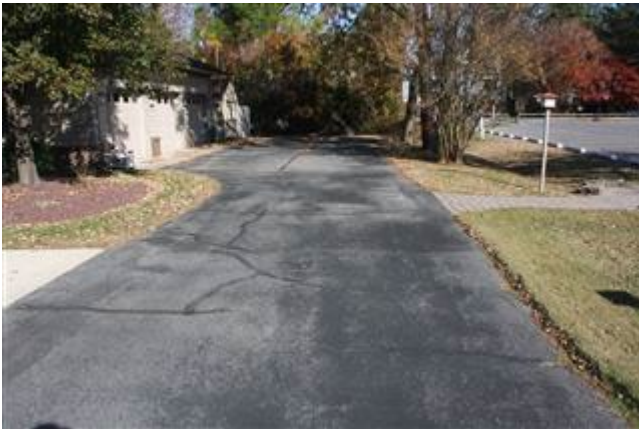
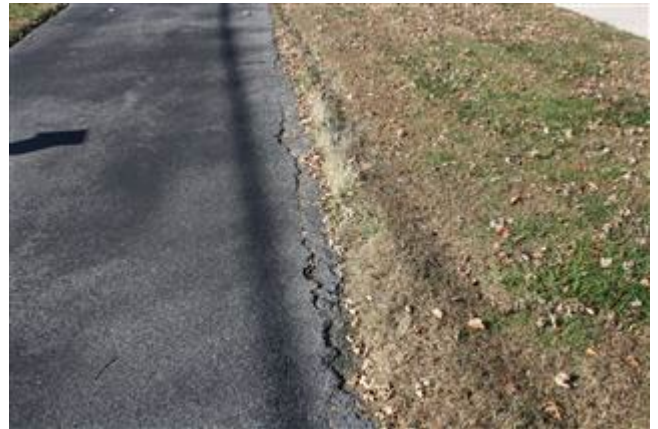
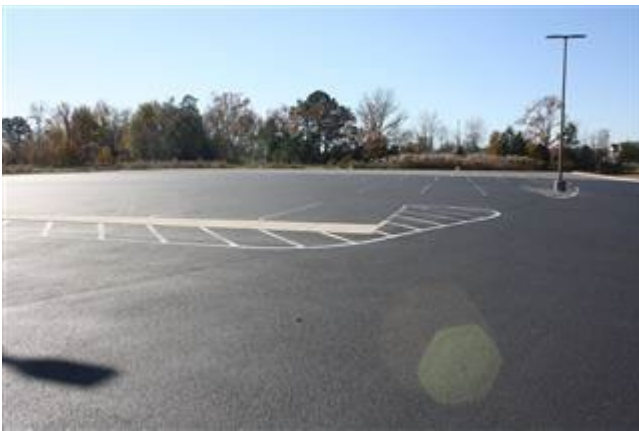
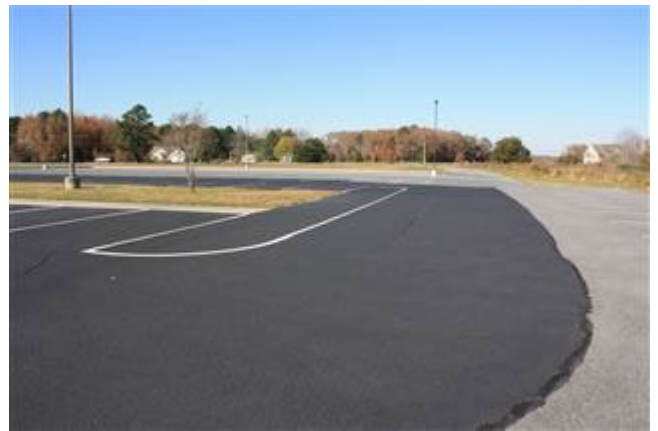
Asphalt Pavement. The Association is responsible for the parking areas and driveways at both Sample and the Mission. Other roadways are maintained by the municipality. In general, the Association's asphalt pavements are in generally good condition. There are a few defects along the driveways at the Rectory.

The Defects noted include the following:

- **Open Cracks.** There are multiple locations where open cracks are allowing water to penetrate to the asphalt base and the bearing soils beneath. Over time, water will erode the base and accelerate the deterioration of the asphalt pavement. If cracks extend to the base and bearing materials, remove the damaged areas, and replace defective materials. As a part of normal maintenance, clean and fill all other cracks.
- **Edge Cracking.** Sections of the asphalt pavement have developed cracks along the pavement edges due to improper confinement. Installation of curbs or installation of a compacted gravel shoulder at the time of an overlay project can address this defect.

For seal coating, several different products are available. The older, more traditional seal coating product is paint. They coat the surface of the asphalt and they are minimally effective. However, the newer coating materials, such as those from Total Asphalt Management, Asphalt Restoration Technologies, Inc., and others, are penetrating. They are engineered, so to speak, to 'remoisturize' the pavement. Asphalt pavement is intended to be flexible. Over time, the volatile chemicals in the pavement dry, the pavement becomes brittle, and degradation follows in the forms of cracking and potholes. Remoisturizing the pavement can return its flexibility and extend the life of the pavement.

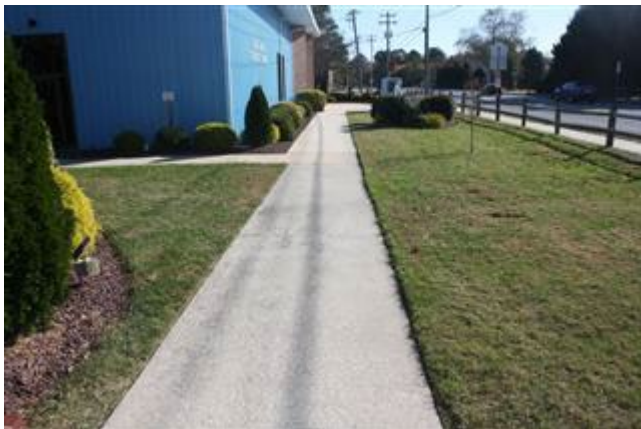
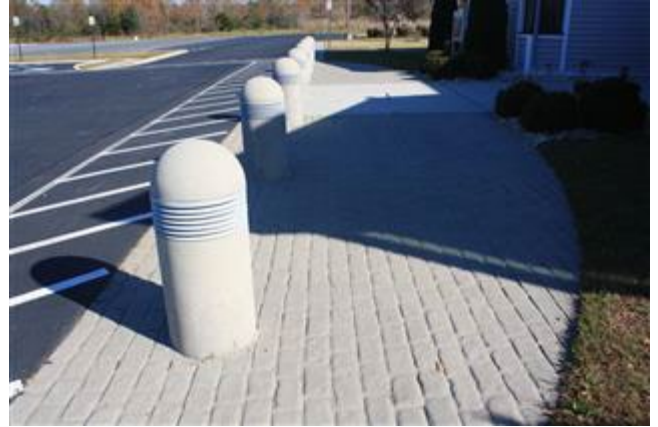
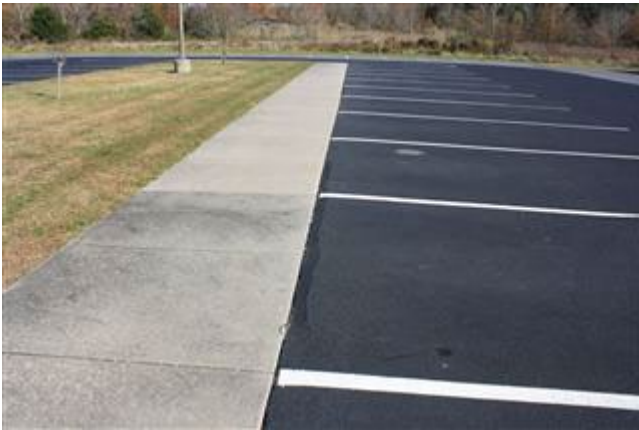
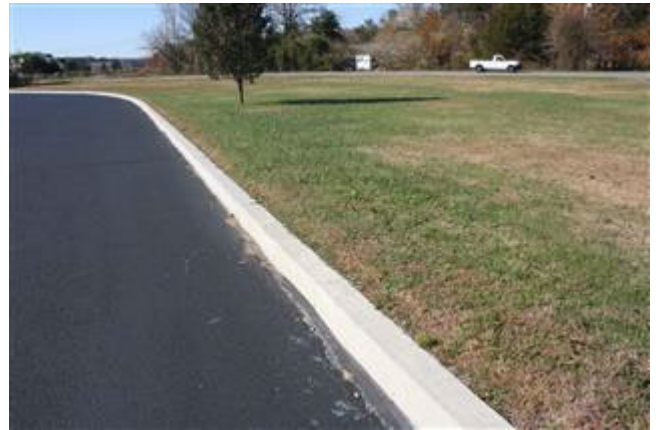
Concrete Work. The concrete work includes the community sidewalks, patios, curbs, and gutter as well as other flatwork. The overall condition of the concrete work is fair. It was noted that the sidewalk is cracking in the center of the concrete sections, indicating that the concrete was cast in sections of excess length. When the concrete is recast these sections should be only cast in half of the current length.

- Trip hazard, ½ inch height difference.
- Severe cracking.
- Severe spalling and scale.
- Uneven riser heights on steps.
- Steps with risers in excess of 8¼ inches.

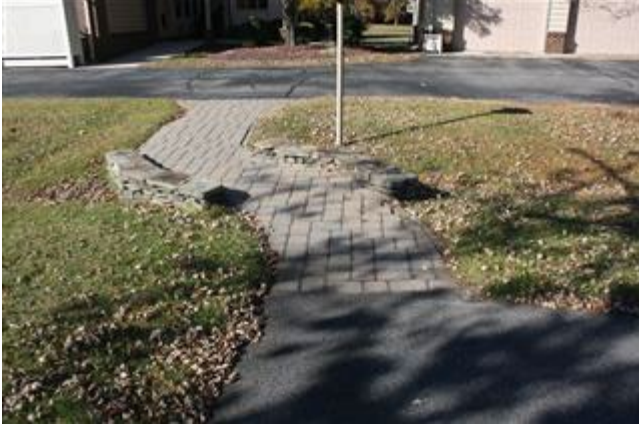
Unit Pavers. Unit pavers provide a solid, decorative, and renewable surface that is part of the community's sidewalk. The overall condition of the unit pavers is good.

To correct defects and provide the longest service life of the unit paver system, periodic re-setting is required. Re-setting provides an opportunity to replace broken unit pavers, fill in voids in the foundation material, and level the surface areas. We have included an allowance for periodic re-setting of those portions of the system.

Unit pavers have a service life of 30 years or more if the system is maintained on a consistent periodic basis. Eventually, the system will require a large-scale replacement, identical paver units may not be available and it is recommended that the unit paver system be replaced.

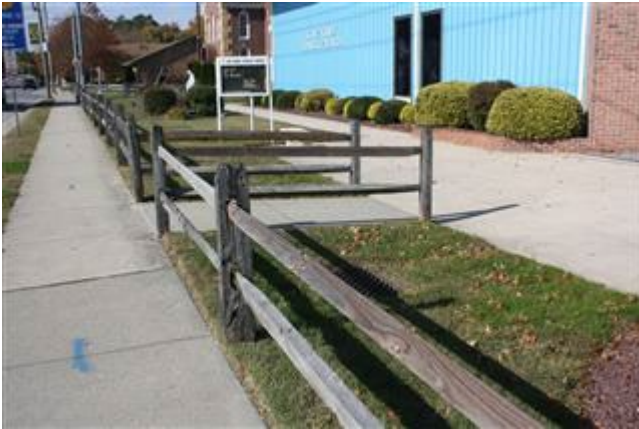
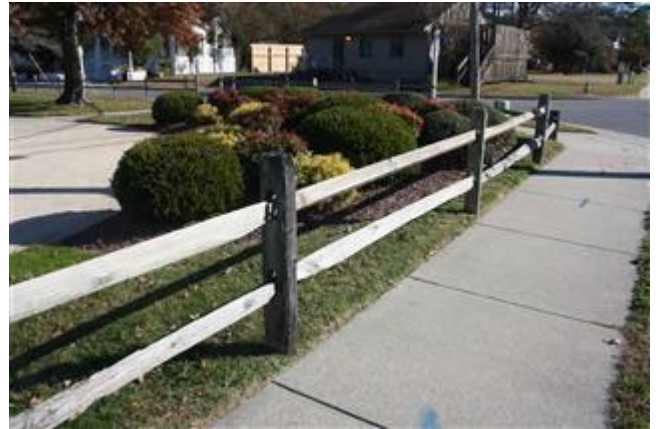
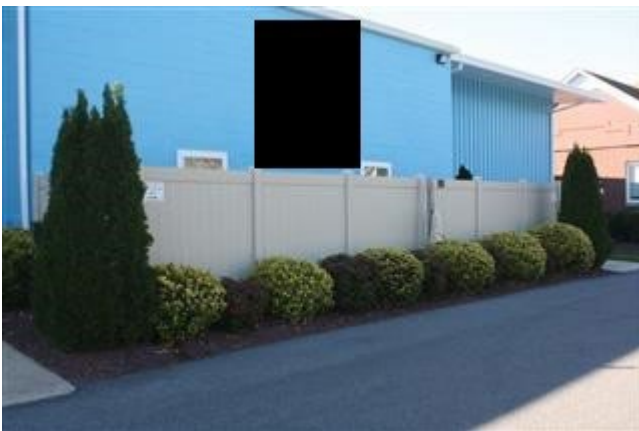
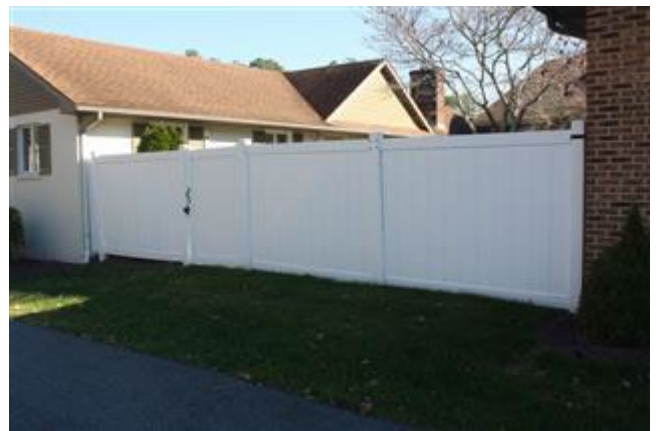
Fencing. The Association maintains split rail and PVC stockade fencing. Fencing systems have a large number of configurations and finishes that can usually be repaired as a maintenance activity by replacing individual components as they become damaged or weathered.

Protection from string machine damage during lawn maintenance can extend the useful life of some fence types. Protection from this type of damage is typically provided by applying herbicides around post bases or installing protective sheathing.

Fence posts can have an extended useful life if these simple maintenance activities are performed. If left unattended, the pressure from expansive post rust can crack and damage the supporting material.

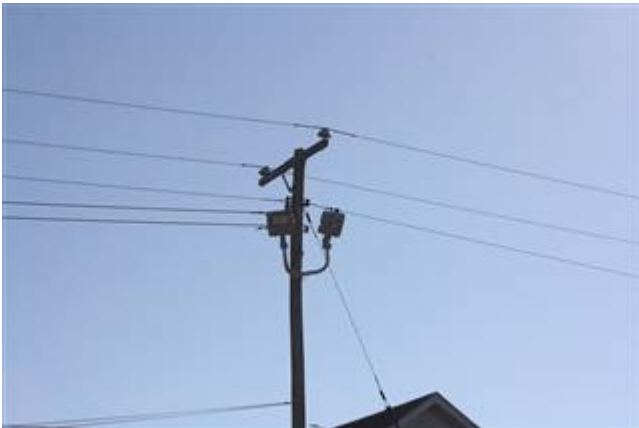
Site Lighting. The Association is responsible for the operation of the facility's lighting.

This study assumes replacement of the light fixtures every 15 to 20 years, and pole replacement every 30 to 40 years. When the light poles are replaced, we assume that the underground wiring will also be replaced.

When a whole-scale lighting replacement project is called for, we recommend consulting with a lighting design expert. Many municipalities have design codes, guidelines, and restrictions when it comes to exterior illumination.

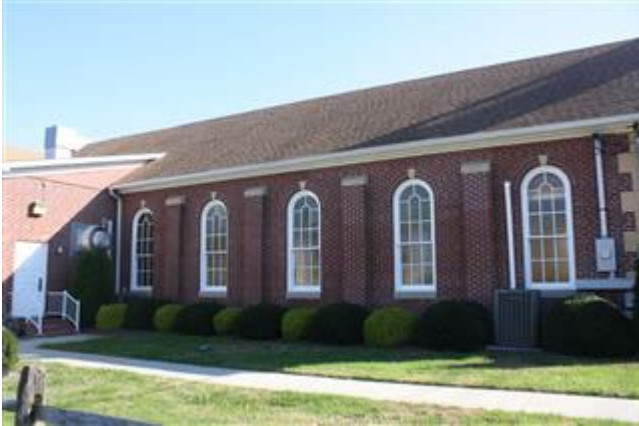
Building Roofing. The Sanctuary at Sample is constructed with metal roofing panels, while all other roofs are constructed with asphalt shingles. The roofs are in varying conditions.

Asphalt shingle roofs can have a useful life of 20 to 50 years depending on the weight and quality of the shingle. Weathered, curled, and missing shingles are all indications that the shingles may be nearing the end of their useful life. The Sanctuary at the Mission was constructed without the proper ventilation nor with an air/water shield at the eaves. This situation is currently being corrected.

Metal roofing can be a standing seam, rolled seam, or shingle with a normal economic life of 50 to 100 years. In some cases, recoating or repainting can extend the useful life of a metal roof. The metal roofing panels at Sample have recently been recoated.

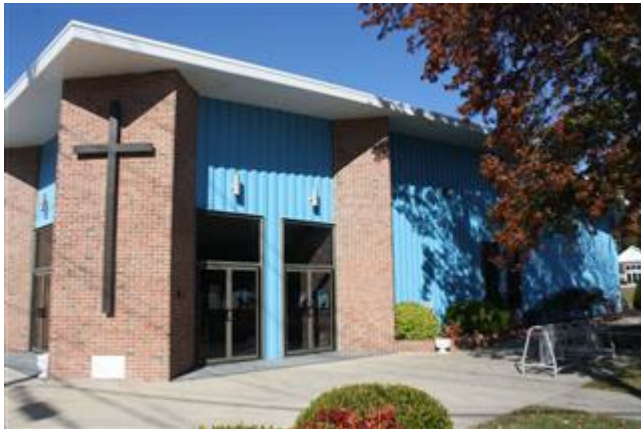
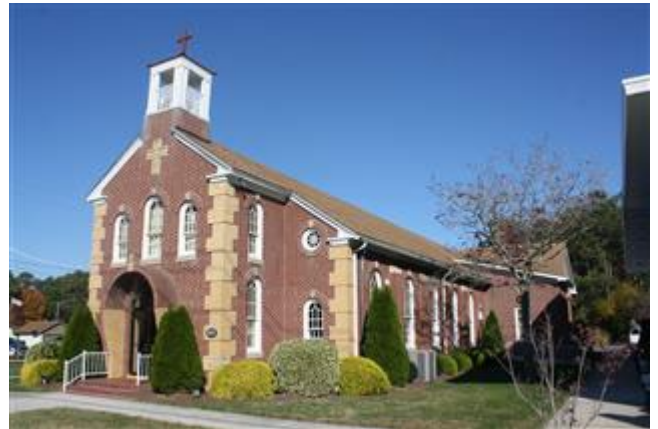
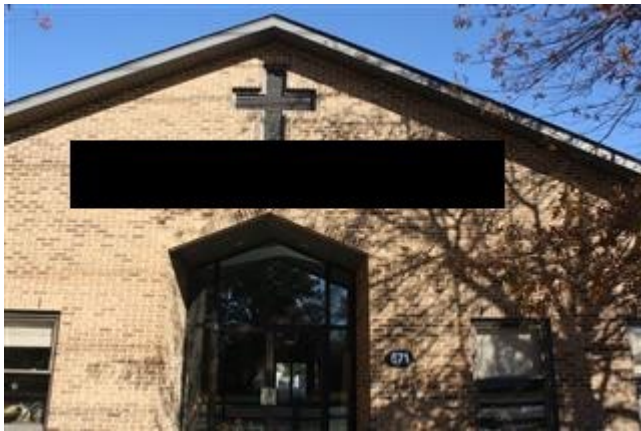
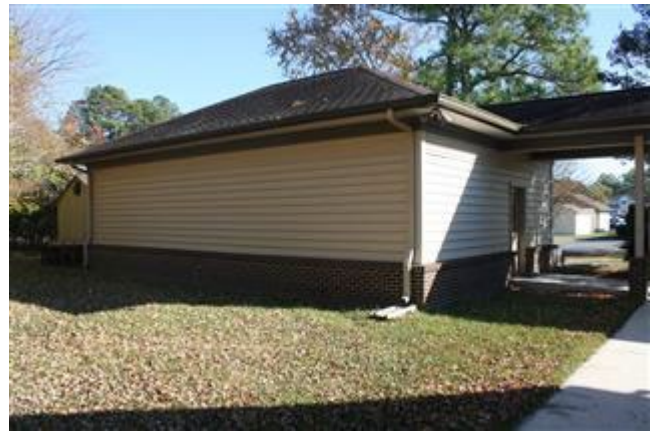
Masonry. A number of the buildings are constructed with a brick veneer which is in good condition.

Brick is used as the main exterior cladding of the building. As masonry weathers, the mortar joints will become damaged by water penetration. As additional water gains access to the joints, repeated freeze-thaw cycles gradually increase the damage to the mortar joints. If allowed to progress, even the masonry units such as brick can have their surfaces affected and masonry units can become loose.

In general, masonry is considered a long-life item and is therefore excluded from reserve funding. However, because weather and other conditions result in the slow deterioration of the mortar in masonry joints, we have included funding in this study for repointing. Repointing is the process of raking and cutting out damaged sections of mortar and replacing them with new mortar.

Periodic repointing and local replacement of damaged masonry units will limit the damage done by moisture penetration. For this study, we assume that 10% of the masonry will require repointing every 10 years after approximately 30 years.

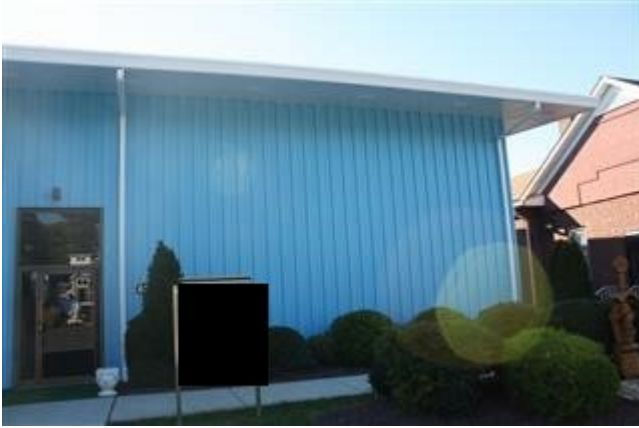
Siding and Trim. The SampleSanitary is constructed with metal siding, while all other buildings are constructed with vinyl siding. All the siding is in good condition.

Vinyl Siding and Trim can have an extended useful life if not damaged by impact, heat, or other physical reasons. However, the coatings and finishes typically have a useful life and over time begin to weather, chalk, and show their age. For these reasons, we have modeled for the replacement of the siding and trim every 25 years.

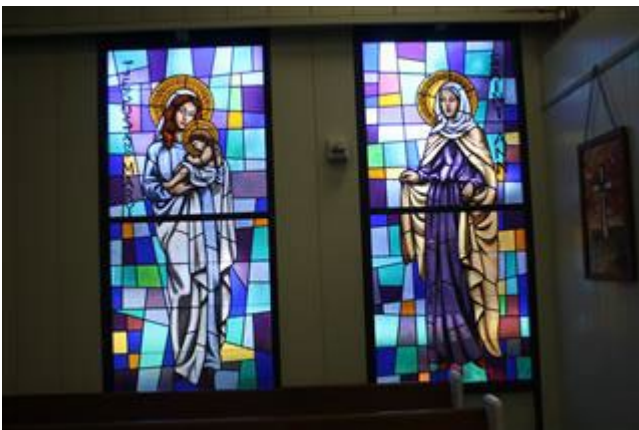
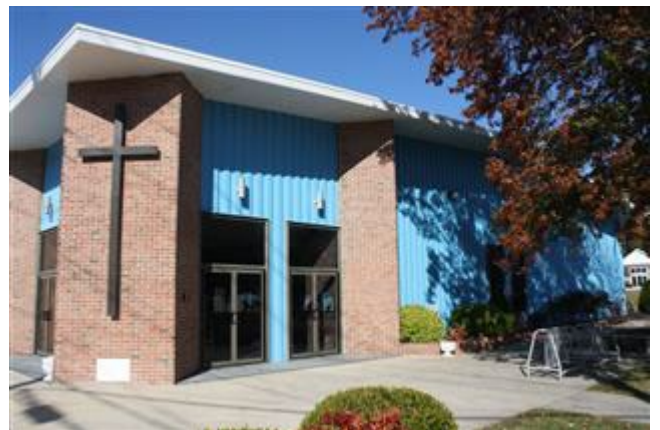
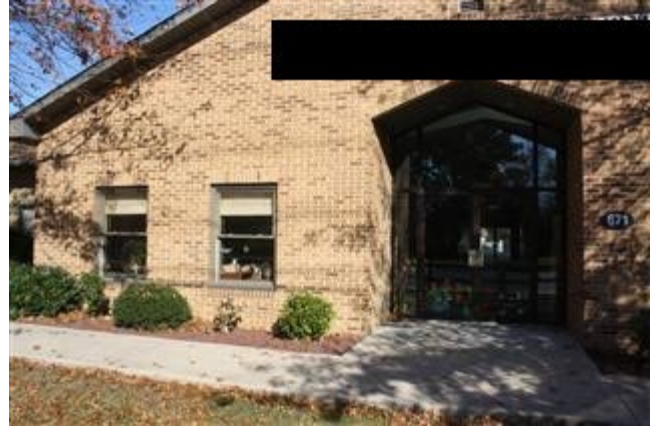
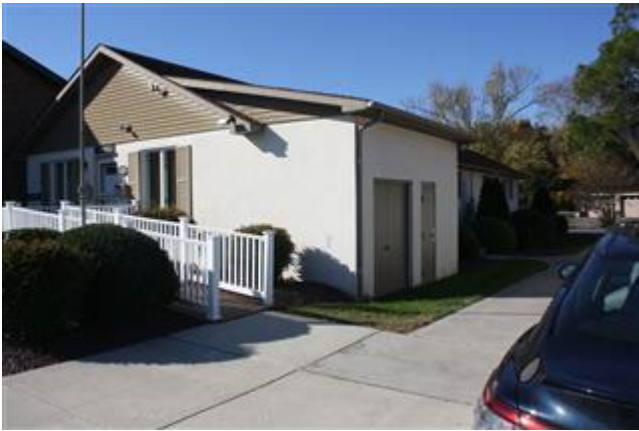
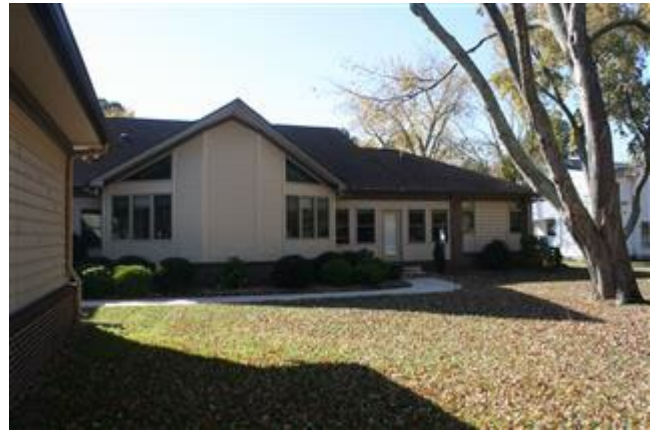
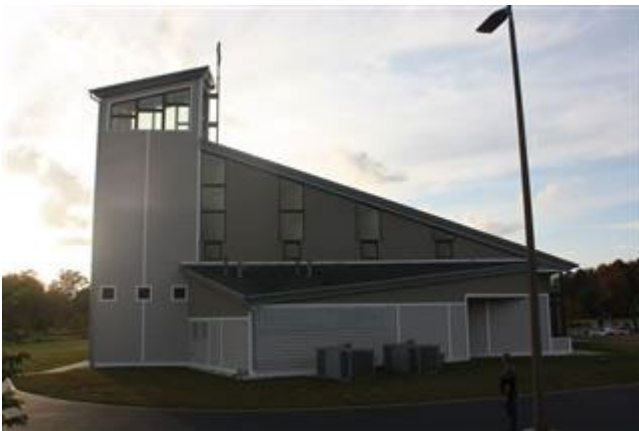
Windows and Doors. The Church is responsible for all of the windows and doors of the facility.

The windows and doors are generally in good condition.

Window and door units play an integral part in a facility's overall comfort, efficiency, and energy use. The quality of the installed units and the care taken in their installation and maintenance are major factors in their effectiveness and useful life. These units can have a useful life of 20 to 35 years or more depending on their use and other factors mentioned above.

In general, we recommend coordinating the replacement of these units with other exterior work, such as siding and roof replacements. The weather tightness of the building envelope often requires transitional flashing and caulking that should be performed in coordination with each other. Warranties and advantages in 'economy of scale' can often result in lower overall replacement costs and results that are more reliable. Lastly, coordinated replacements offer the opportunity to correct initial construction defects and improve the effectiveness of details with improved construction techniques and materials.

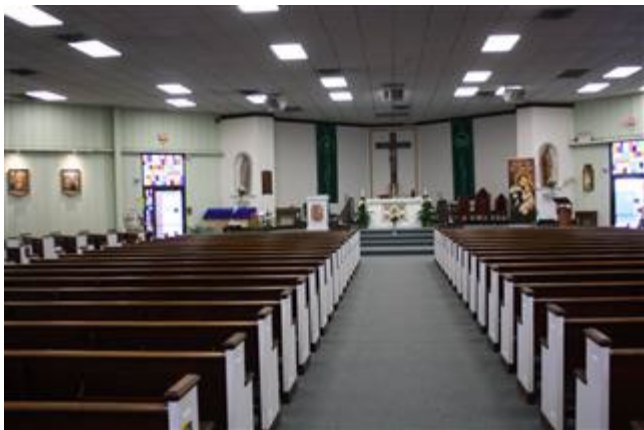
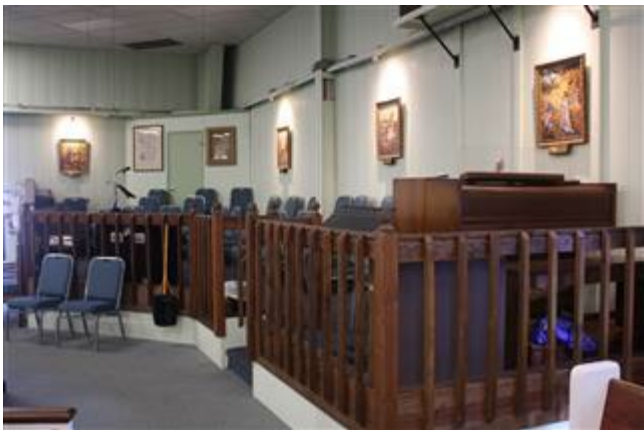
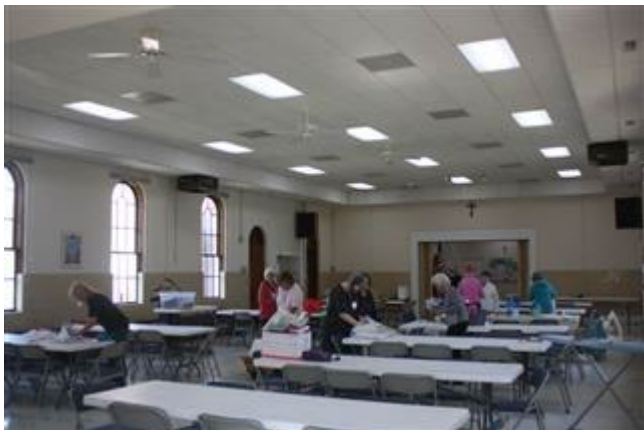
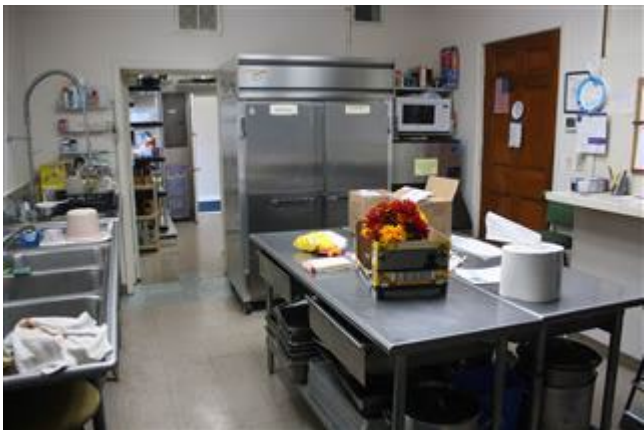
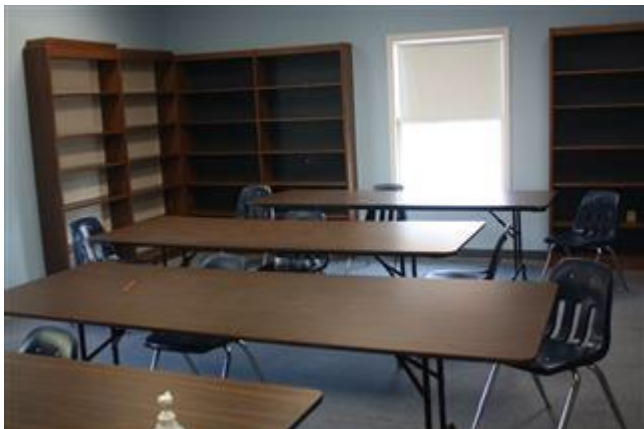
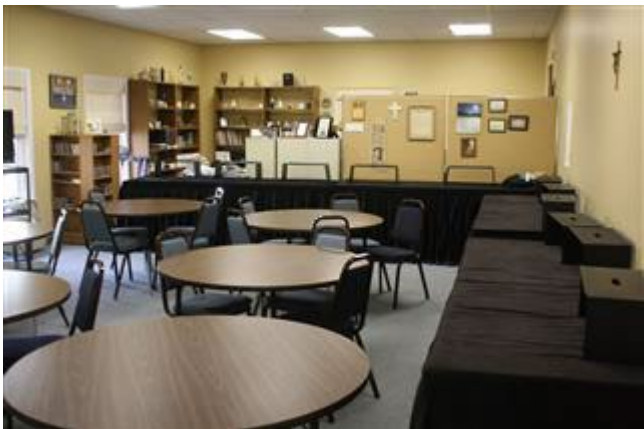
Building Interiors. The Church maintains all interior spaces. The finishes are in generally good condition.

We have assumed that the Church will want to maintain these areas in a commercially acceptable condition. Typically, replacement cycles for common interior spaces vary between 5 to 14 years depending on the aesthetic tastes of the community, usage, and construction. Material selection and the community's preferences are the major factors in setting the reserve components for items such as refurnishing and interior refurbishment. The Association will need to establish these cycles as these facilities age. Maintaining historical records and incorporating these trends and preferences into a future Reserve Study update is the best way to adjust for these cycles.

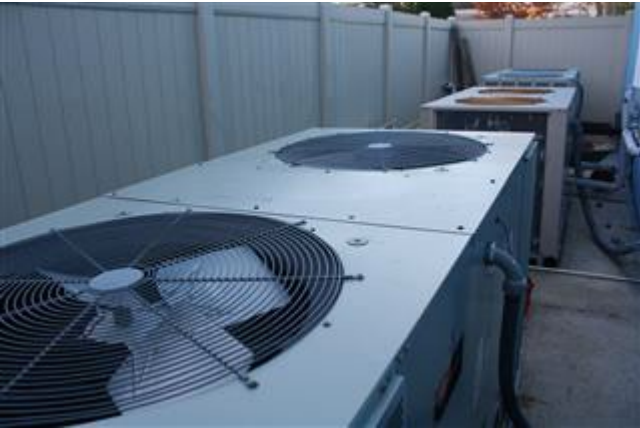
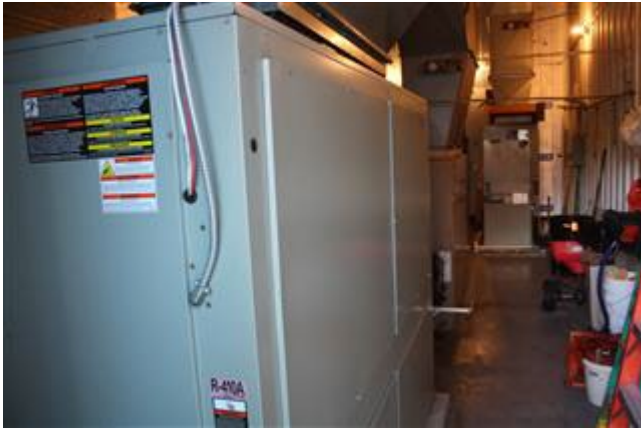
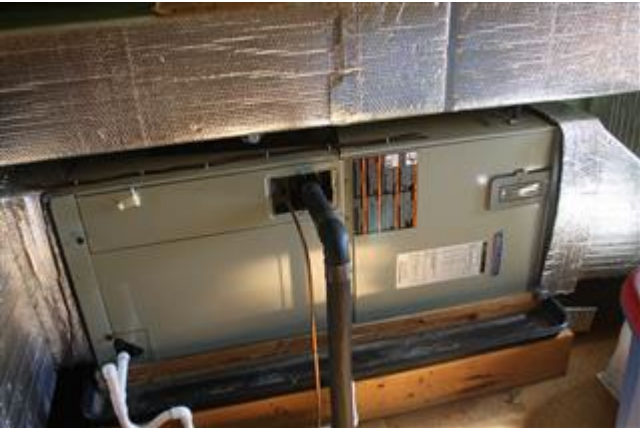
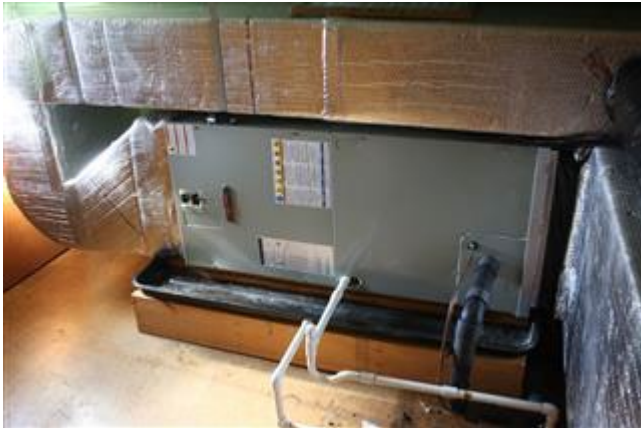
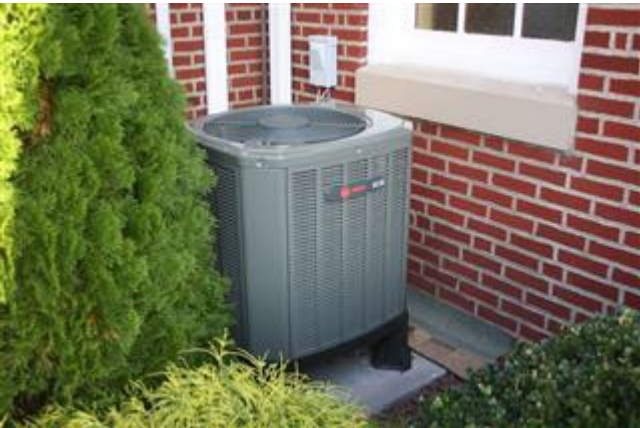
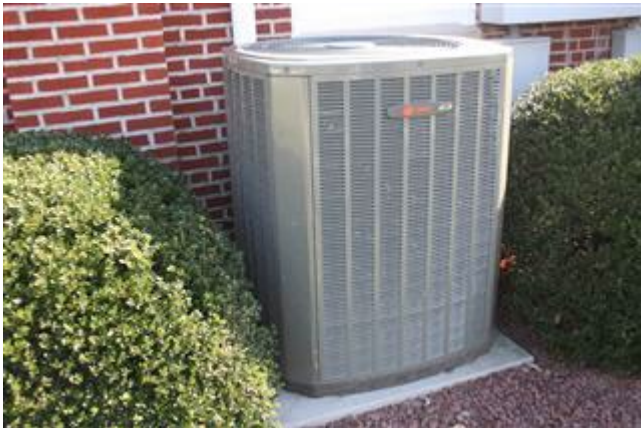
Split and Package HVAC Systems. The heating ventilation and air conditioning (HVAC) of the facility are reported to be in good operating condition. Detailed inspection and testing of these systems is beyond the scope of this study.

Even though manufacturers continue to predict 15 to 20-year life cycles for HVAC equipment that use these new refrigerants, this is not proven by historical data. We therefore recommend anticipating a normal economic life of 15 years for all HVAC equipment that uses pressurized refrigerants of these types.

In addition, the Association maintains air handlers/furnaces throughout the facility, and these components can have a useful life of 20 to 40 years. With fan, motor, and coil replacements performed as needed, the casings of these systems can last significantly longer.

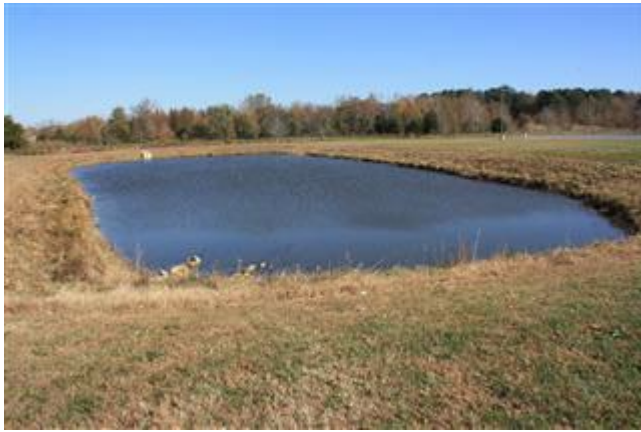
Stormwater Pond. The Mission site is served by a stormwater management pond.

The pond will accumulate silt and over time and lose the ability to store stormwater at design levels, which could result in overflows and minor local flooding. In addition, water quality can be negatively affected by increased siltation and debris accumulation. Accordingly, ponds require periodic dredging.

Estimates of cost and the frequency of dredging ponds are a function of many variables, including the volume of the pond, the siltation rate, the nature of the material being removed, the method of removal, and the haul distance to a site that will accept the spoil material. Most of this information is unknown and must be assumed for the purpose of reserve study planning. The siltation rate and cost of periodic dredging are speculative, varying greatly depending on local conditions. It is not possible to accurately estimate dredging volume in a body of water without the data provided by a detailed Bathymetric Study. Miller Dodson recommends that the Association arranges through their Pond and Lake specialist to have Bathymetric Studies conducted. At that time, the Reserve Study can be revised to reflect the data provided by the Bathymetric Study.

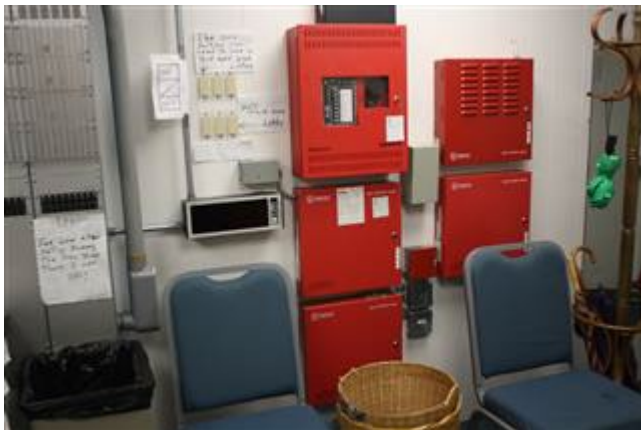
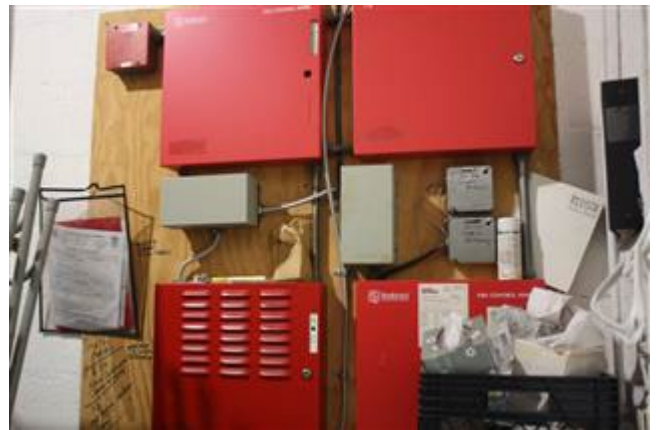
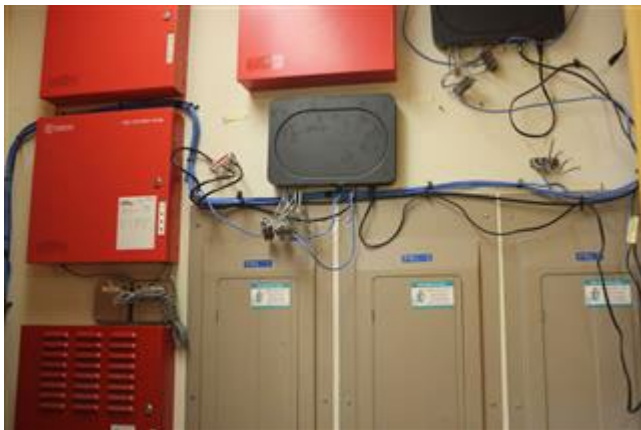
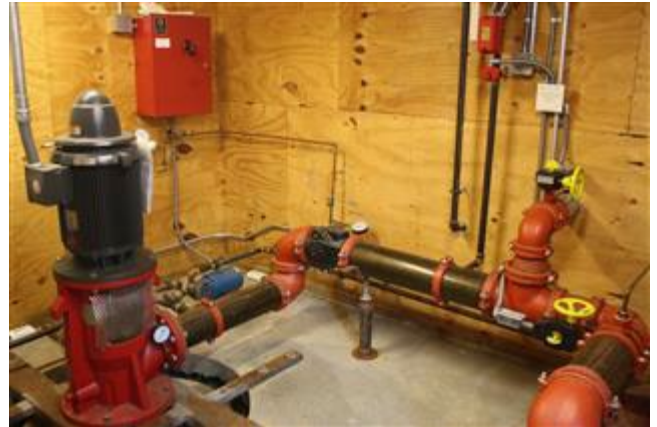
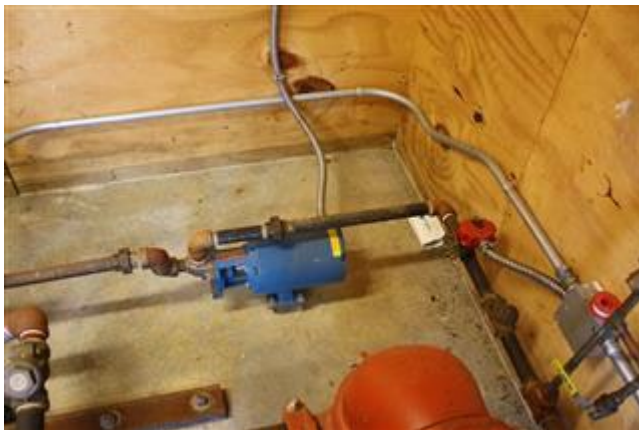
Fire Safety Systems. The buildings are fitted with a fire safety system that includes sprinklers and alarms, and these are reported to be operating normally. Sprinkler systems are located in the Rectory and the Mission Sanctuary. Testing and inspection of fire safety systems are not included in this study.

Sprinkler pipe systems have a wide variety of configurations and requirements depending on their age, condition, and jurisdictional location. Specific county and municipal codes can make a significant difference in what your facility's specific requirements may be.

Building fire alarm systems have a service life of 15 to 25 years. While the panels may continue to operate past this point, changes in fire safety technology and building fire safety codes tend to render them obsolete. In addition, manufacturers only support their systems for a limited period, typically about 15 years. After this time, it may be increasingly difficult to obtain replacement parts and services. When it becomes necessary to upgrade the fire alarm system, differences in the technologies and new code requirements are likely to require upgrades in lighting, sensors, alarms, and other system and sub-components.
