LEVEL 1 REPLACEMENT RESERVE REPORT FY 2025

OAKS AT BRUNSWICK

BRUNSWICK, NORTH CAROLINA

June 10, 2025

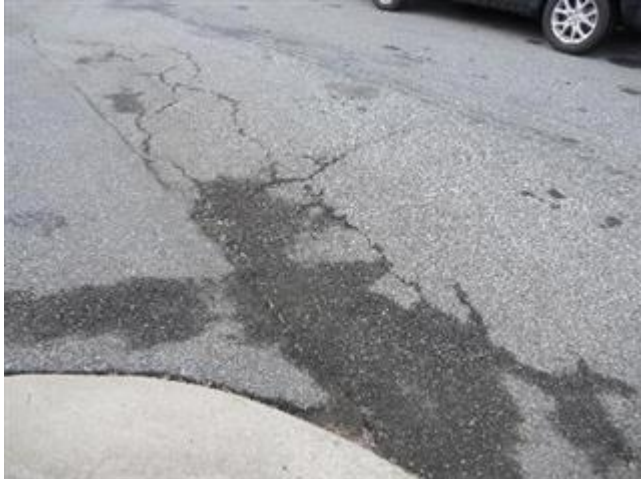
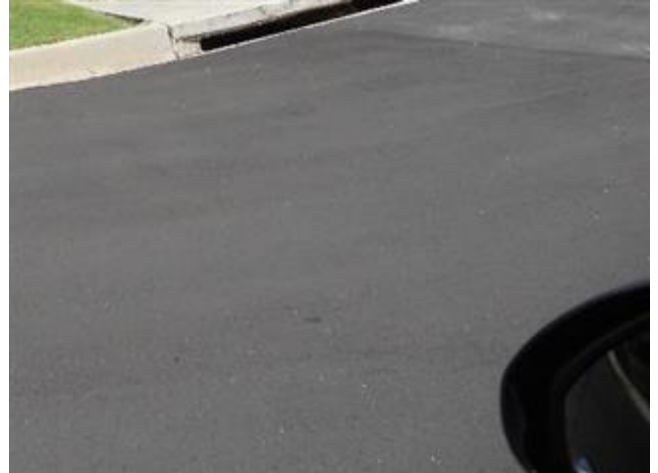
- **Reflective Cracking.** The asphalt pavement has a significant number of reflective cracks. Reflective cracks occur when placing a new asphalt overlay over and existing cracked pavement. With time and movement, existing cracks will migrate through the new asphalt. Installing a bridging membrane or fabric at the time of overlay can control reflective cracking.

In an effort to maintain the condition of the pavement throughout the community and ensure the longest life of the asphalt, we recommend the Association adopts a systematic and comprehensive maintenance program that includes: As a rule of thumb, asphalt should be overlaid when approximately 5% of the surface area is cracked or otherwise deteriorated. The normal service life of asphalt pavement is typically 18 to 20 years.

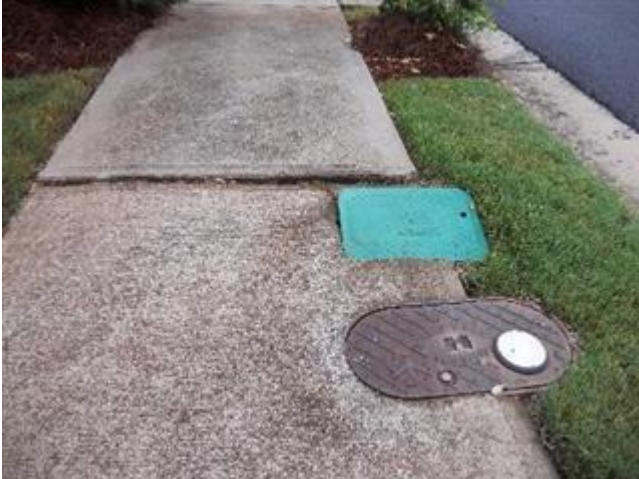
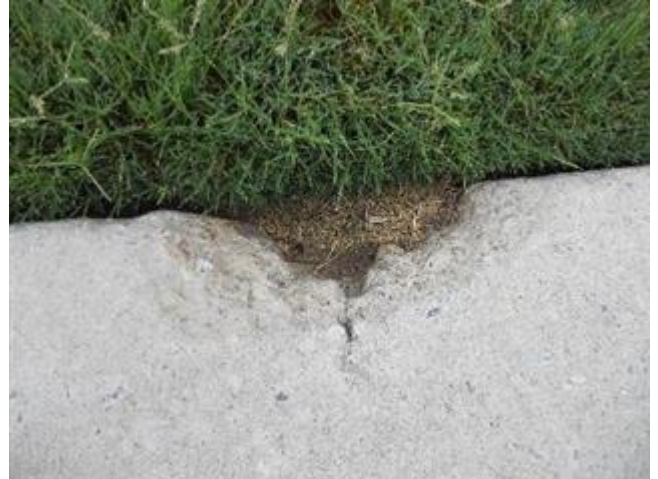
Concrete Work. The concrete flatwork includes the community sidewalks and unit lead walks. The Association maintains an inventory of approximately 13,620 square feet of concrete flatwork. The overall condition of the concrete flatwork appears to be good.

The standards we use for recommending replacement are as follows:

- Trip hazard, ½ inch height difference.
- Severe cracking.
- Severe spalling and scale.
- Uneven riser heights on steps.
- Steps with risers in excess of 8¼ inches.

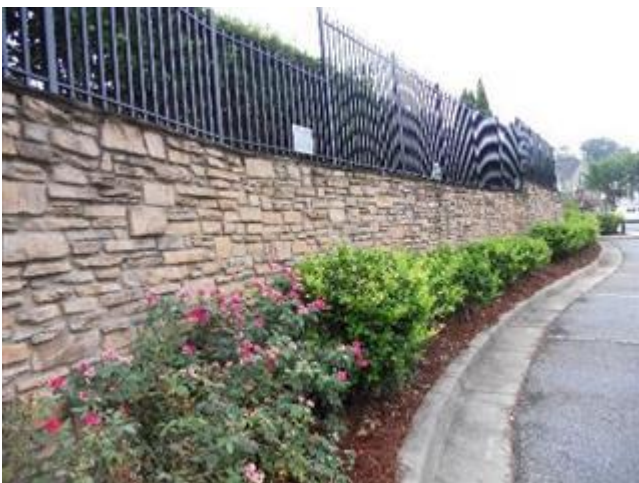
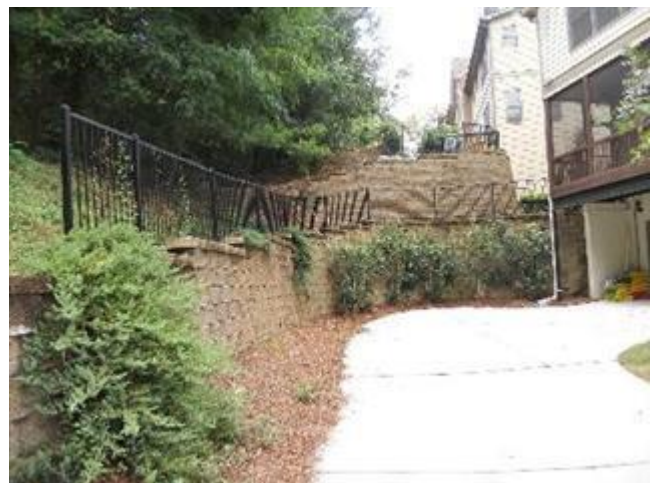
Segmental Block Retaining Walls. The community maintains an inventory of 2,324 square feet of segmental block retaining wall. The overall condition of these walls is good.

Retaining walls, in general, are designed to provide slope stabilization and soil retention by means of a structural system. Typically, walls that are three feet high or more require some level of design.

Movement and displacement of any retaining wall is a sign of general settlement or failure. This typically is in the form of leaning and bowing and can involve the entire wall or localized sections of the wall. Typically, these types of movements are gradual and may require the replacement of the wall. Movement of retaining walls located near other buildings or structures may negatively affect the stability of the adjacent structure. These conditions can become extremely costly if not properly identified, monitored, and addressed.

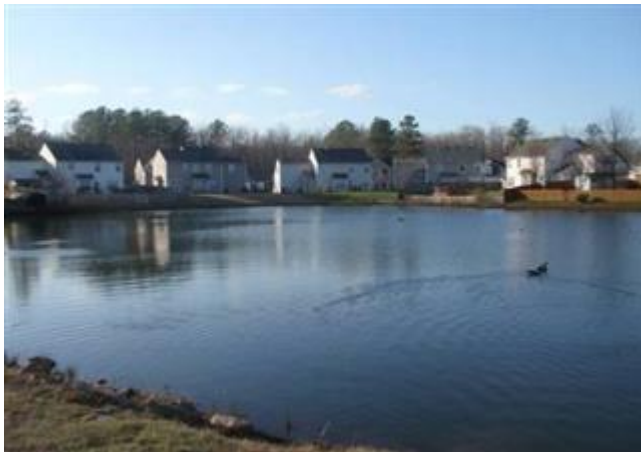
Stormwater Pond. The community is served by a stormwater pond that has an approximate total surface area of one acre (45,000 sq. feet.).

Estimates of cost and the frequency of dredging ponds are a function of many variables, including the volume of the pond, the siltation rate, the nature of the material being removed, the method of removal, and the haul distance to a site that will accept the spoil material. The siltation rate and cost of periodic dredging are speculative, varying greatly depending on local conditions. Ponds will accumulate silt and over time and lose the ability to store stormwater at design levels, which could result in overflows and minor local flooding. In addition, water quality can be negatively affected by increased siltation and debris accumulation. Accordingly, ponds require periodic dredging. Without Bathymetric data, however, it is not possible to accurately estimate the amount of dredging that will be required to return the ponds to their designed holding capacity. It is strongly suggested that the Association make arrangements to undertake Bathymetric Surveys. These Surveys can be arranged through your Pond and Lake contactor.

As a rule of thumb, dredging should be performed when approximately one-third of the volume of the pond has been filled with silt. We have assumed that the material being removed is free of heavy metals and hydrocarbons and that it will be accepted as fill at a local landfill. A more accurate prediction of cost and cycles will require a hydrologic analysis and testing, which is beyond the scope of our study. As a supplement to traditional dredging methods, hydro-raking can prolong the interval between dredging.

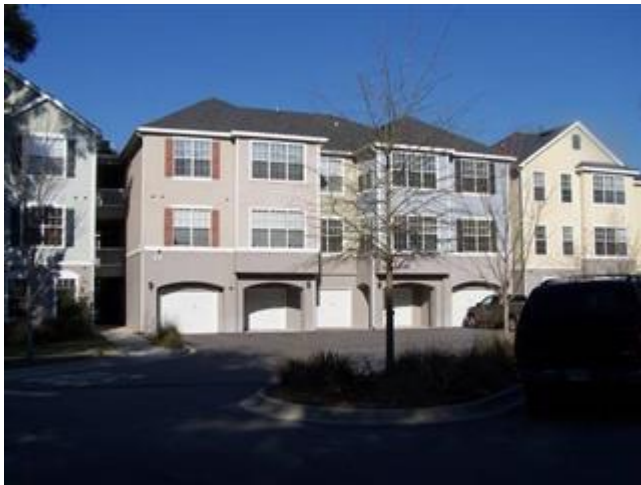
Asphalt Shingle Roofing. The asphalt shingle roofs appear to be in good condition. We have estimated the remaining useful life of the roofs based on the conditions seen at the site as well as the age of the roofs. We have assumed that when the roofs eventually will require replacement, all roofs will be replaced with 20-year roofs. We have assumed that the gutters and downspouts will be replaced when the roofs are replaced.

Due to the large inventory and the varying rates at which the roofing materials will age and require replacement, we have divided the roof inventory into five equal components and spread their replacement over a 14-year period.

As roofing systems age, periodic inspections are recommended and repair work may be required. In order to obtain the maximum useful life possible, we recommend performing routine inspections and cleanings at decreasing intervals as the roof ages. Access, inspection, and repair work should be performed by contractors and personnel who are experienced in the types of roofing used for the facility.

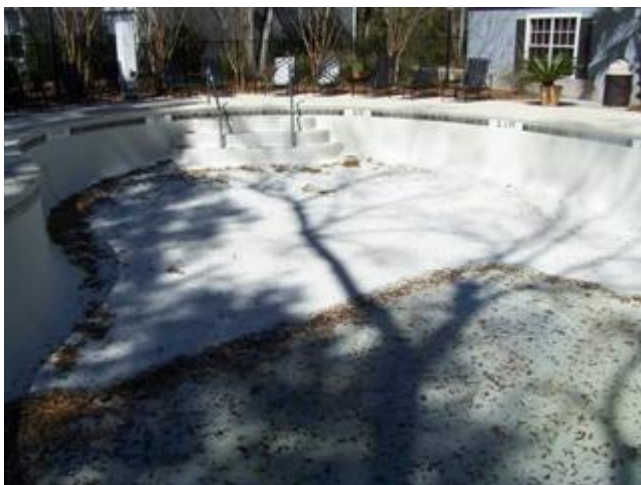
Swimming Pool. The community operates an outdoor pool and spa of concrete construction with a concrete deck. The concrete deck is coated. Listed below are the major components of the pool facilities:

- **Pool Shell.** The shell for the swimming pool appears to be in good condition.
- **Pool Deck.** The pool has a concrete deck. The overall condition of the deck appears to be in good condition with tripping hazards.
- **Pool Deck Coating.** The concrete pool deck is coated with an elastomeric coating. The coating appears to be in good condition. We have assumed a service life for the coating of ten years.

- **Whitecoat.** The pool whitecoat appears to be in fair condition. We have assumed a service life of ten years for the pool whitecoat.
- **Waterline Tile.** The waterline tile appears to be in good condition. We have assumed that the waterline tile will be replaced or restored when the pool is whitecoated.
- **Pump and Filter System.** The filter system appears to be in good operating condition. We have assumed a service life of 20 years for the filter system and 10 years for the pump.

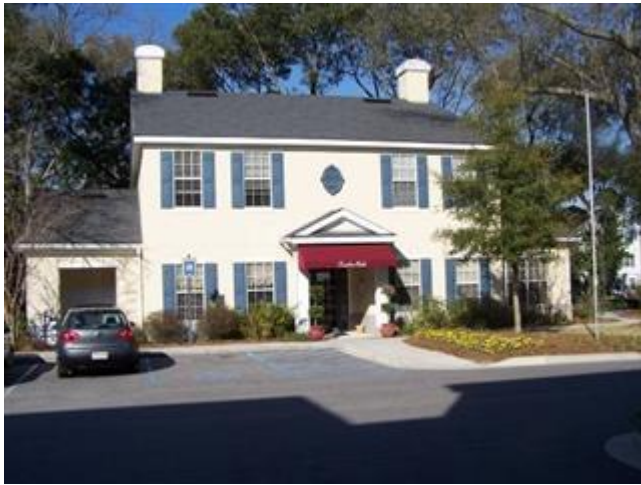
Community Building. The Association operates a community building. The second floor of the building includes two condominium units, which have been excluded from the Reserve Analysis. The first floor is currently being used as a sales office. Listed below are the major components of the community building:

- **Asphalt Shingle Roofing.** The asphalt shingle roof appears to be in good condition. We have estimated the remaining useful life of the roof based on the conditions seen at the site as well as the age of the roof. We have assumed that when the roof eventually will require replacement, it will be replaced with a 20-year roof. We have assumed that the gutters and downspouts will be replaced when the roof is replaced.

- **EIFS Siding.** The exterior of the buildings has an Exterior Insulation and Finish Systems (EIFS) finish. The EIFS material appears to be in good condition. For the Reserve Study, we have included an allowance for re-coating and caulking of the EIFS surface every 10 years. We included the joint caulking at the same time as re-coating. We have also included funding for replacement of ten percent of the EIFS area every twenty years.
