# LEVEL 1 REPLACEMENT RESERVE REPORT FY 2026 A SAMPLE HOMEOWNER'S ASSOCIATION

# REPLACEMENT RESERVE REPORT

## A SAMPLE HOMEOWNER'S ASSOCIATION

ANNAPOLIS, MARYLAND  
January 18, 2025

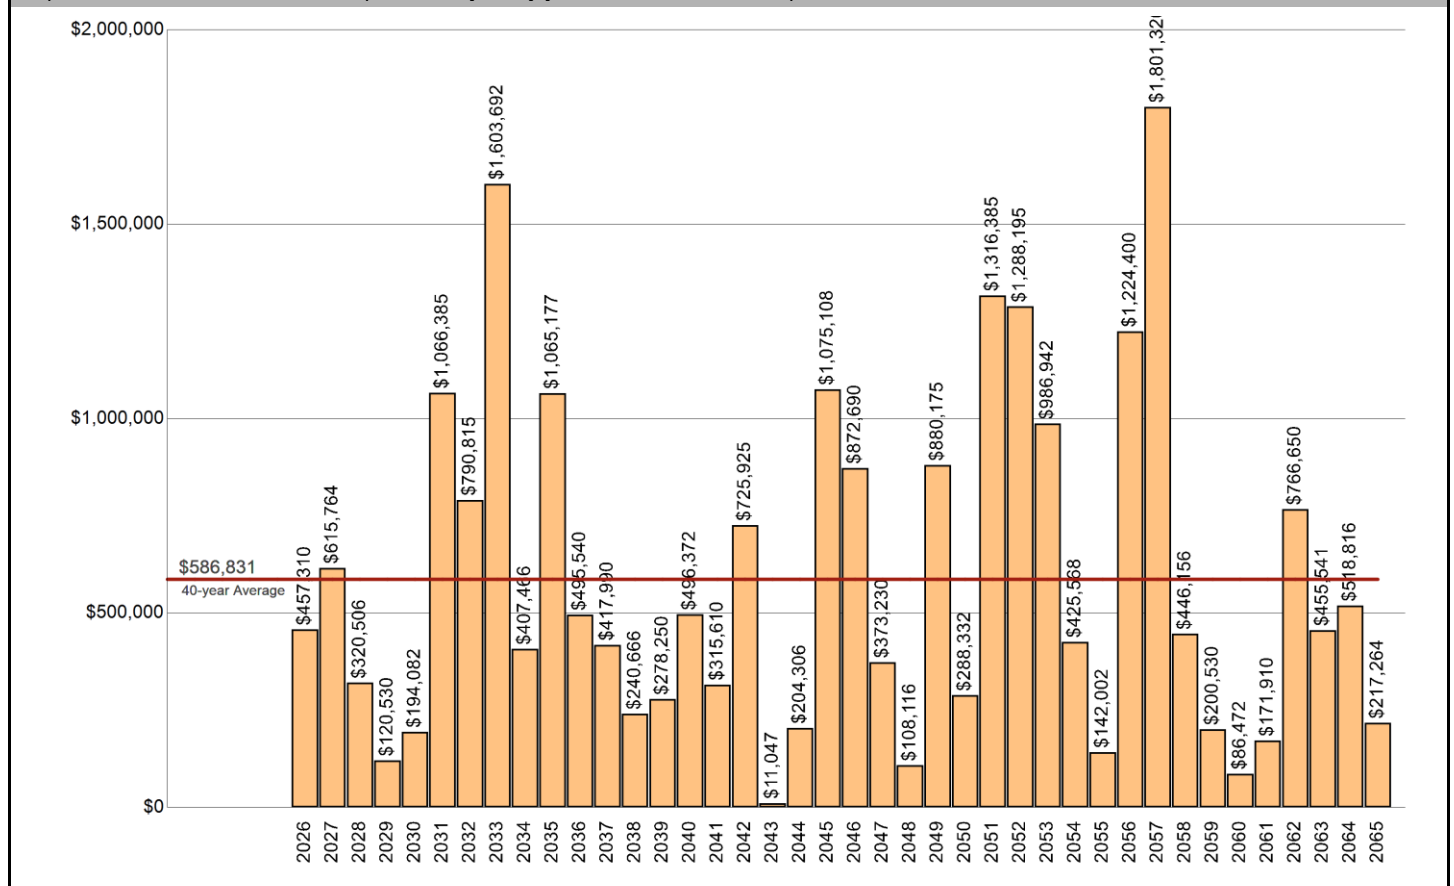
## #2 - Annual Expenditures for Projected Replacements Graph

This graph shows annual expenditures for Projected Replacements over the 40-year Study Period. The red line shows the average annual expenditure of \$586,831. Section C provides a year by year Calendar of these expenditures.

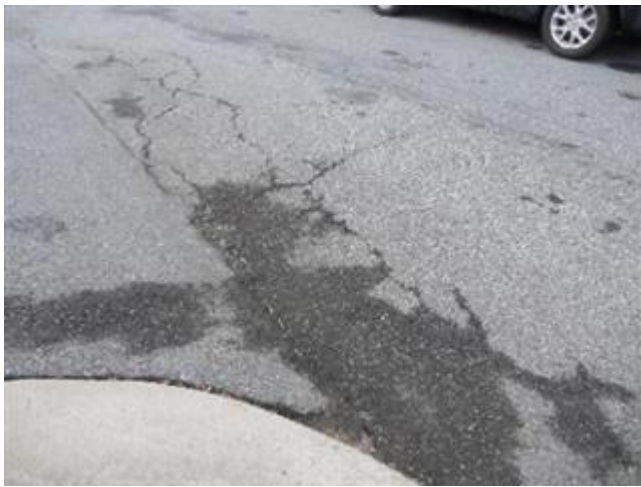
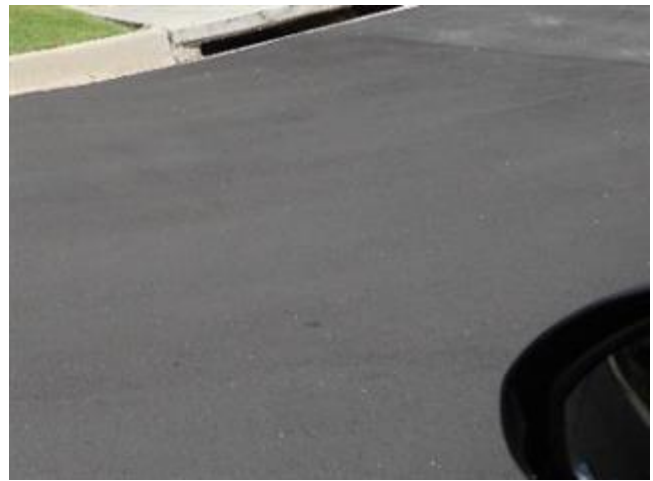
**Asphalt Pavement.** The Association is responsible for the roadways and parking areas except for the alley ways within the community; other roadways are maintained by the City, County, or other municipality. In general, the Association's asphalt pavements are in good to fair condition, with minor cracking.

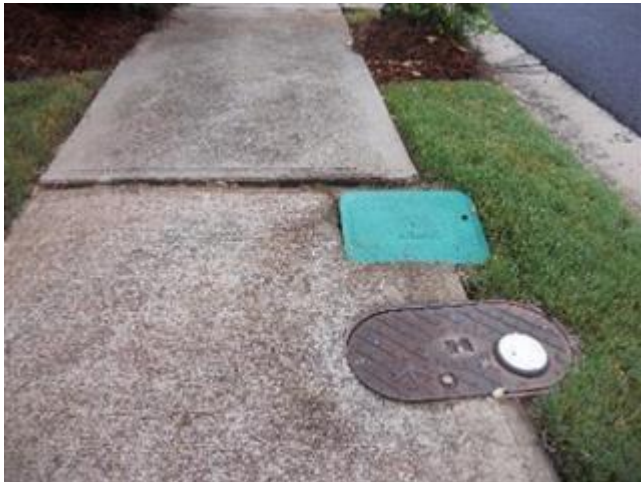
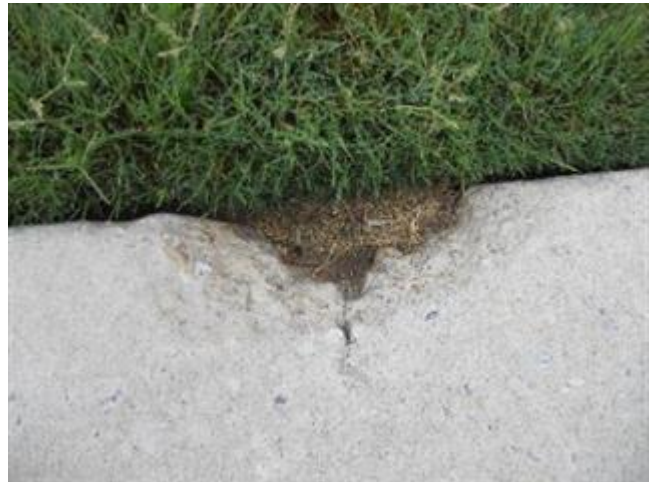
**Concrete Work.** The concrete work includes the community curbs, sidewalks, concrete pads and other flatwork. We have modeled for curb replacement when the concrete flatwork is replaced. The overall condition of the concrete work is good to poor with a few tripping hazards and poor patching of the curbs.

- Trip hazard, ½ inch height difference.
- Severe cracking.
- Severe spalling and scale.
- Uneven riser heights on steps.
- Steps with risers in excess of 8¼ inches.

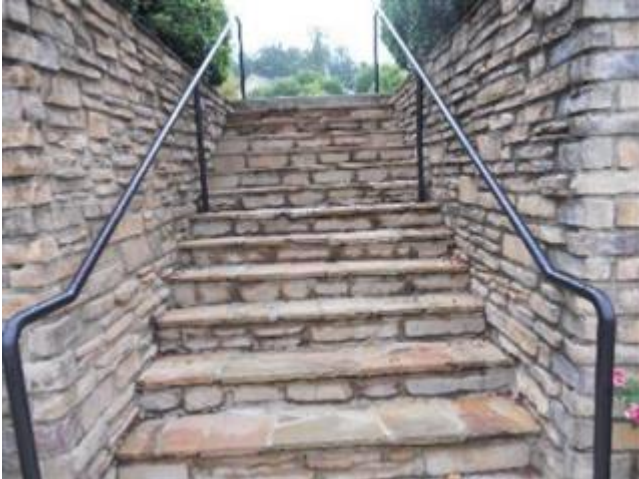
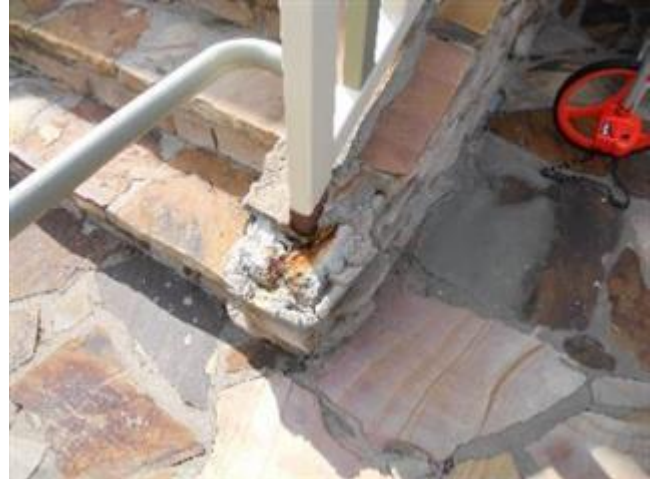
**Stone Steps.** The community has several sets of exterior steps that are of stone construction. The general condition of the steps is good to fair with a number of defects.

- Failed Mortar Joints. A number of the mortar joints between the stones have failed and are in need of repointing.
- Cracks. Movement of the base material under the bricks has resulted in the development of cracks in a number of the stone steps.
- Settlement. We noted some locations where steps have settled, creating uneven surfaces that pose a trip hazard.

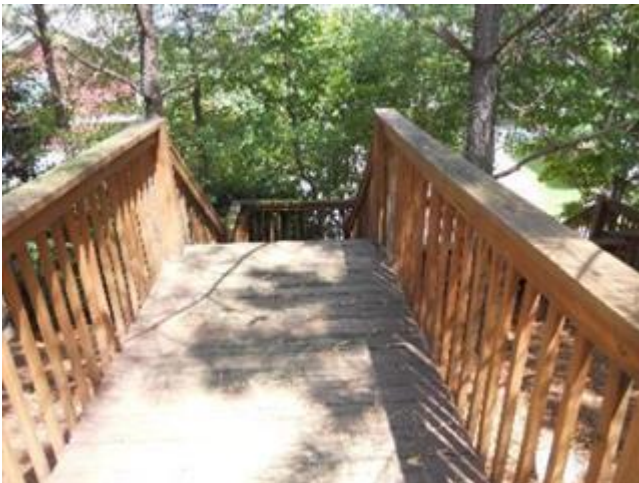
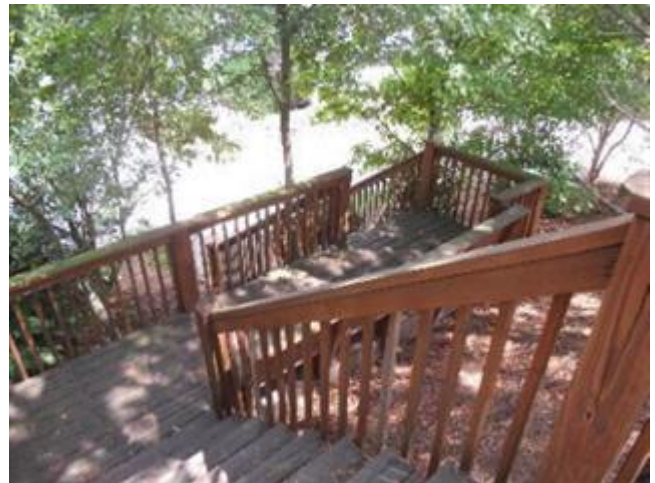
**Exterior Wood Stairs.** The exterior stairs consist of wood treads and landings with wood stringers. The stairs are in good condition.

The wood in the exterior stairs expands and contracts with changes in temperature and moisture levels within the wood, leading to cracks. Untreated, these cracks will expand and can lead to the development of rot within the wood.

It is recommended that the Association inspect all stairs at least once each year. All areas with moderate cracking or rot should be replaced. Areas covered with mold should be cleaned and treated.

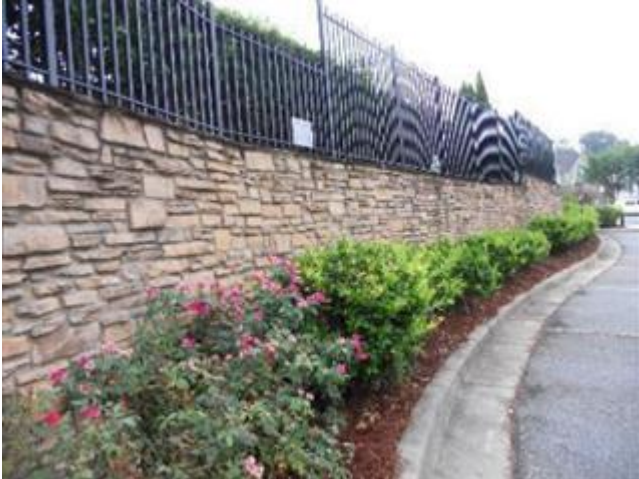
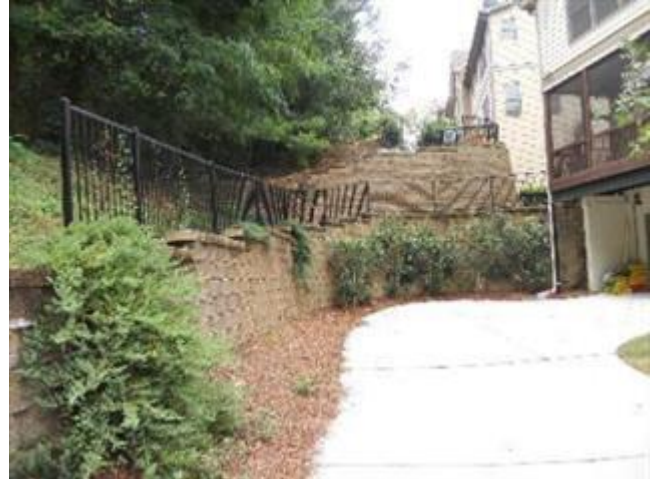
**Retaining Walls.** The Association maintains several stone and segmental block retaining walls. The retaining walls are in good condition.

Movement and displacement of any retaining wall is a sign of general settlement or failure. This typically is in the form of leaning and bowing, and can involve the entire wall or localized sections of the wall. Typically, these types of movements are gradual and may require the replacement of the wall. Movement of retaining walls located near other buildings or structures may negatively affect the stability of the adjacent structure. These conditions can become extremely costly if not properly identified, monitored, and addressed.

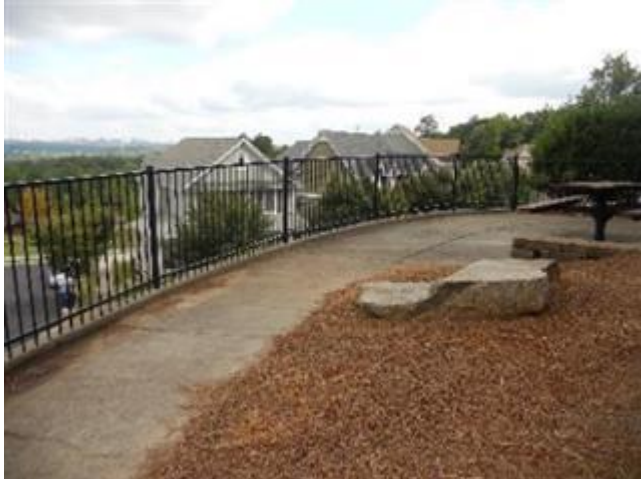
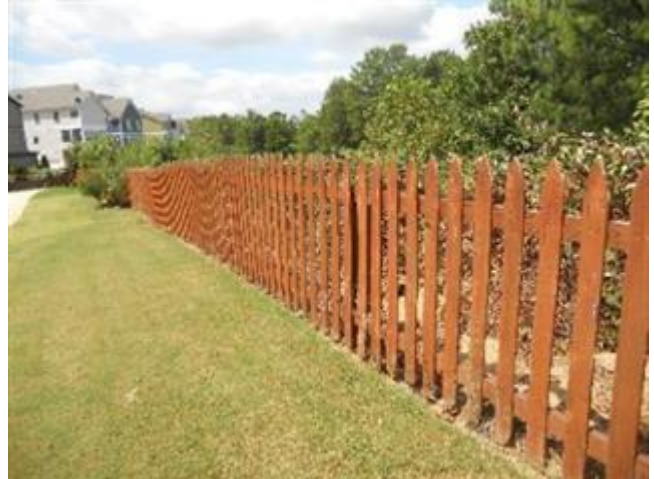
**Fencing.** The Association maintains wood, aluminum and chain-link fencing that is in generally good condition. Fencing systems have a large number of configurations and finishes that can usually be repaired as a maintenance activity by replacing individual components as they become damaged or weathered.

Protection from string machine damage during lawn maintenance can extend the useful life of some fence types. Protection from this type of damage is typically provided by applying herbicides around post bases or installing protective sheathing.

Pressure treated wood fencing should be cleaned and sealed every year or two. Typically the least cost fencing option, this type of fence can last 15 to 20 years if maintained properly.

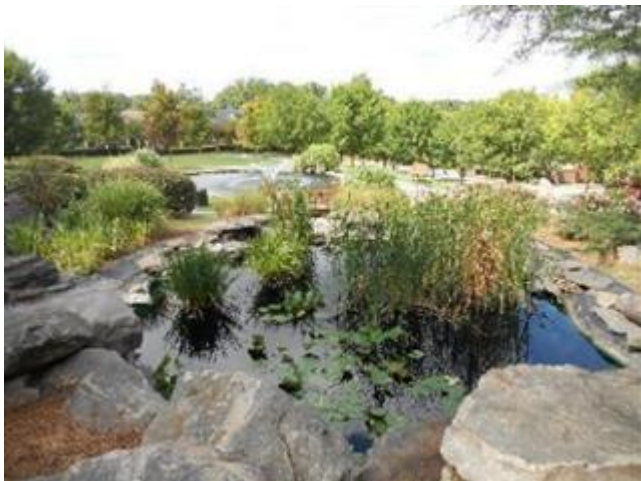
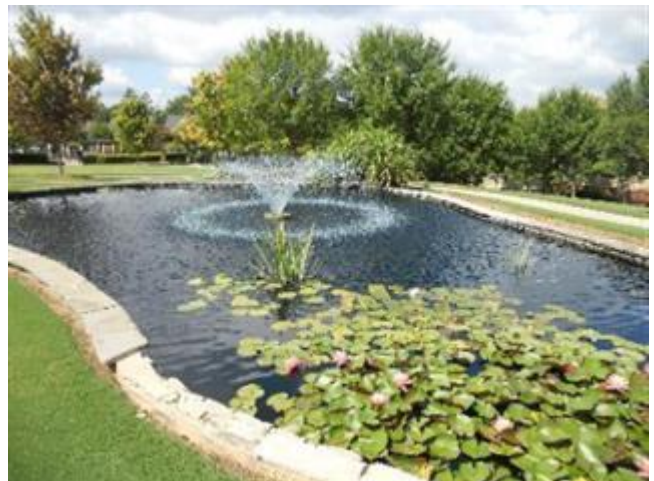
**Ponds.** The community is served by two feature ponds. The ponds are lined with a membrane that is reported to be leaking. The pond is fed by a well and the water is used for irrigation in the common areas. We have provided for the replacement of the pumps and membrane. Keeping the ponds clean is a maintenance function and not included in the analysis.

- Periodically remove accumulated debris and vegetation growing in and around the ponds.

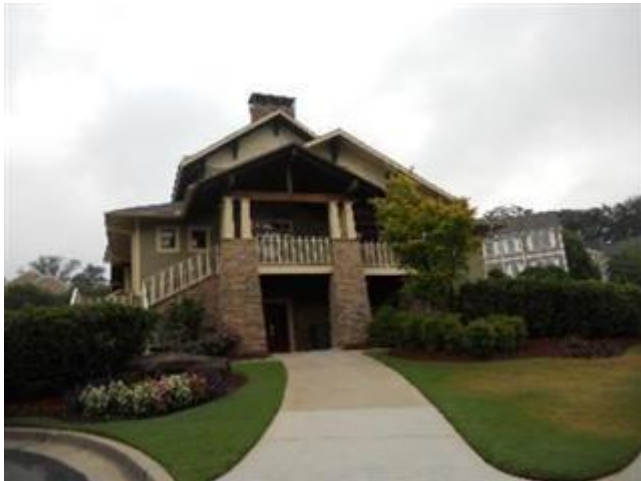
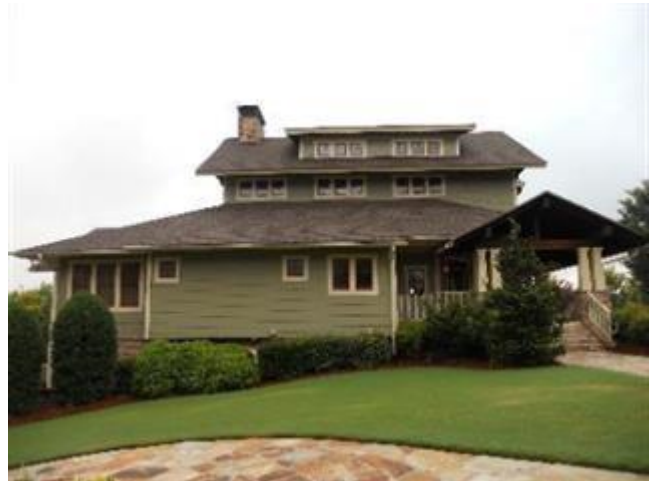
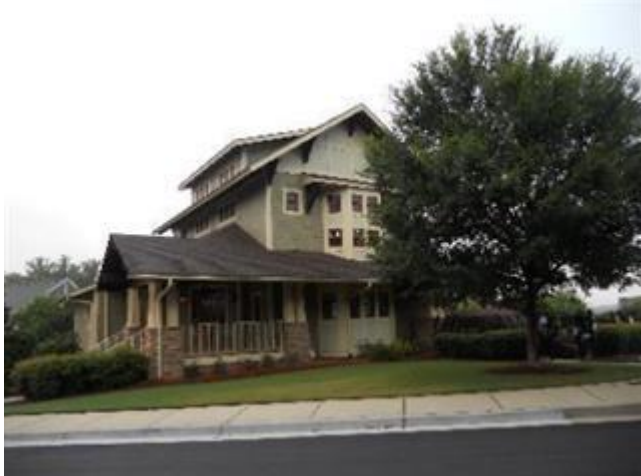
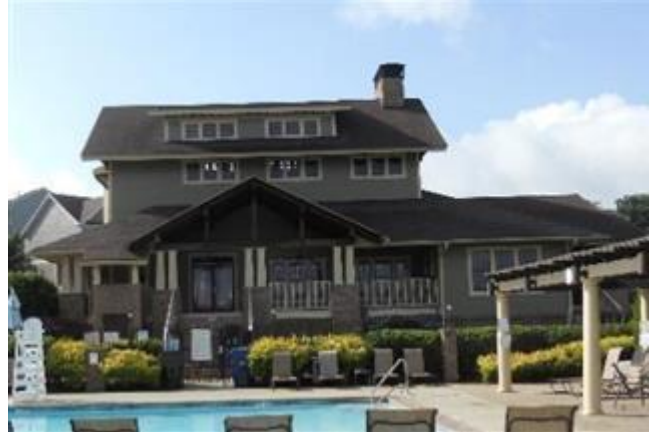
**Building Roofing.** The clubhouse is roofed in a green roof product that has a recall for product failure. Roof is not expected to last for normal life and we have programmed replacement accordingly with a 25-year asphalt roof product.

Asphalt shingle roofs can have a useful life of 20 to 50 years depending on the weight and quality of the shingle. Weathered, curled, and missing shingles are all indications that the shingles may be nearing the end of their useful life. Access to the roof was not provided at the time of inspection. Annual inspections are recommended, with cleaning, repair, and mitigation of vegetation performed as needed.

Access, inspection, and repair work should be performed by contractors and personnel with the appropriate access equipment who are experienced in the types of roofing used for the facility.

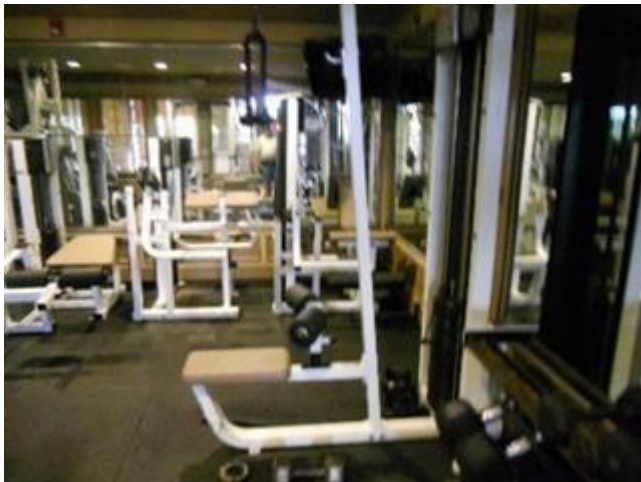
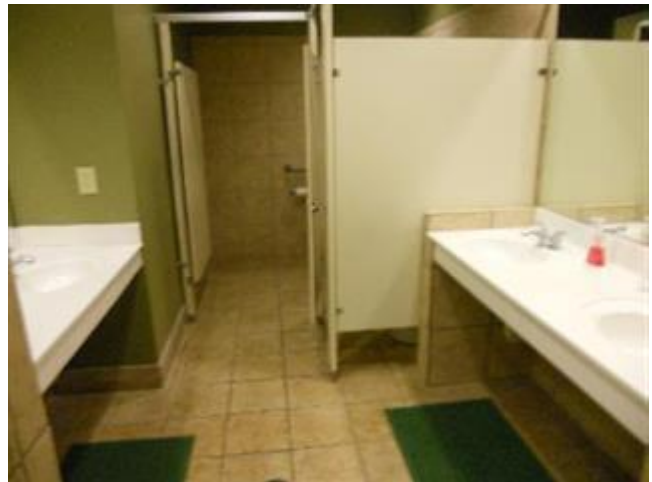
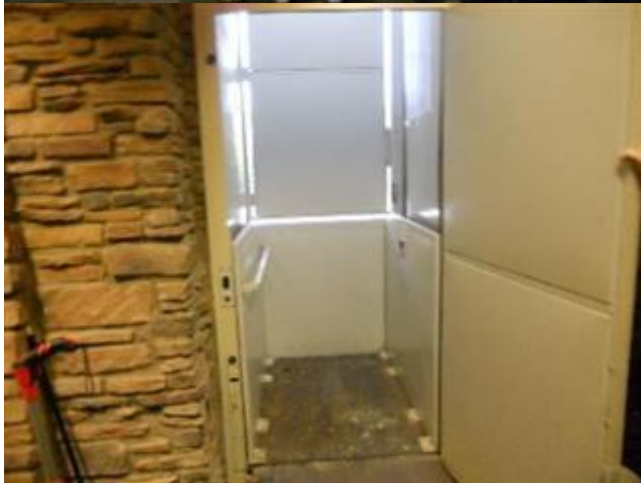
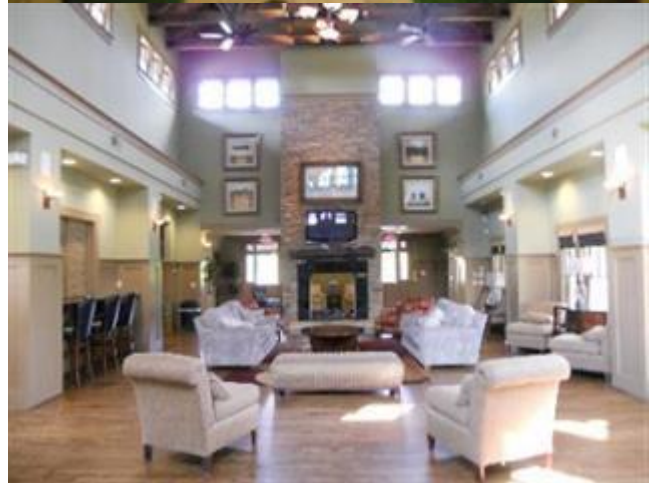
**Restrooms.** The two restrooms and two locker rooms in the Club House are in good condition. We have provided an allowance for the renovation of all four rooms.

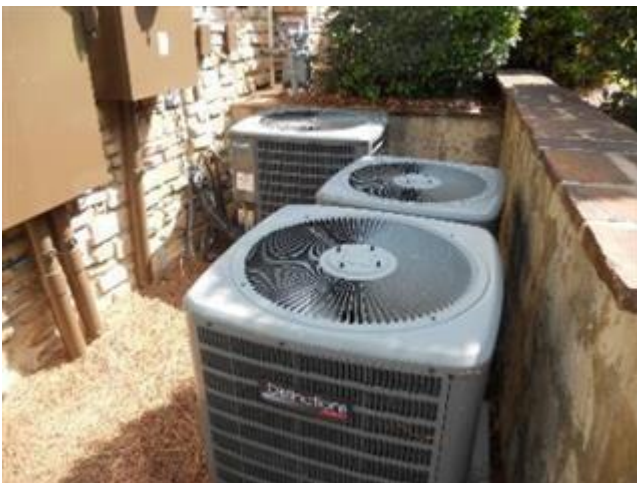
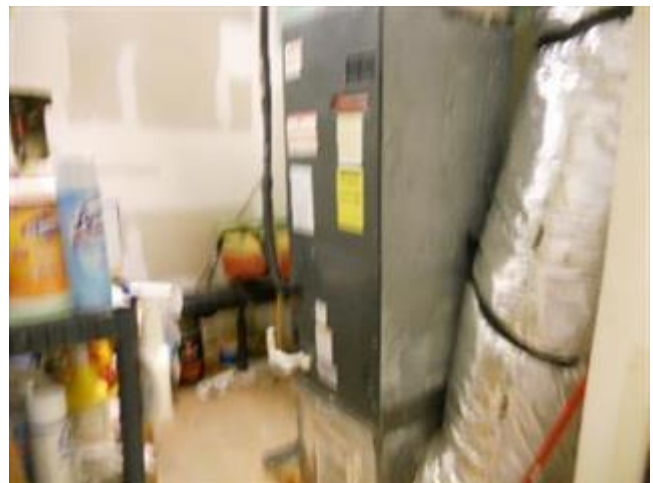
**Split and Package HVAC Systems.** The heating ventilation and air conditioning (HVAC) of the facility are reported to be in good operating condition. Detailed inspection and testing of these systems is beyond the scope of this study.

The Association maintains a number of HVAC systems that use one of the new generation refrigerants. Unlike the old R22 refrigerant, the new refrigerants are expected to be available throughout the period of this study. However, the operating pressure for new refrigerant systems is approximately twice as high as older systems. Many of the standard components have not been redesigned for these higher pressures, including the coils, which generally fail due to metal fatigue.

Even though manufacturers continue to predict 15 to 20-year life cycles for HVAC equipment that use these new refrigerants, this is not proven by historical data. We therefore recommend anticipating a normal economic life of 15 years for all HVAC equipment that uses pressurized refrigerants of these types.

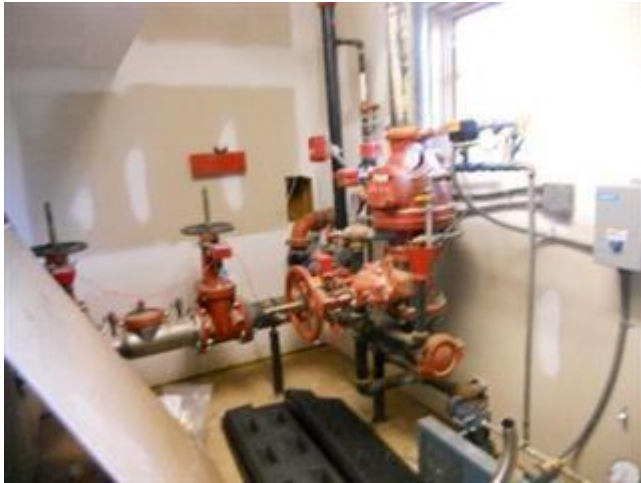
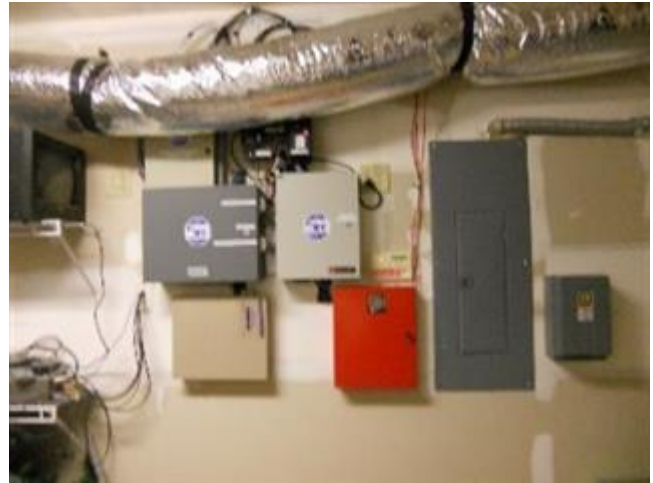
**Fire Safety Systems.** The building is fitted with a fire safety system that includes sprinklers and alarms, and these are reported to be operating normally. Testing and inspection of fire safety systems are not included in this study.

Sprinkler pipe systems have a wide variety of configurations and requirements depending on their age, condition, and jurisdictional location. Specific county and municipal codes can make a significant difference on what your facility's specific requirements may be.

Building fire alarm systems have a service life of 15 to 25 years. While the panels may continue to operate past this point, changes in fire safety technology and building fire safety codes tend to render them obsolete. In addition, manufacturers only support their systems for a limited period, typically about 15 years. After this time, it may be increasingly difficult to obtain replacement parts and service. When it becomes necessary to upgrade the fire alarm system, differences in the technologies and new code requirements are likely to require upgrades in lighting, sensors, alarms, and other system and sub components.

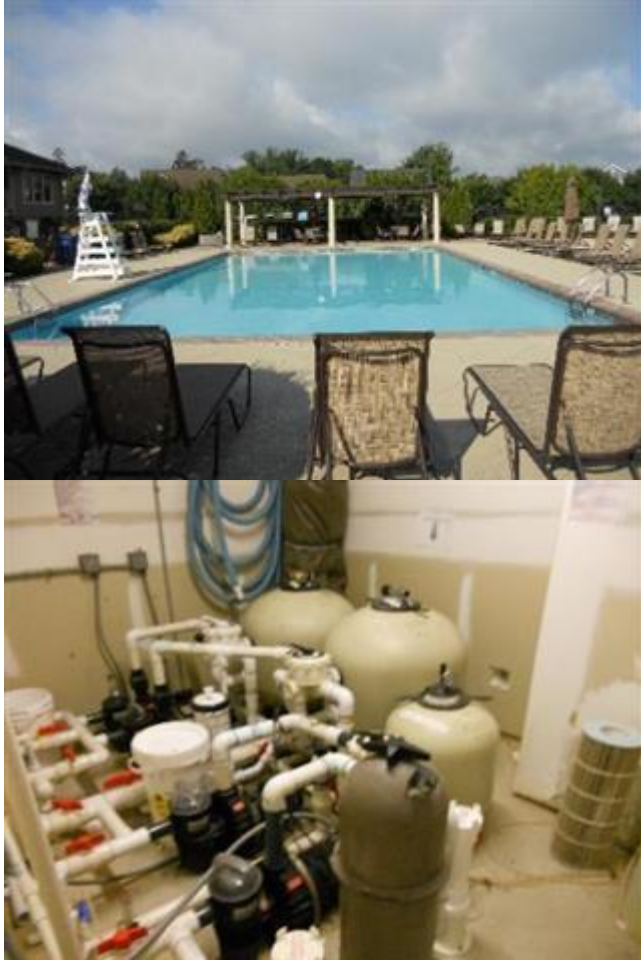
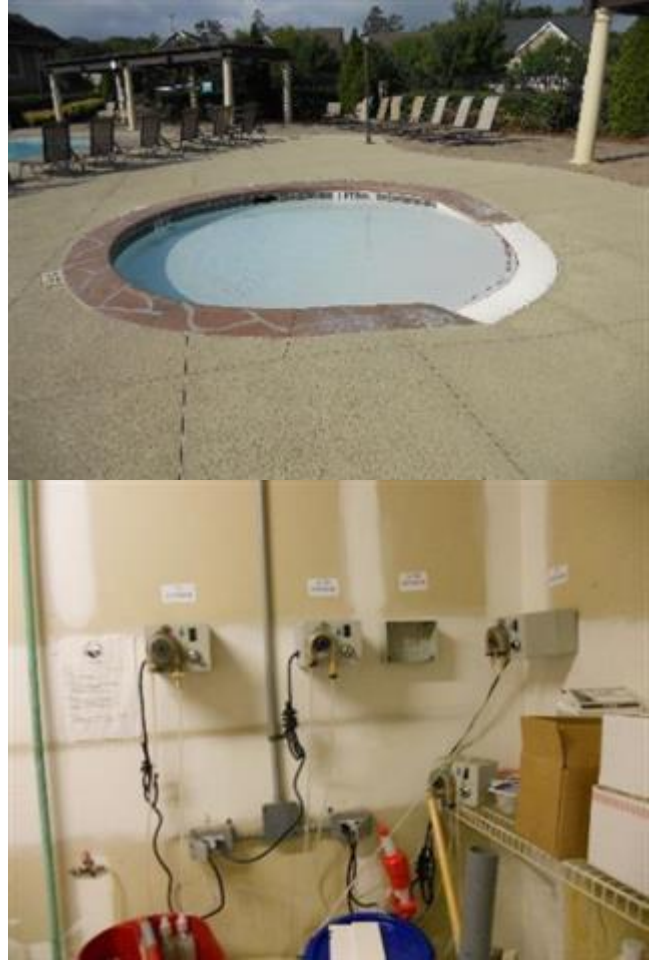
**Swimming Pool.** The community operates an outdoor pool and wading pool of concrete construction. Listed below are the major components of the pool facilities:

- Pool Shell. The shell for the swimming pool is in good condition.
- Pool Deck. The pool has a concrete and pavers deck. The overall condition of the deck is good.
- Pool Deck Coating. The concrete pool deck is coated. The coating is in fair condition. We have assumed a service life for the coating of ten years.
- Whitecoat. The pool whitecoat is in good condition. We have assumed a service life of eight to ten years for the pool whitecoat.
- Waterline Tile. The waterline tile is in good condition. We have assumed that the waterline tile will be replaced or restored when the pool is whitecoated.
- Coping. The pool is edged with masonry coping. The coping is in good condition.
- Pump and Filter System. The filter system is in fair operating condition.
- Pool Fence. The swimming pool is enclosed by a metal fence that is in good condition.

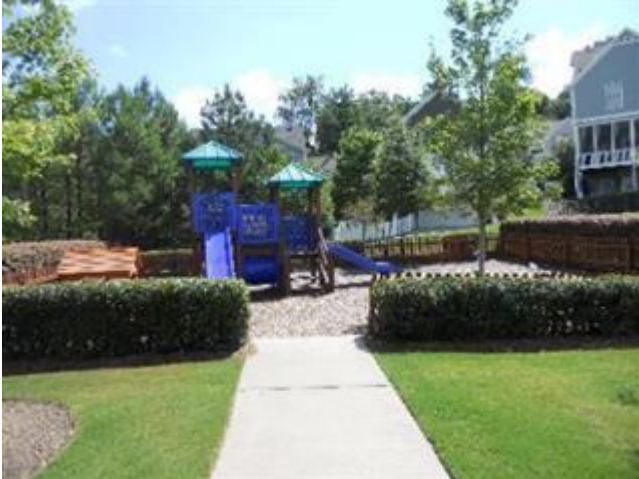
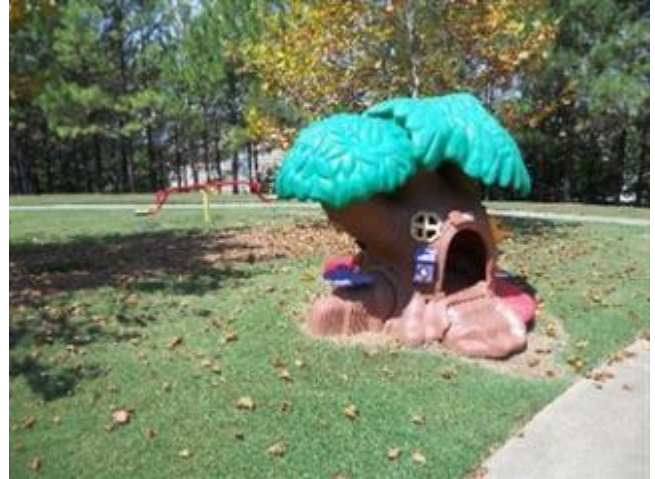
**Tot Lots.** The community maintains a tot lot. The tot lot includes play structures, miscellaneous play equipment, synthetic borders, and a wood chip surface. The facility is in generally good condition. The wood chip surface is displaced or missing or does not appear to be adequate.

The safety of each individual piece of playground equipment as well as the layout of the entire play area should be considered when evaluating a playground for safety. The installation and maintenance of the protective surfacing under and around all equipment is crucial. Please note that the evaluation of the equipment and these facilities for safety is beyond the scope of this work.
