LEVEL 1 REPLACEMENT RESERVE REPORT FY 2026

SAMPLE CHURCH AND SCHOOL

REPLACEMENT RESERVE REPORT

August 19, 2025

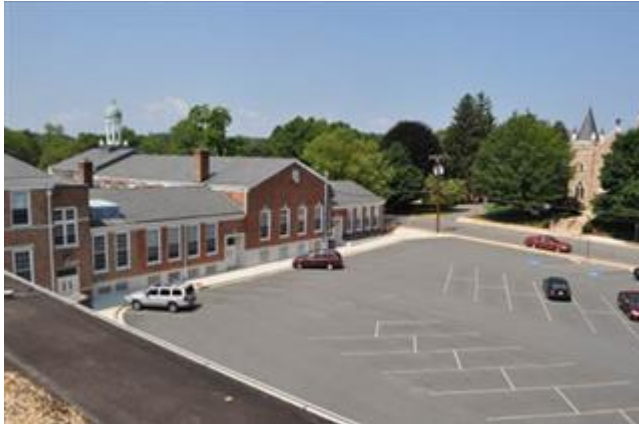
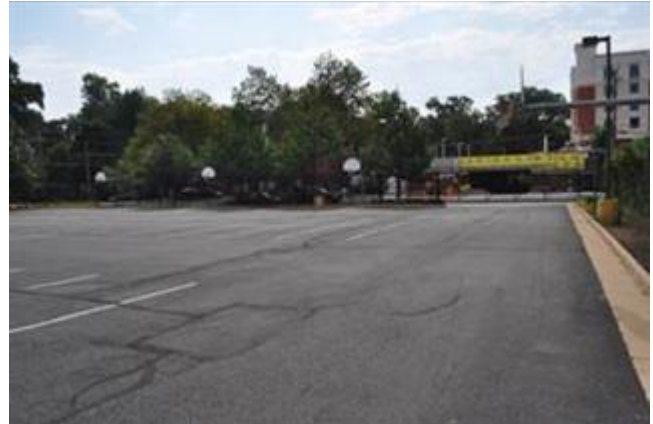
Asphalt Pavement. The Church is responsible for the parking areas, and paths within the facility. In general, the Church's asphalt pavements are in good condition.

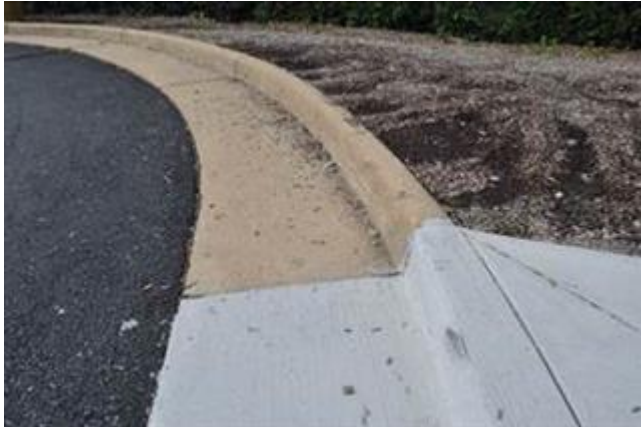
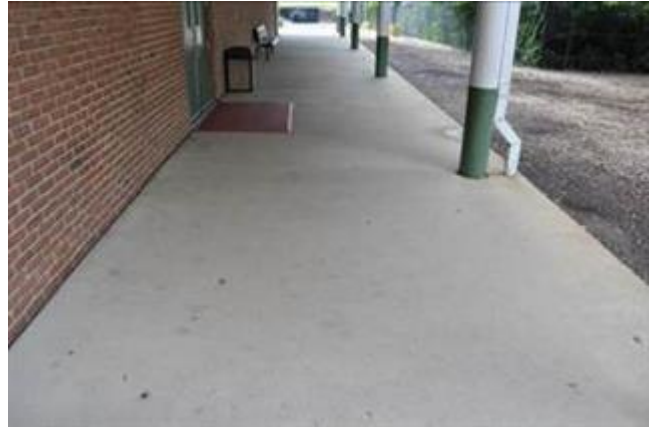
Concrete Work. The concrete work includes the community curbs, sidewalks, leadwalks, stairs, stoops, and other flatwork. We have modeled for curb replacement when the asphalt pavement is overlaid. The overall condition of the concrete work is good.

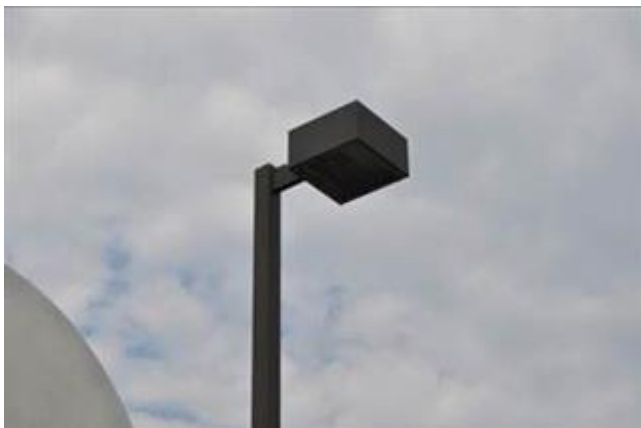
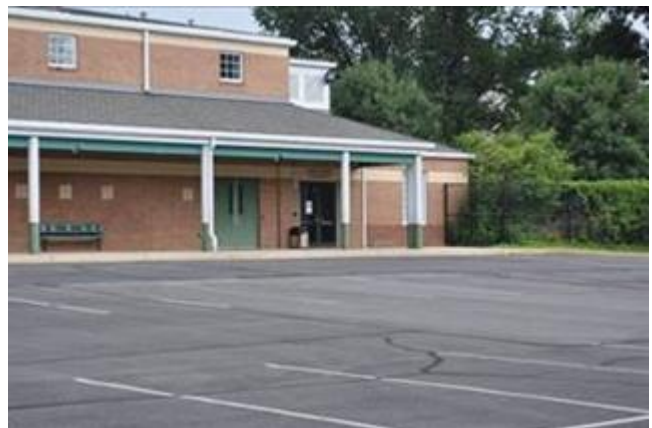
Site Lighting. The Church is responsible for the operation of the facility's site lights, and there are poled streetlights, and building mounted lights. The lighting system was not on at the time of our site visit. We understand that the lighting system is in operating condition.

This study assumes replacement of the light fixtures every 15 to 20 years, and pole replacement every 30 to 40 years. When the light poles are replaced, we assume that the underground wiring will also be replaced.

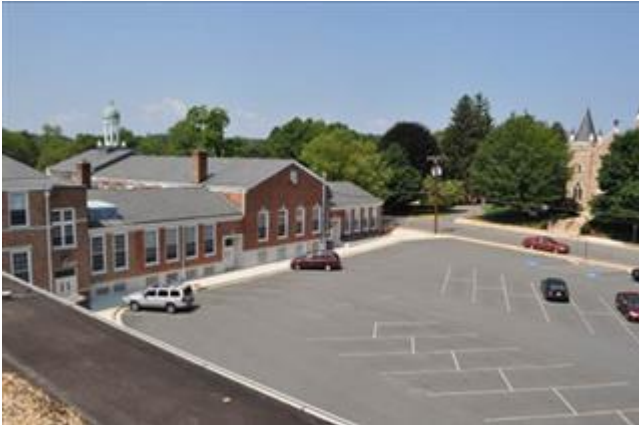
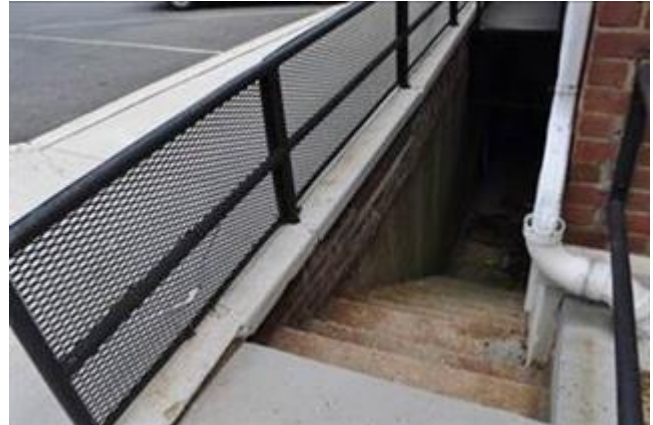
Retaining Walls. The Church maintains masonry, poured concrete and stone retaining walls. The retaining walls are in mixed condition relative to the age of the installation.

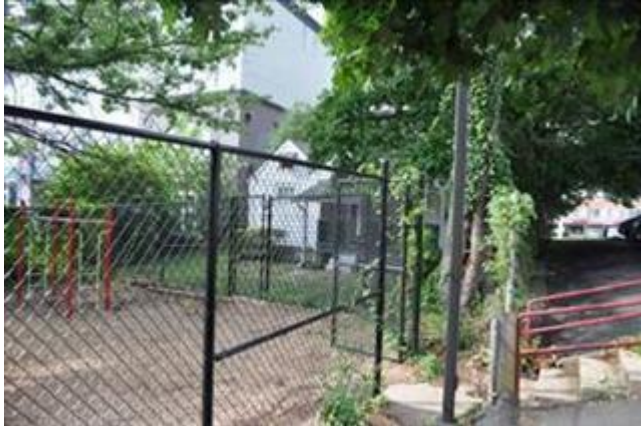
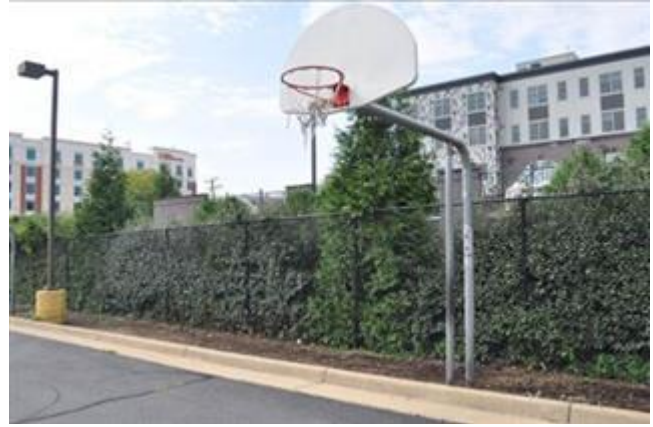
Fencing. The Church maintains metal fencing that is in generally good condition. Fencing systems have a large number of configurations and finishes that can usually be repaired as a maintenance activity by replacing individual components as they become damaged or weathered.

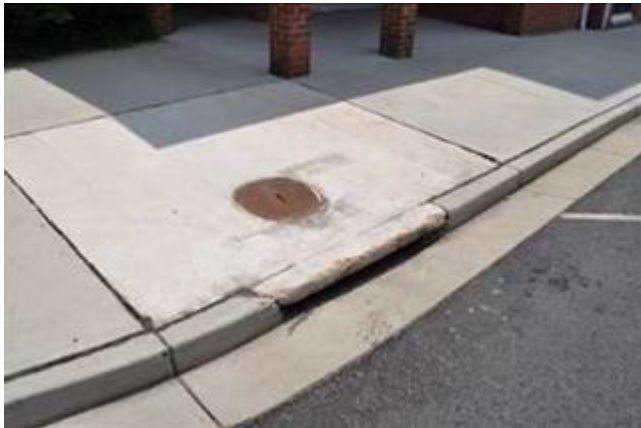
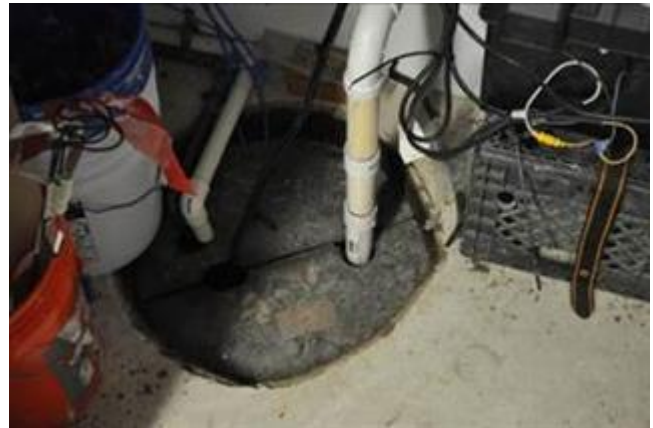
Storm Water Management. Storm water can be problematic in areas with high runoff water or dramatic changes in elevation. Typically, the majority of storm water management systems are maintained by the county or municipality. This study attempts to include the portions of the system are considered common property. The share line between municipality and community responsibility is often obscure and subject to the judgment of the county authority.

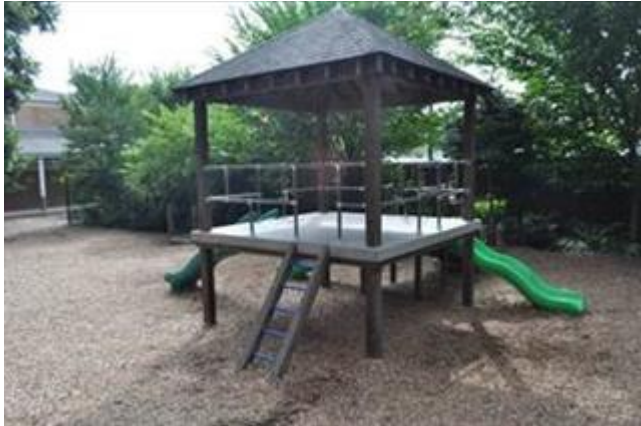
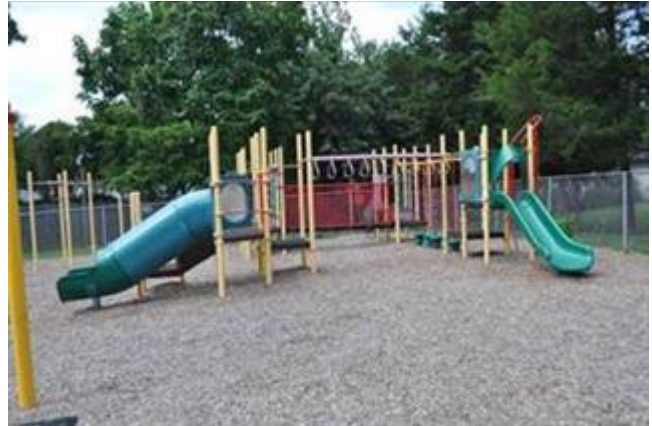
Tot Lots. The facility maintains two tot lots. These tot lots include play structures, miscellaneous play equipment, and a wood chip surface. The facility facilities are in generally good condition.

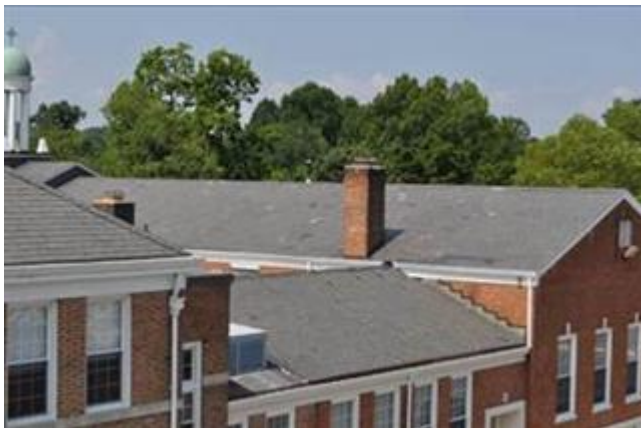
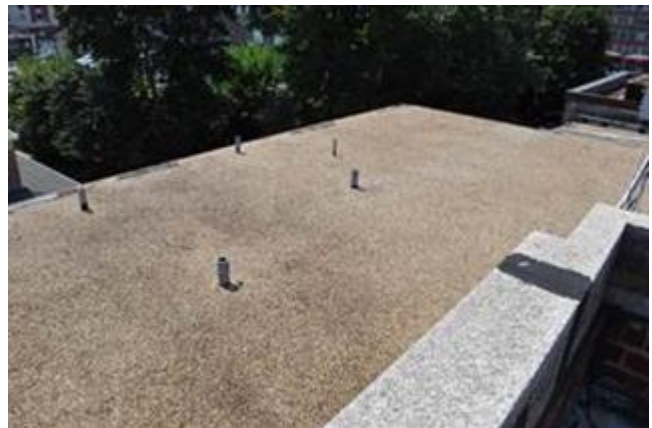
Building Roofing. The buildings are roofed in asphalt, slate, and flat roofing systems that are in generally mixed condition based on the age of the installation.

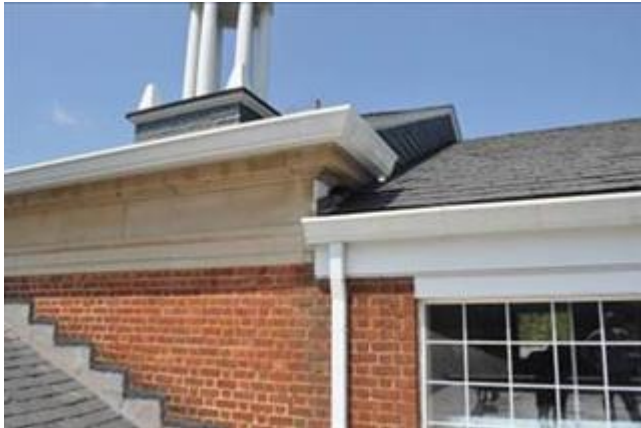
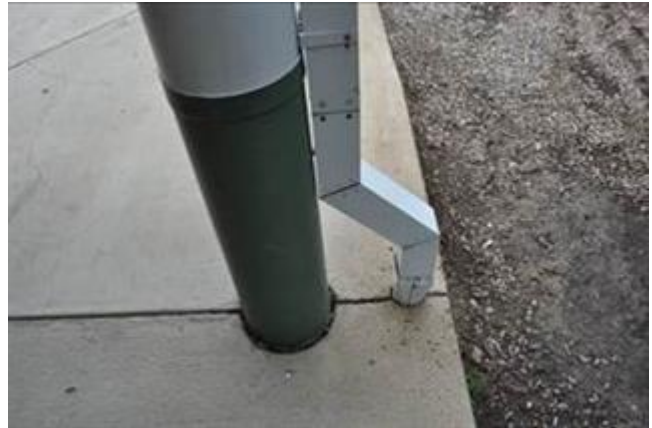
It is recommended that all gutters be cleaned at least twice each year. If there are a large number of trees located close to a building, consider installing a gutter debris shield that will let water into the gutters but will filter out leaves, twigs, and other debris.

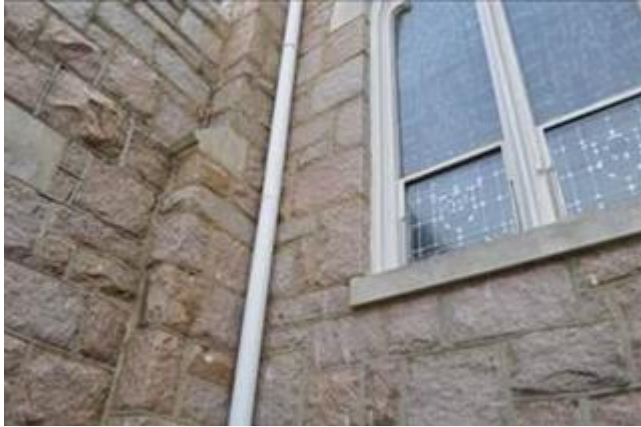
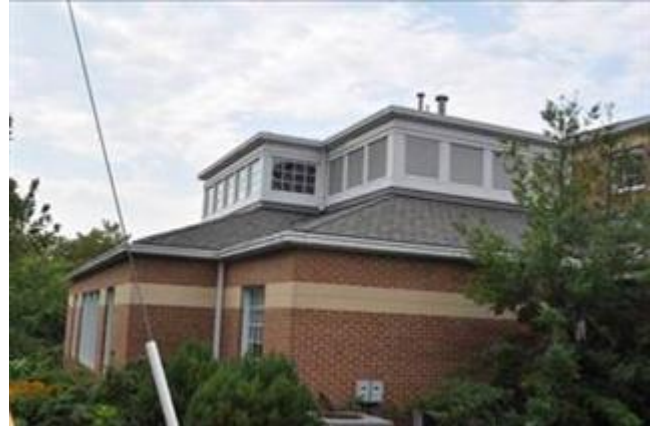
Siding and Trim. The exteriors of the buildings are clad in wood, vinyl, and masonry siding and trim. The siding and trim materials are in generally good condition.

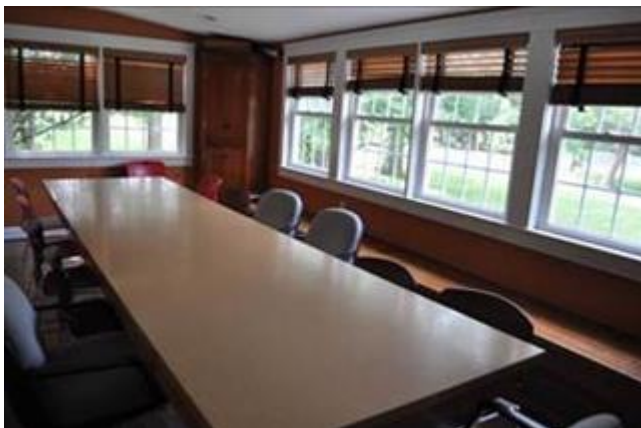
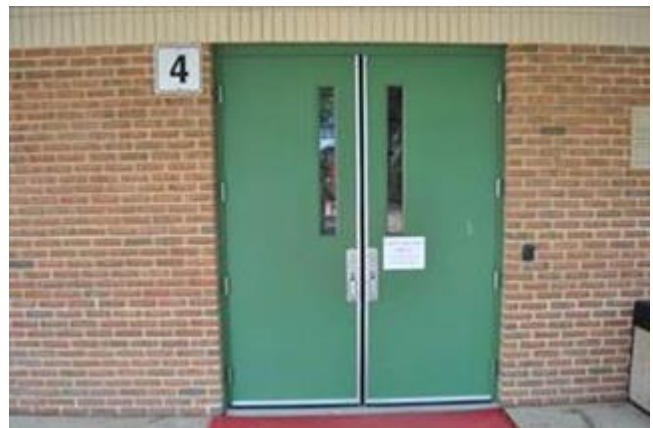
The Church is responsible for all of the windows and exterior doors of the facility. The windows and doors are in generally good condition.

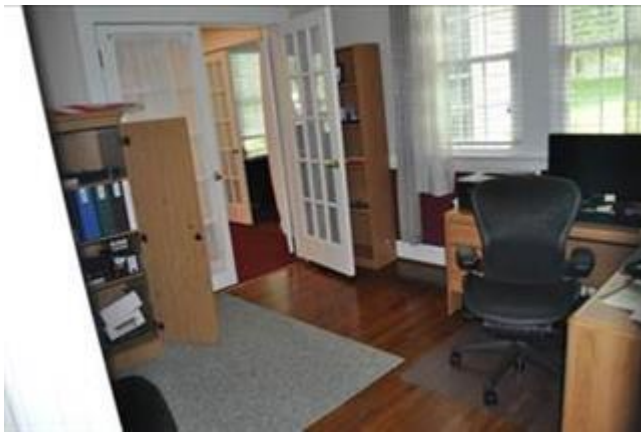
Building Interiors. The Church maintains the lobbies, halls, classrooms, residences, offices, and meeting area that are in generally good condition.

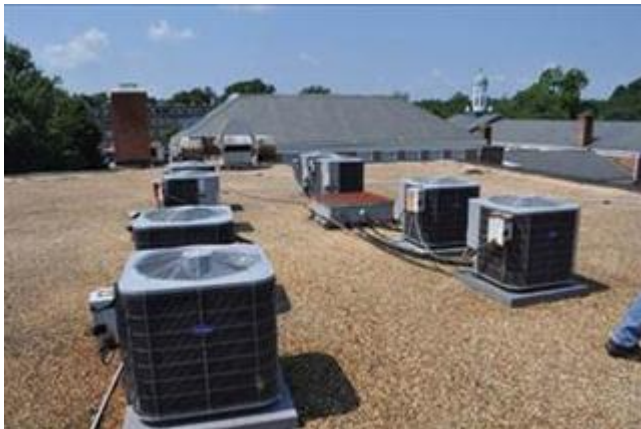
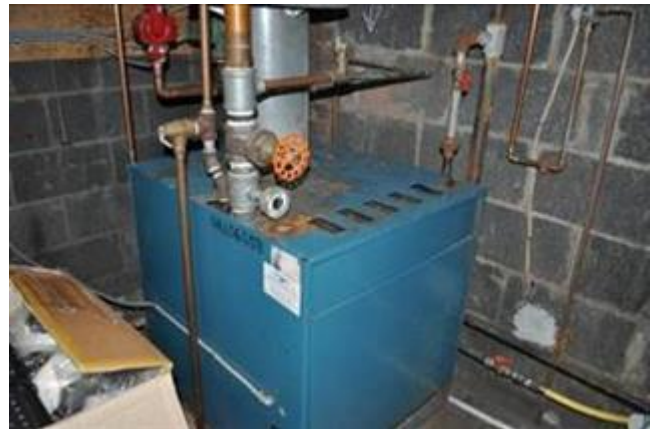
Split and Package HVAC Systems. The heating ventilation and air conditioning (HVAC) of the facility are reported to be in good operating condition. Detailed inspection and testing of these systems is beyond the scope of this study.

The Church maintains a number of HVAC systems that use the refrigerant known as R22. This refrigerant will be phased out of production by the year 2030 and was generally phased out of use in new systems in 2010.

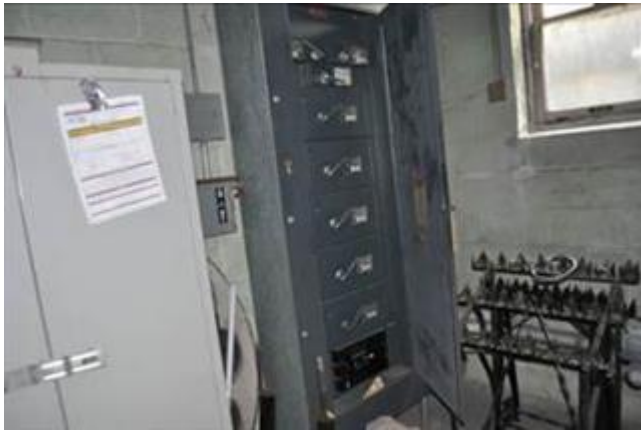
Building Electrical Service. The electrical systems of the buildings are reported to be operating normally.

In order to maintain this equipment properly, periodic tightening of all connections is recommended every three to five years. Insurance policies in some cases may have specific requirements regarding the tightening of electrical connections. It is also recommended that outlets, sockets, switches, and minor fixtures be replaced at a maximum of every 30 years.
