LEVEL 1 REPLACEMENT RESERVE REPORT FY 2026 SAMPLE COUNTRY CLUB

REPLACEMENT RESERVE REPORT

SAMPLE COUNTRY CLUB

April 30, 2025

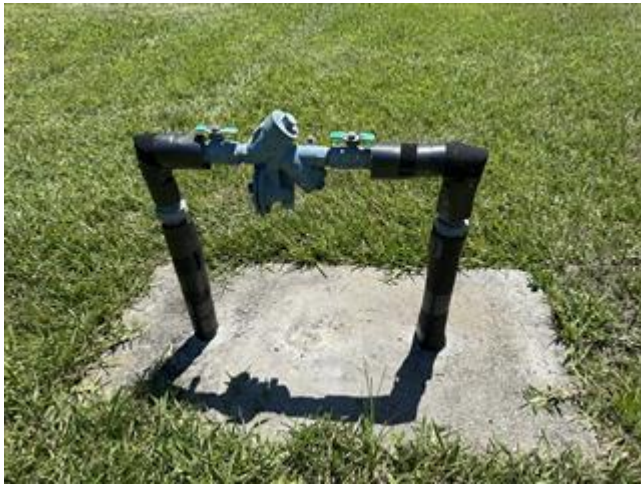
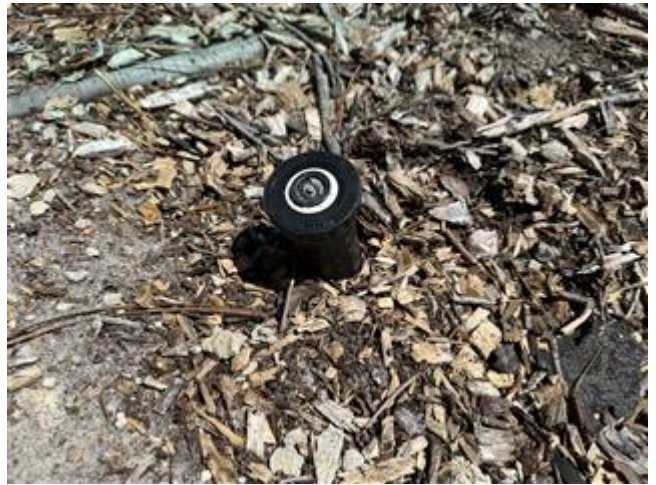
The irrigation system was renovated in 2023. The monitoring system is scheduled to be addressed in 2024, including GPS of 1,250 large sprinkler heads. Control boxes are also scheduled to be replaced in 2024.

Over time, underground portions of the system will deteriorate to the point where a complete system replacement will be required. In typical applications, this replacement interval is approximately 30 years long. System controllers have a typical service life of ten years. We have included an allowance for controllers and major components on an annual basis using figures provided by the Community Manager and based on historical data. We have also included funds for the replacement of control boxes, monitoring system, weather station, and irrigation system renovations in keeping with the last Reserve Study.

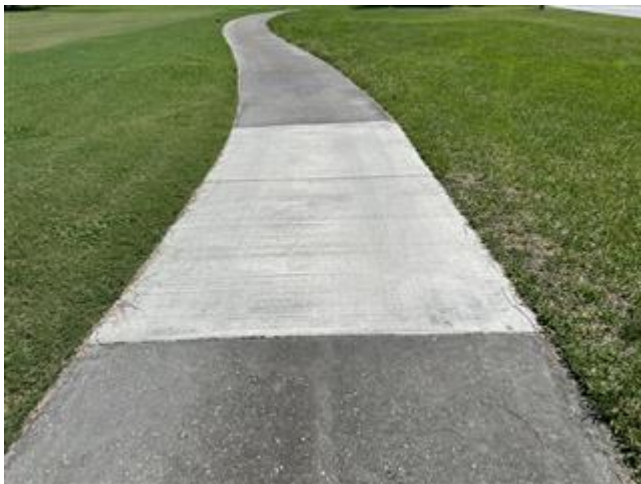
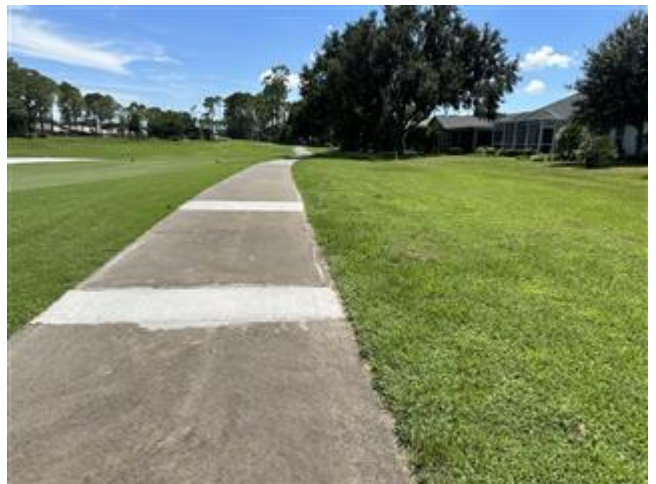
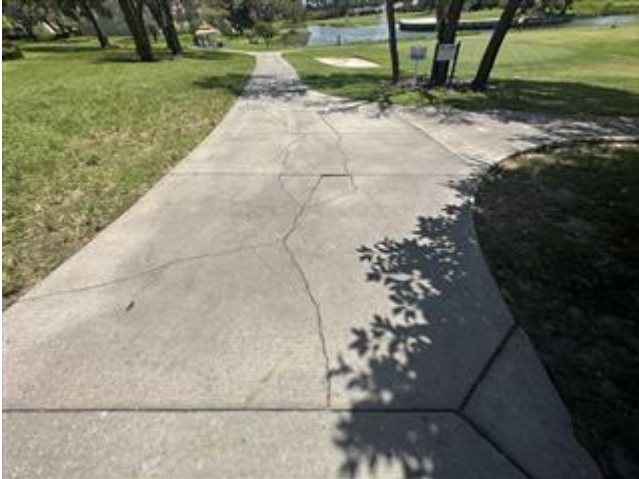
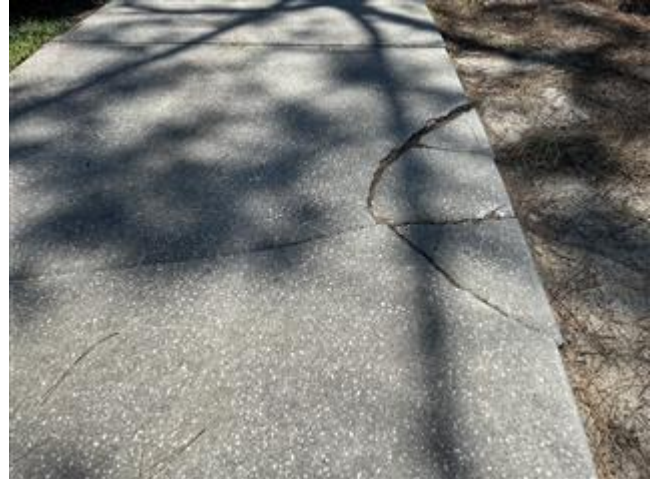
Concrete Golf Cart Paths. The 18-hole golf course includes a concrete path for golf cart access. No work was done on the path for a number of years until the Association began a repair program that lasted several years with the most recent project costing \$24,555 in 2021.

The final phase is scheduled for 2024. The overall condition of the concrete work appears to be mixed with a number of cracked or settled sections that will be replaced in 2024.

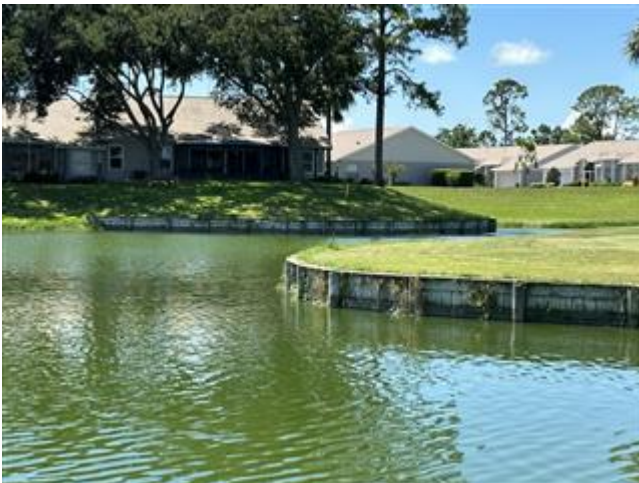
The two bulkheads at Hole #5 are shown below.

Wood Bulkheads. There are four timber bulkheads at three ponds: two at Pond #5, and one each at #7 and #18. All appear to be in fair condition. Although some maintenance and repair may be required over the next several years, major renovation should not be needed for a number of years.

The Association may benefit from scheduling bulkhead work concurrent with the renovation of that part of the course, to take advantage of the closed course, even if the bulkhead work could have been deferred a year or two.

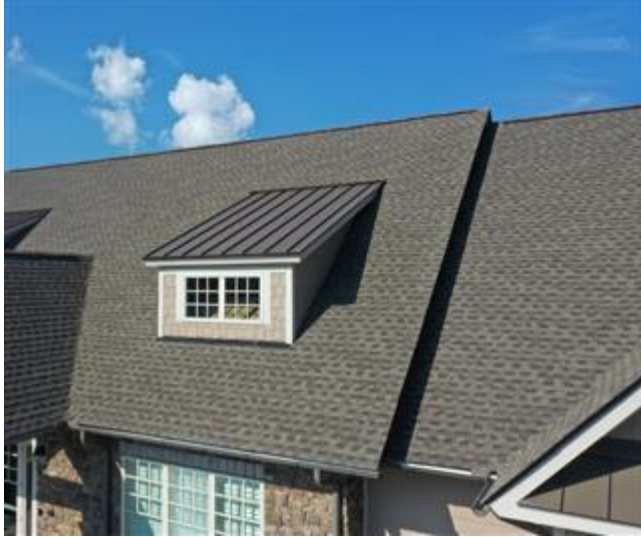
Building Roofing. The asphalt shingle roof appears to be in good condition.

Asphalt shingle roofs can have a useful life of 20 to 50 years, depending on the weight and quality of the shingle. Weathered, curled, and missing shingles indicate they may be nearing the end of their useful life.

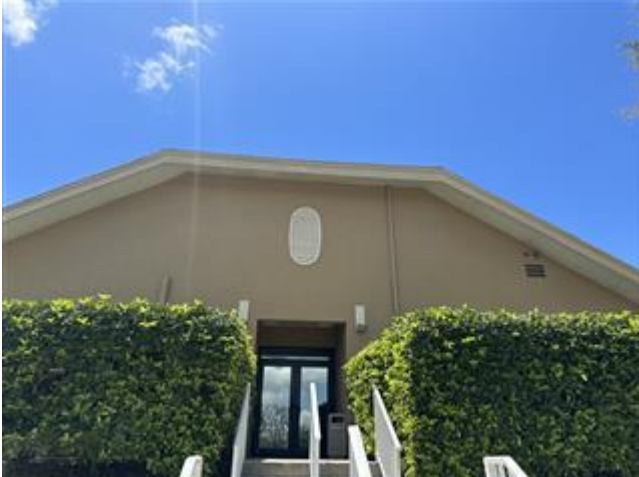
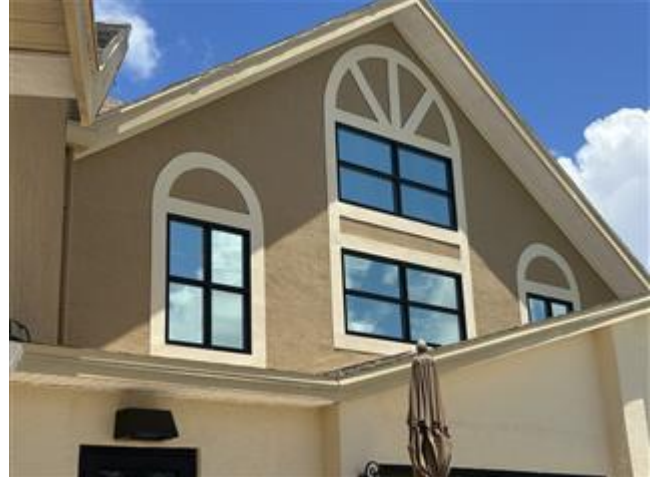
The stucco is painted every couple of years, and deficiencies that are discovered during this process are addressed immediately. The life of the stucco should be extended through this proactive maintenance approach.

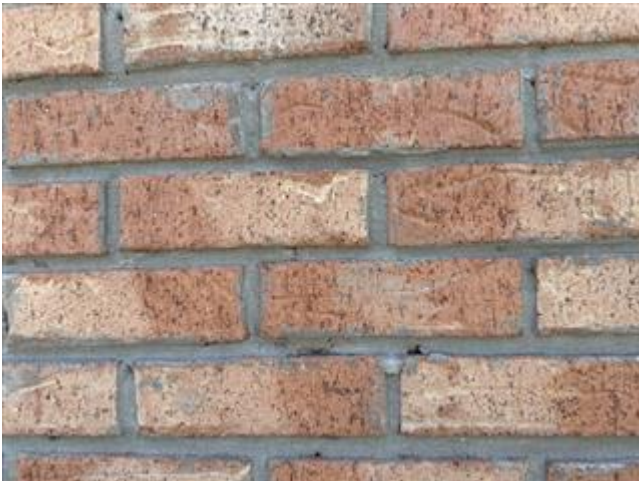
Brick masonry is used at the base of the walls. As masonry weathers, the mortar joints will become damaged by water penetration. As additional water gains access to the joints, repeated freeze-thaw cycles gradually increase the damage to the mortar joints. If allowed to progress, even the masonry units such as brick can have their surfaces affected and masonry units can become loose.

In general, masonry is considered a long-life item and is therefore excluded from reserve funding. However, because weather and other conditions result in the slow deterioration of the mortar in masonry joints, we have included funding in this study for re-pointing. Re-pointing is the process of raking and cutting out damaged sections of mortar and replacing them with new mortar.

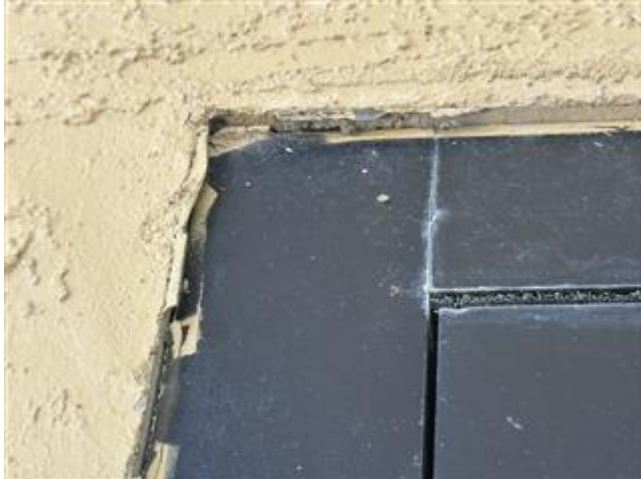
Caulking. The caulking on the facility's exteriors appears to be in fair condition. We have scheduled the caulking project to coincide with the masonry re-pointing project.

Caulking and sealants play a primary role in the protection of the facility's exterior components and the overall weather tightness of the facility. Caulking also provides a seal between dissimilar materials and changes in construction where movement is expected. We, therefore, recommend re-caulking every 10 to 20 years, when painting or other exterior repairs and replacements are scheduled.

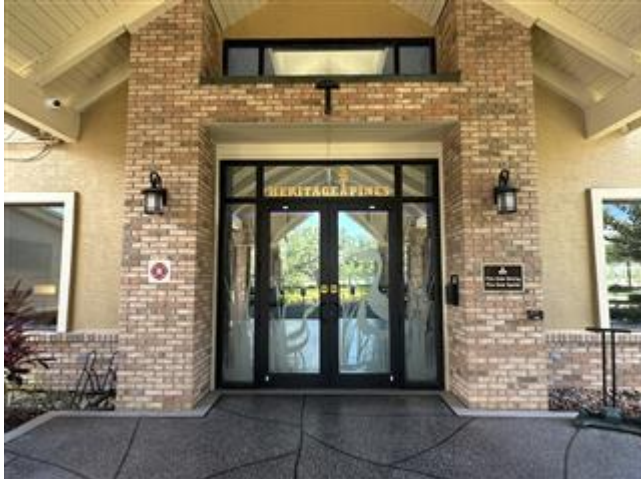
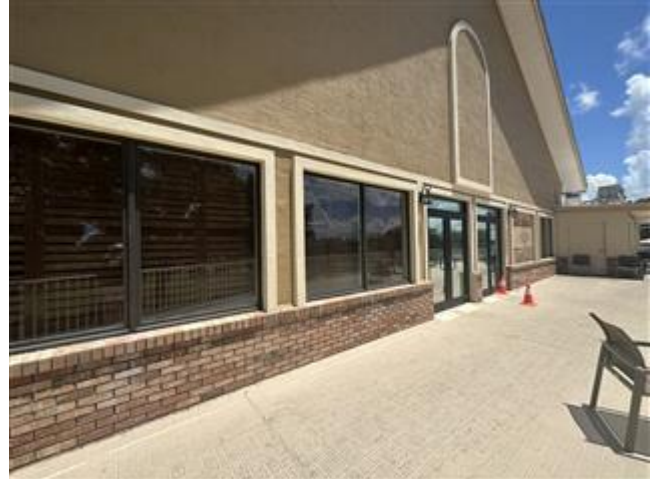
Windows and Doors. The windows and doors are reported to be in good condition. The exterior door hardware was replaced in 2023.

Window and door units play an integral part in a facility's overall comfort, efficiency, and energy use. The quality of the installed units and the care taken in their installation and maintenance are major factors in their effectiveness and useful life. These units can have a useful life of 20 to 35 years or more depending on their use and other factors mentioned above.

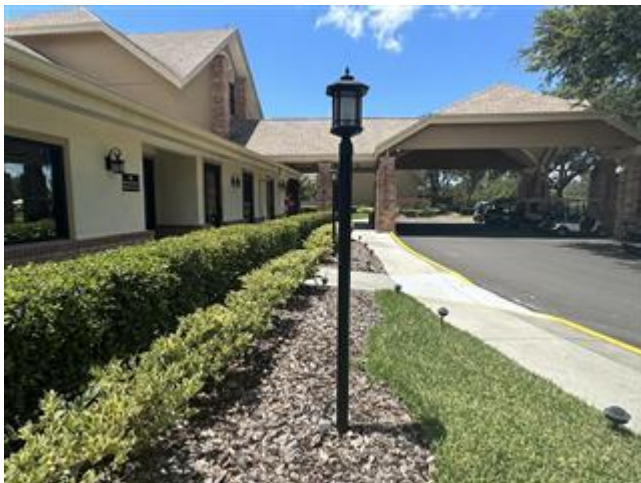
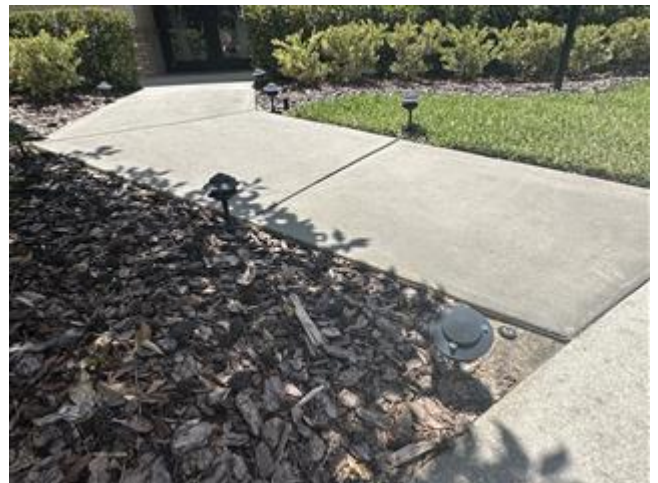
Site Lighting, Clubhouse. There is a combination of light poles and ground-mounted lights illuminating the clubhouse site. The lights were replaced in 2021 and 2022 and are LED. The lights were not on at the time of our site visit, but we understand they remain in good operating condition.

This study assumes the replacement of the light poles with fixtures every 20 years, and ground-mounted lights every 10 years.

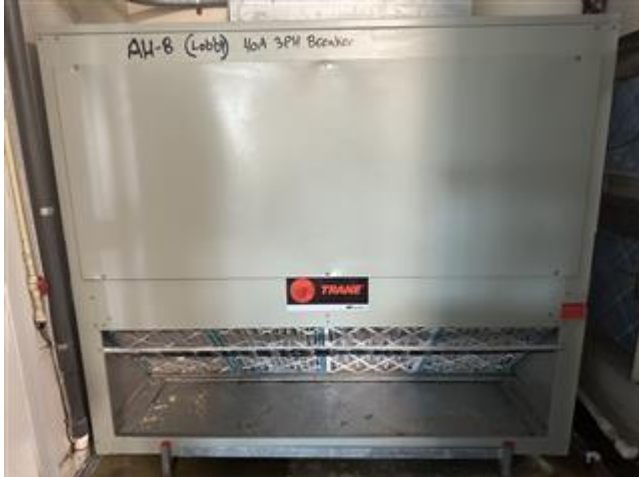
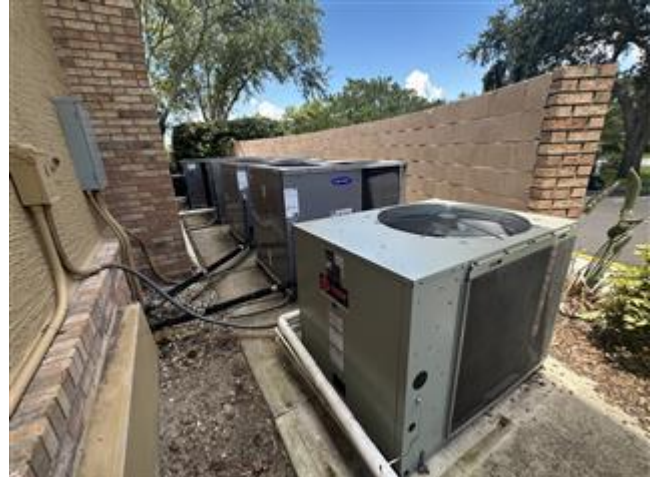
The 10-ton units #1 and #2 were replaced in 2023. Other units with a Remaining Expected Life of more than 0 years were replaced between 2014 and 2022. The remainder of the HVAC systems show a remaining life of 0 years, but the replacement of individual units should be deferred until they require major repair or replacement.

The Association maintains a number of HVAC systems that use one of the new-generation refrigerants. Unlike the old R22 refrigerant, the new refrigerants are expected to be available throughout the period of this study. However, the operating pressure for new refrigerant systems is approximately twice as high as for older systems. Many of the standard components have not been redesigned for these higher pressures, including the coils, which generally fail due to metal fatigue.

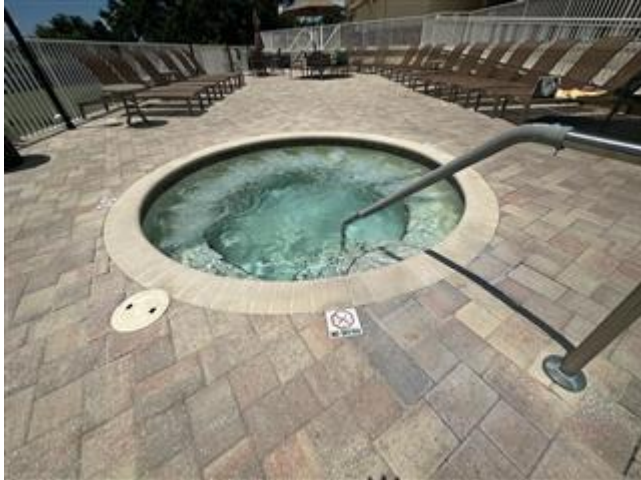
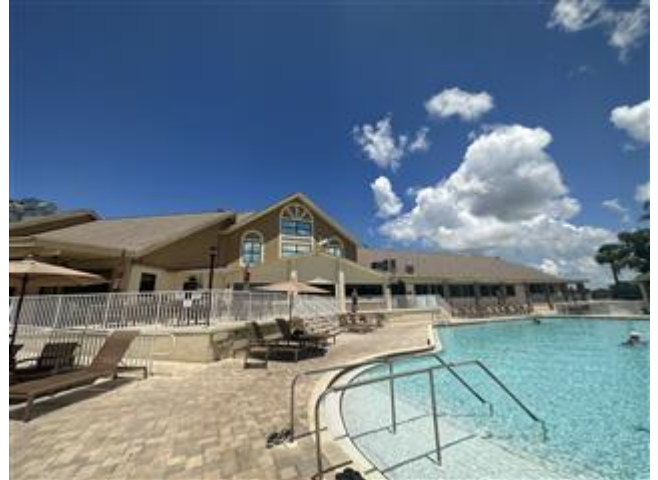
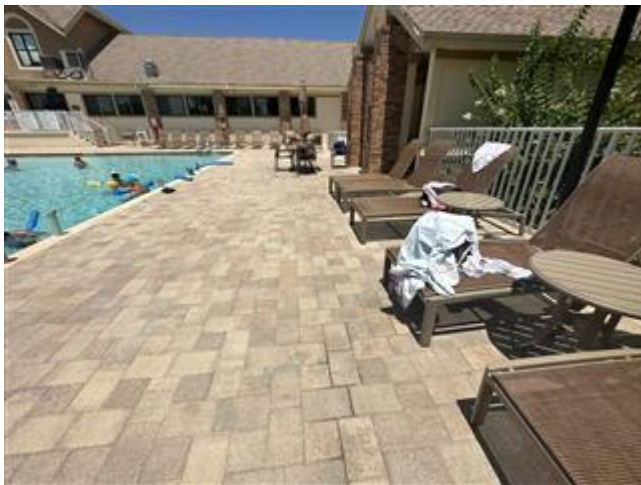
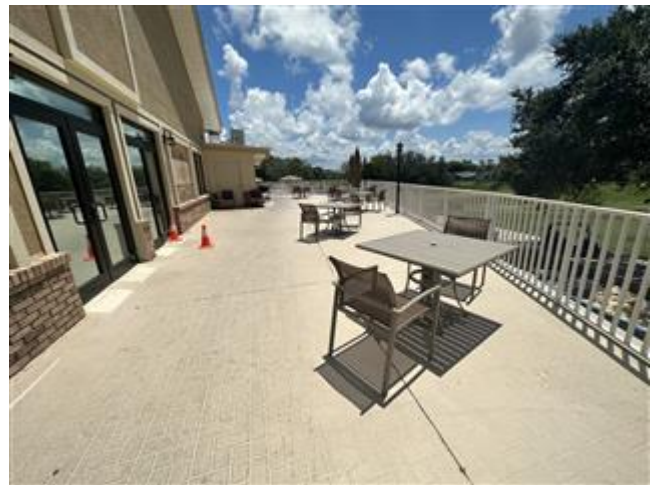
Swimming Pool. The community operates an outdoor pool and a spa of concrete construction. The pool is heated during cool months and is open year-round. Listed below are the major components of the pool facilities:

- **Pool Shell.** A major leak in the pool's drainage system was repaired in 2021 at a cost of \$8,100. There are no reports of active leaks. Pool shells normally have a finite life of approximately 60 years. At that point in time, it may not be necessary to replace the entire structure. However, it is prudent to anticipate a major expenditure for the replacement of underground lines and sections of the pool. Pool surfaces should be resurfaced every 10 years to maintain and extend the life expectancy of the structure.
- **Pool Deck.** The pool has two levels of concrete decking, and the overall condition of the deck appears to be good. In 2011, issues with both decks were corrected. The lower deck surface was covered with pavers. The upper deck was covered with an acrylic coating.

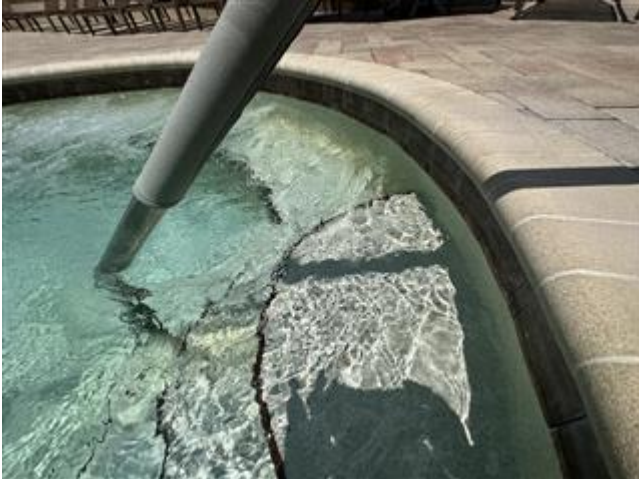
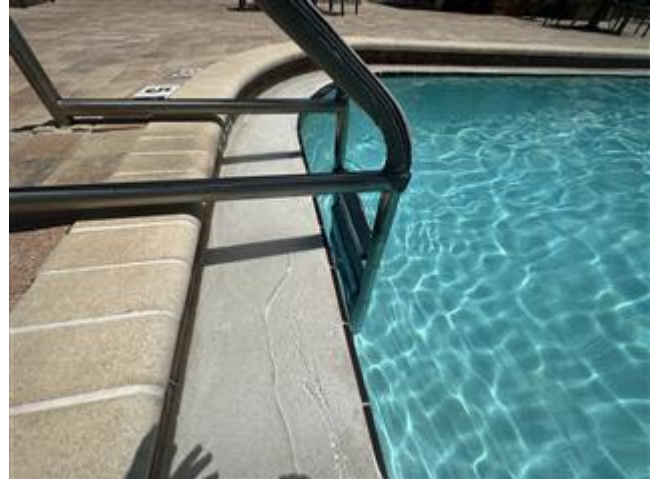
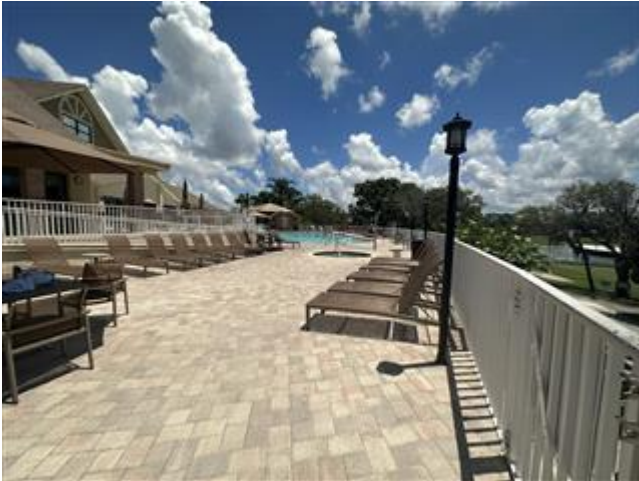
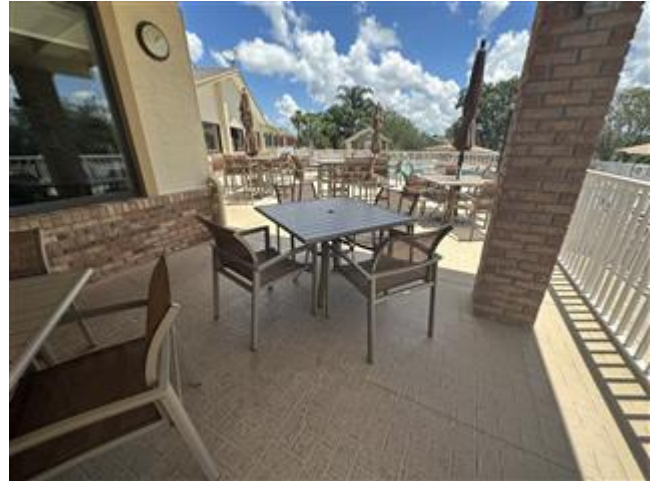
- **Whitecoat.** The pool was whitecoated in 2021 and appears to be in good condition. We have assumed a service life of 10 years for the pool whitecoat.
- **Waterline Tile.** The waterline tile was replaced in 2021 and appears to be in good condition. We have assumed that the waterline tile will be replaced or restored when the pool is whitecoated. The edge of the pool structure where it meets the deck and the waterline tiles are the first line of defense to maintain the water-tight integrity of the structure. The tiles were replaced in 2010, before being replaced again in 2021.

- **Coping.** The pool is edged with masonry coping. The coping appears to be in good condition. Cracked coping is typically replaced as needed when the waterline tiles are replaced and/or the pool is whitecoated.
- **Pool Furniture.** Pool and upper-level patio furniture is top-of-the-line in quality. The current plan calls for the replacement of the furniture every 10 years.

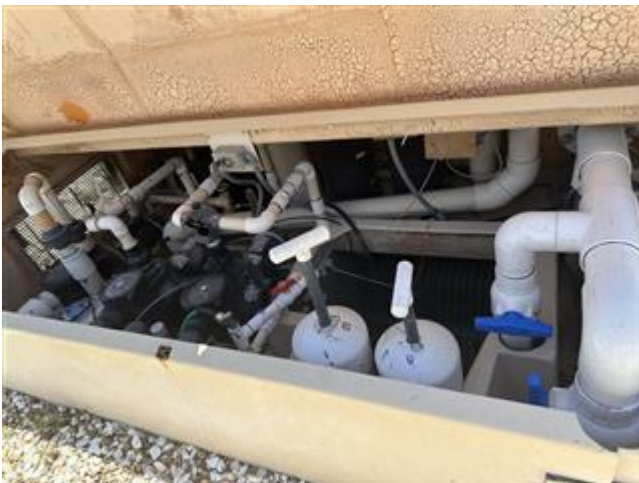
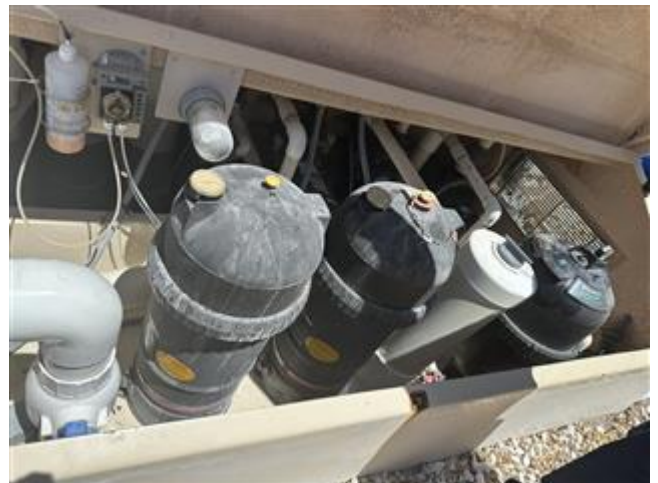
- **Pump and Filter System.** The filter system is reported to be in good operating condition. The spa jet pump motor and grid filter system were replaced in 2023 for a total of \$2,083.

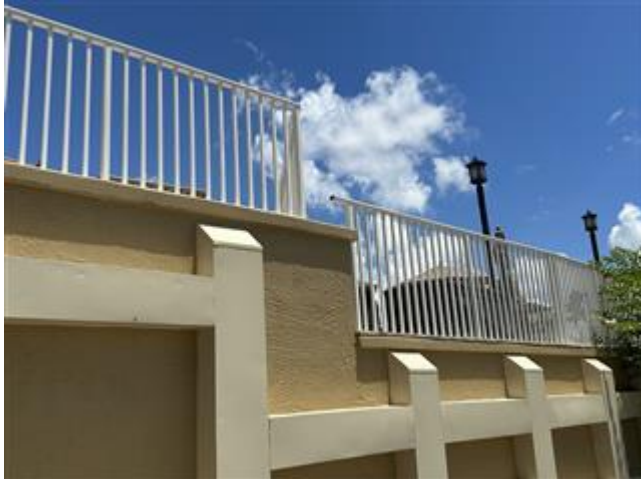
- **Pool Heaters.** Pool water is heated with a system of 9 geothermal heaters that were installed in 2021. There have been minor issues, and all repairs were covered under warranty.
- **Pool Fence.** The swimming pool is enclosed by a metal fence that appears to be in fair condition.

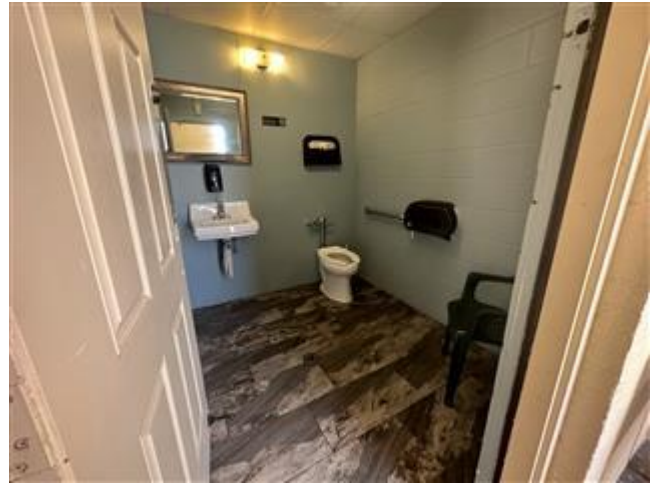
Pool House. The pool house roof is under contract to be replaced in 2023 with the clubhouse roof. All other components are reported to be operating normally.

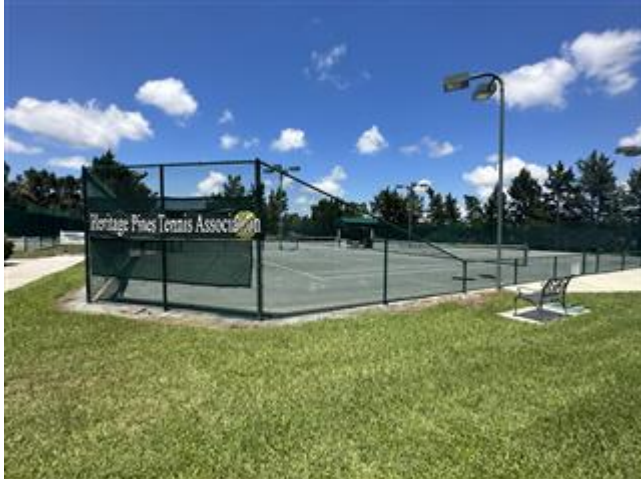
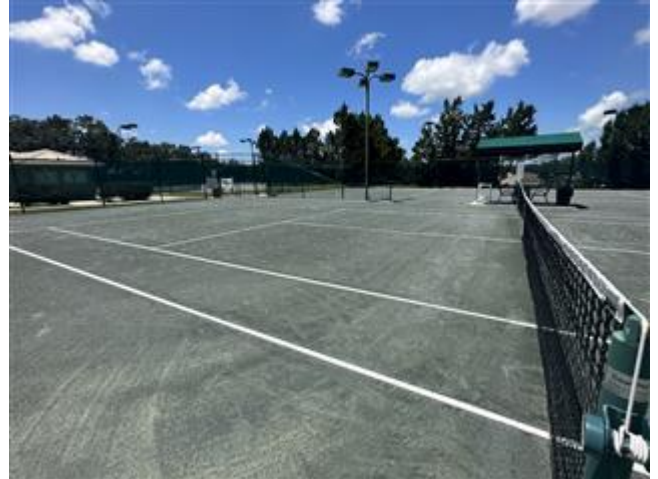
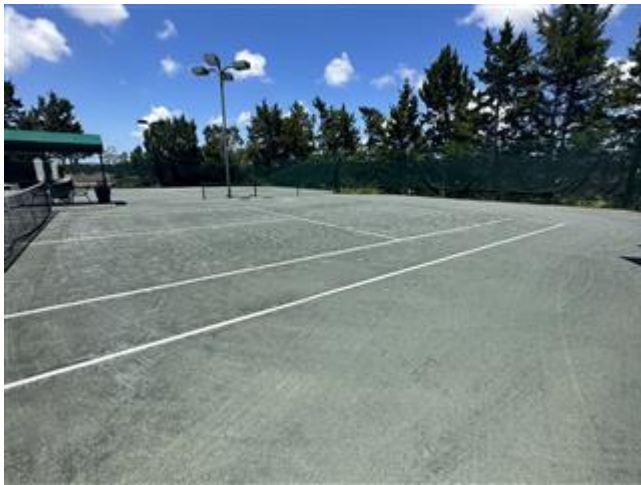
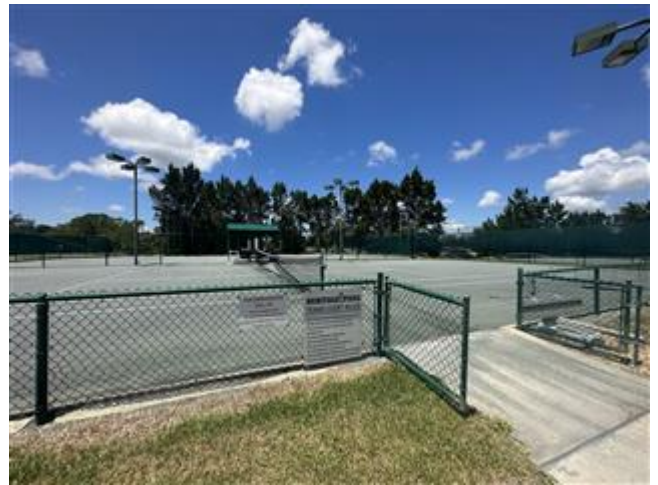
Tennis Courts – Har-Tru. The community maintains multiple tennis courts. The overall condition of these courts appears to be good. The court surface is Har-Tru. Har-Tru is a clay-like material manufactured from crushed green stone. There are two types of Har-Tru courts: sprinklered and subsurface irrigated. The courts operated by the Association are subsurface irrigated.

Subsurface irrigated courts have a tendency to develop depressions or low spots over time. These areas will require patching and rolling, activities that are considered to be routine maintenance. Although subsurface irrigated courts lose material at a slower rate than sprinklered courts, they too have to be top-dressed annually. We have included resurfacing of the court on a six-year basis and replacement of the subsurface irrigation system on a 24-year basis.

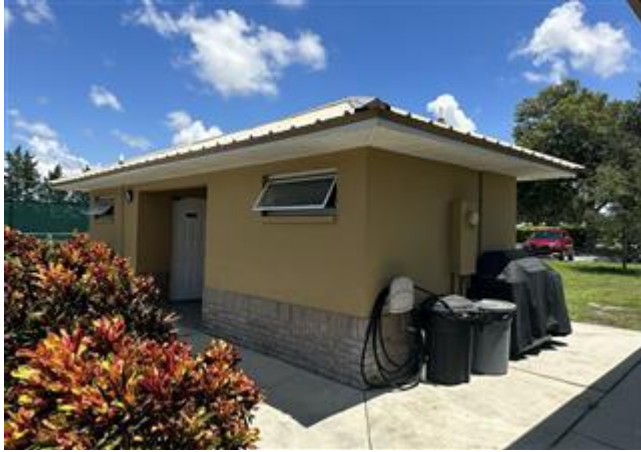
Tennis Court Restroom. A restroom at the tennis facility is constructed with a standing seam metal roof and stucco/brick siding. An allowance is included to renovate the restroom.

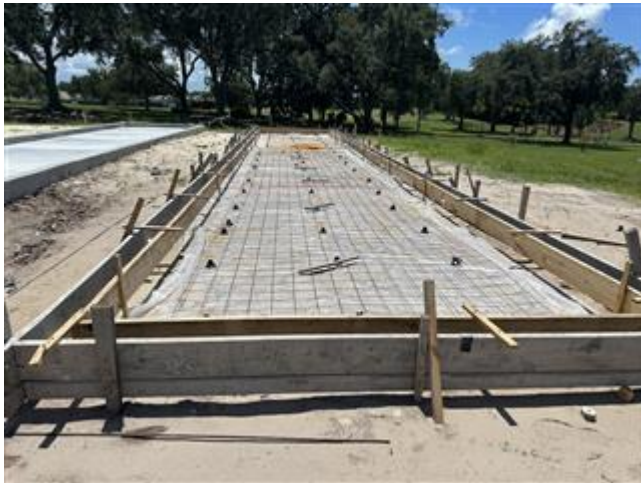
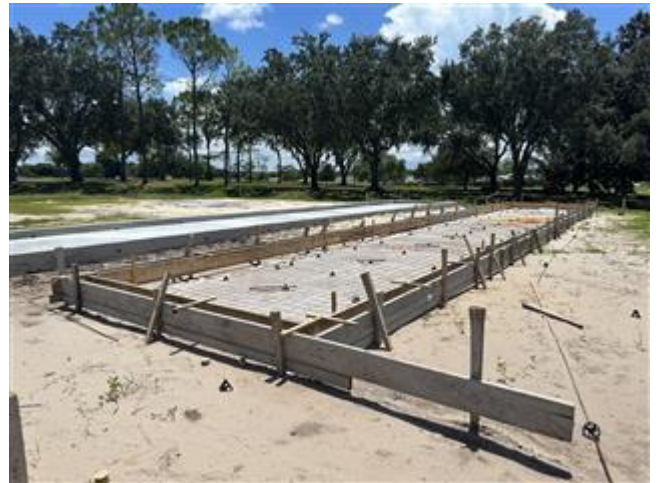
Bocce Court. The wood courts were being replaced with concrete structures during our site visit in August 2023. The total project cost is approximately \$100k which includes the following components:

- **Lighting.** Basic lighting will be installed. The quantity of lights should be verified during the next Level 2 Reserve Study update.

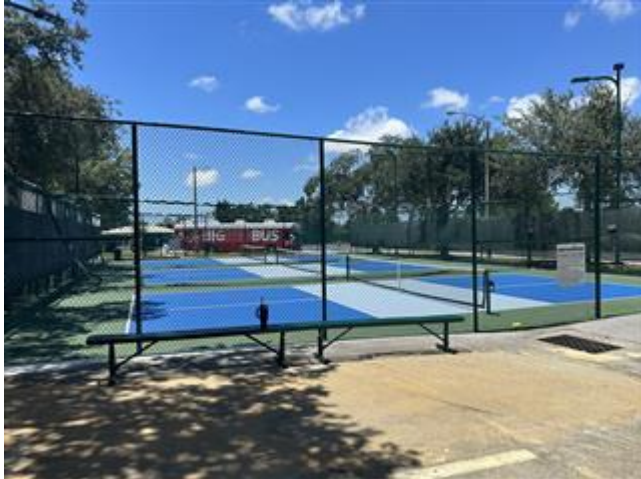
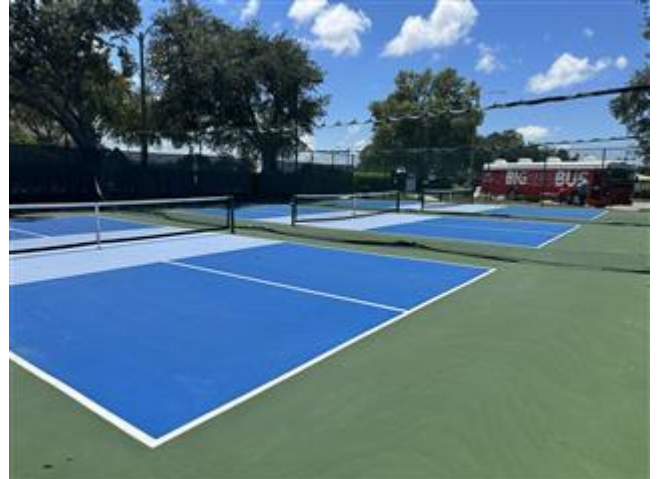
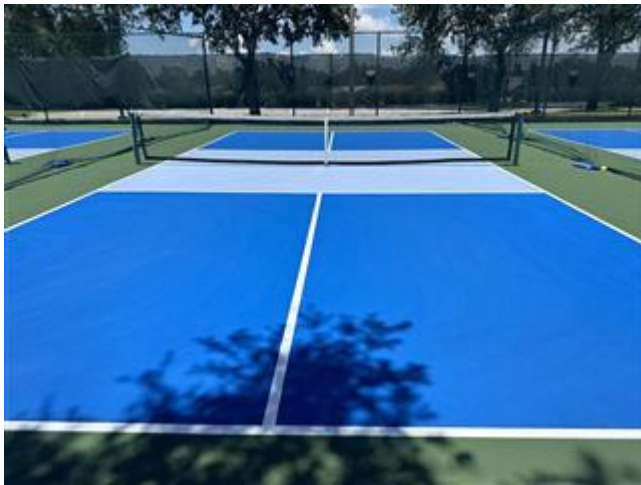
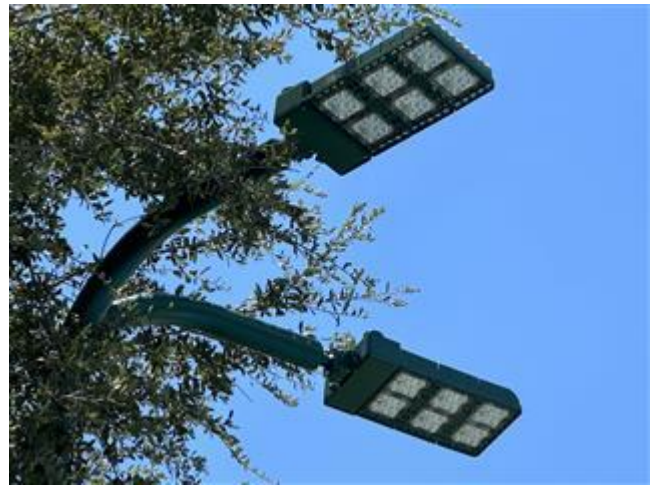
Pickleball Courts. The Association installed three pickleball courts in 2020 with fencing, pole lighting, benches, and a water cooler cabinet. All components are in good condition.
